Tsunami Evacuation Study | Viña del Mar Zone 1

Preetish Kakoty, Barbara Simpson, Marisella Ortega, and Wael Hassan
EERI Learning From Earthquakes Travel Study Program, Chile 2017

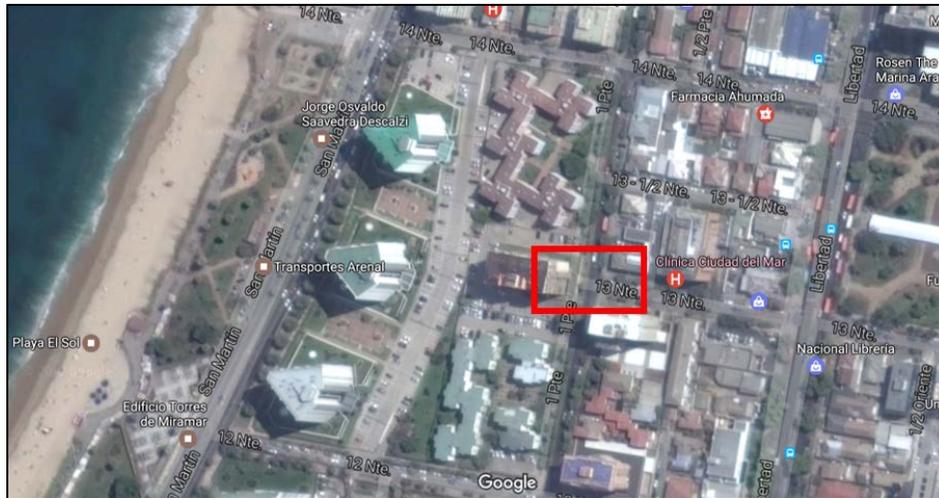
Fig. 3. A close-up of Routes 12, 13 and 14 Norte where the blockage of 13 Norte by a residential complex is highlighted.

Route 13 Norte did not extend completely to Avenida San Martin (Fig. 1). It ended at gated communities a block away from the main road (Avenida San Martin). Thus, no beach access for 13 Norte could be used during actual tsunami evacuation. Given the long distance between routes 12 Norte and 14 Norte, proper detour signage at the beach to direct evacuees to 13 Norte route is essential. A review of the evacuation route on 13 Norte Street revealed a hospital located one block from the beach in the inundation zone (**Fig. 8**).

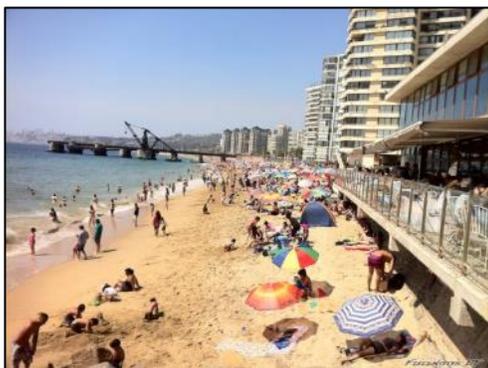
The beach area was quite crowded with people on a Sunday in summer time (**Fig. 4**). In the beach area observed for this study, there was only one staircase for beach access (**Fig. 10**) along nearly a 400 meter beach stretch that represents Zone 1, despite the steepness of the slope from the street level to the beach. Dirt trails up a small berm were also used to enter and exit the beach (**Fig. 6(a)**). These trails were relatively steep and not located along the street evacuation routes. Many street vendors occupied the walkway at the beach with their merchandise comprising possible obstacles during tsunami evacuation. It is noteworthy that many restaurants and cafes were closed on Sunday, so the possibility of blocking the sidewalks with their tables was not assessed.

Fig. 4. Number of people at beach.

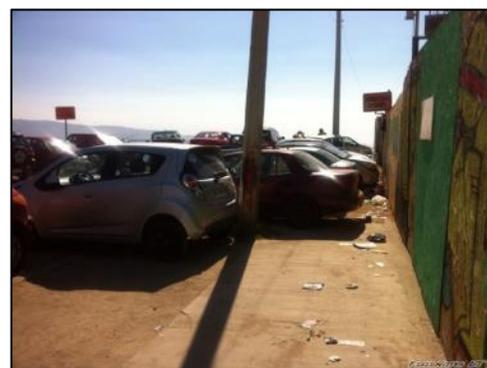
Fig. 5. Blockage of car.

Illegally parked cars on sidewalks were observed near the beach access and along all the evacuation routes (**Fig. 6(b)**). Many cars were parked next to the beach (**Fig. 5**), some of which were illegally parked and blocked the escape route from the beach. This is a law enforcement challenge that appears

to be one of the most hindering obstacles along the routes. Proper parking signs were posted along the routes, yet illegal parking appeared to be a problem. It could be these parking regulations were not enforced on Sundays. These parked cars narrowed the sidewalks significantly and could be potential bottle necks during a real evacuation. Garbage disposal bins that occupied a significant portion of the sidewalk were observed at some locations along the evacuation routes (**Fig. 7**), which also represent evacuation obstacles. The authors' observation of illegally parked cars and motorcycles on sidewalks was also observed in the other evacuation zones in the city (Zones 2, 3, 4) surveyed by other groups in the project.

6. Strictly enforce legal car parking through heavy fines and visible law enforcement officers.
7. Consider vertical evacuation as an alternative (or perhaps primary) evacuation protocol. A cascading earthquake-tsunami hazard structural review must be conducted to verify existing building suitability.

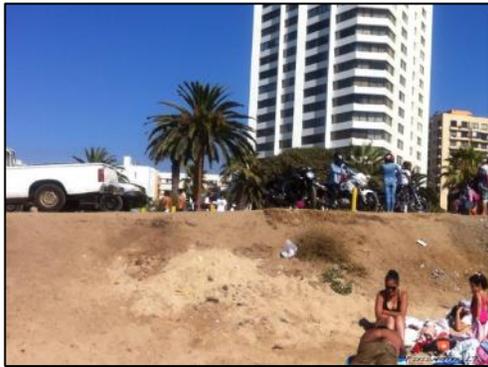
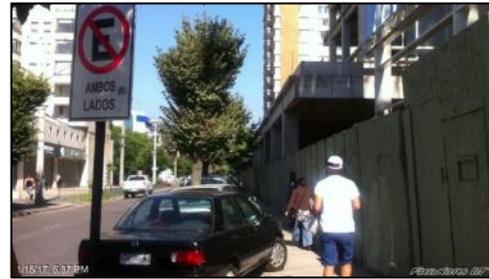
Fig. 6. Limited access to the routes.

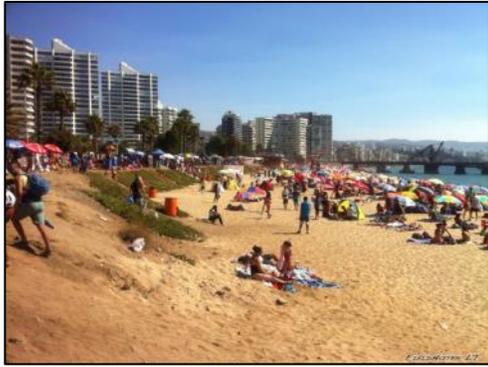
There were no tsunami hazard zone signs or tsunami evacuation instruction signs on the beach or even near the beach access along the entire stretch of Zone 1 (e.g. a sign used by ONEMI, **Fig. 11**). Thus, tourists or non-locals may not be able to find the beginning of the evacuation routes during an actual tsunami warning. This explains that most of the fatalities due to past tsunamis in the region were tourists. A single tsunami evacuation sign was located on the long crowded sea pier across 12 Norte route (Fig. 1).

Fig. 9. No sign of tsunami awareness.

1. Provide more access staircases at the beach and more accessibility to the evacuation routes.
2. Improve tsunami risk signage, evacuation route signage and detour signage at the beach and along the evacuation routes.

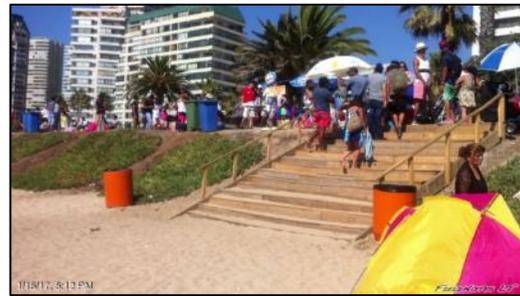
Fig. 10. Only one stair.

2. Beach access is inadequate in Zone 1. Beach evacuation could be difficult due to limited beach access stairs (one staircase per 400 meters of beach stretch in Zone 1) and the steep dirt slope from the beach to the street.

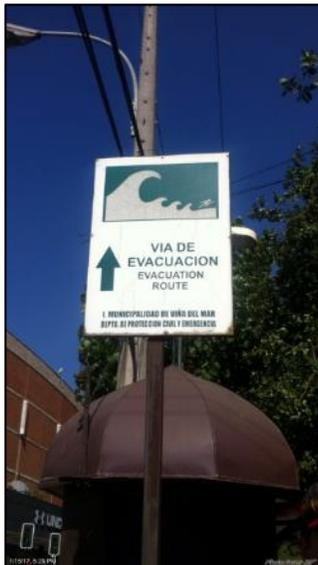
The first tsunami evacuation route street sign (**Fig. 11**) was located next to the shopping mall on route 14 Norte. One street later there was a second tsunami evacuation route sign (**Fig. 12**). Similarly, 13 Norte route had only two non-uniform evacuation signs. However, route 12 Norte had five signs that were all well distributed to the meeting point. The poor signage on 14 and 13 Norte streets could represent a major obstacle for evacuees. At the end of the evacuation routes at Quillota Avenue, there was also no signage indicating the end of the evacuation route or the meeting point location. Poor tsunami warning and evacuation signage at the beach, along evacuation routes, and near the meeting zone was a common observation by other groups who surveyed evacuation Zone 2, 3 and 4 within the same projects.

Fig. 11. Sign next to Mall.

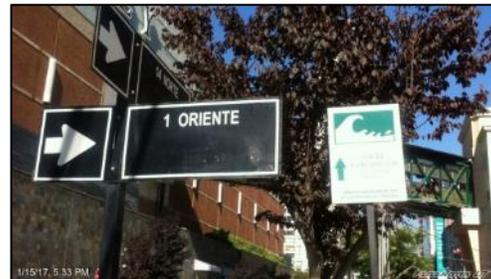
Fig. 12. Second sign of evacuation.

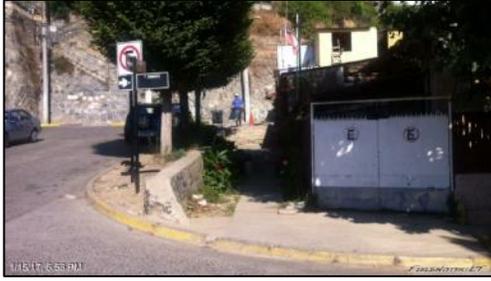
At the end of each evacuation route, the authors had great difficulty finding the “safe” assembly or meeting point 3. It is still unclear where the final meeting point was located at the ends of the routes. No visible signage to the meeting point was found on any of the routes. According to a map distributed to the authors by city officials, these meeting points required evacuees to make a right turn. However, no signage showed this turn location. Stairs located at the end of these routes further made accessing these meeting points difficult. However, there was a civil defense building located near the safe point (**Fig. 15**). A local girl of about nine years of age was interviewed near the assumed meeting point location at the end of route 13 Norte. She stated that her house was in a safe area (based on information given to her at school), and that the ground above the 13 Norte Street sign was considered a safe place (**Fig. 13**). On 13 Norte Street, one block from 14 Norte Street, there was an area that could have been a meeting point, but there was no sign to designate it as such (**Fig. 14**). Signage designating the safe zones was also missing, even though they may be mandatory signs.

Fig. 13. No sign to show safe meeting point.

3. Provide sufficient pavement maintenance particularly along the evacuation routes.
4. Provide proper signage for the safe zone at the end of evacuation routes and direction arrows to the assembly meeting point.

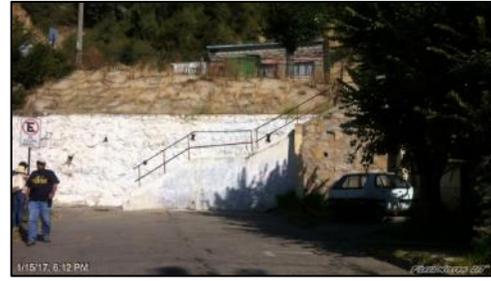
The last block of all three routes had moderately steep slopes. Stairs were located at the end of each evacuation route (**Fig. 14**). These stairs were relatively narrow and many steps were uneven. The stairs and slopes represent a challenge for the elderly, disabled, and families with children/strollers. It is unclear whether these stairs were supposed to be climbed at the end of each evacuation route because there was no signage to indicate arrival at the safe meeting point. However, a subsequent interview with a local girl showed that the meeting point is just at the stair bottom. Proper signage is a necessity in this regard. At the end of evacuation routes uphill at Quillota Avenue, there was also no signage indicating the end of the evacuation route and the location of the meeting point.

Fig. 14. Possible meeting point (assembly area).
