Preliminary Statistics of Collapsed Buildings in Mexico City in the September 19, 2017 Puebla-Morelos Earthquake

Francisco Galvis, Eduardo Miranda, Pablo Heresi, Héctor Dávalos and José Ramón Silos

John A. Blume Earthquake Engineering Center
Department of Civil and Environmental Engineering
Stanford University

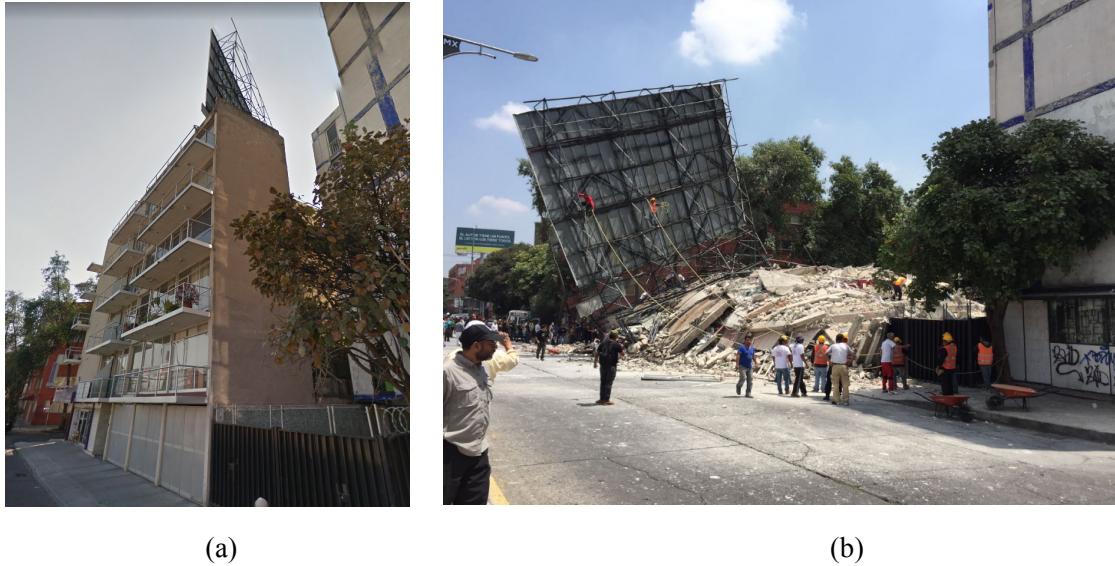
Figure 5 presents a histogram of the structural systems of the collapsed buildings. It is worth noticing that the structural system of more than 60% of the 44 collapses corresponds to a reinforced concrete (RC) column and flat slab system. This percentage is even higher than the observed in the 1985 earthquake which corresponded to 43.3% (91/210) (Meli and Miranda, 1985). The flat slab system is a system was developed in the early 1900s as a “beamless” primarily aimed at carrying gravity (vertical) loads and to facilitate construction by simplifying the formwork. However, when used as a lateral resisting system, the system is characterized by a very low lateral stiffness and prone to experiencing punching shear failures and soon after the slab-to-column connection loses its vertical carrying capacity it leads to a partial or total collapse of the building. During the 1985 earthquake 91 buildings with this structural system collapsed. In the emergency code that was issued a few days after the 1985 earthquake design forces for this structural system were greatly increased in order to disincentivize its use, however unfortunately it is still allowed by the code and continues to be used in buildings constructed after 1985. An example of the total collapse of one of these flat-slab reinforced concrete buildings is shown in Figure 6.

Figure 6. Building with flat slab system at Viaducto Miguel Alemán 106, Piedad Narvarte. (a) Before Sep. 19, 2017 (taken from Google Street View); and (b) After Sep. 19, 2017 (The Huffpost 2017).

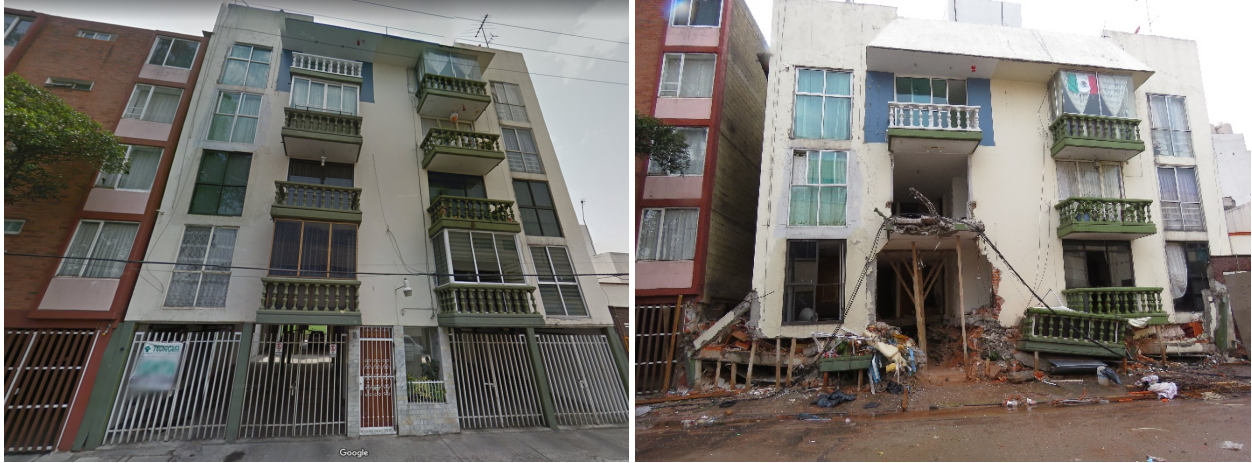
Figure 8. Residential building with a soft first story at Balsas 18, Miravalle. (a) Before Sep. 19, 2017 (taken from Google Street View); and (b) After Sep. 19, 2017 (photo by Pablo Heresi).

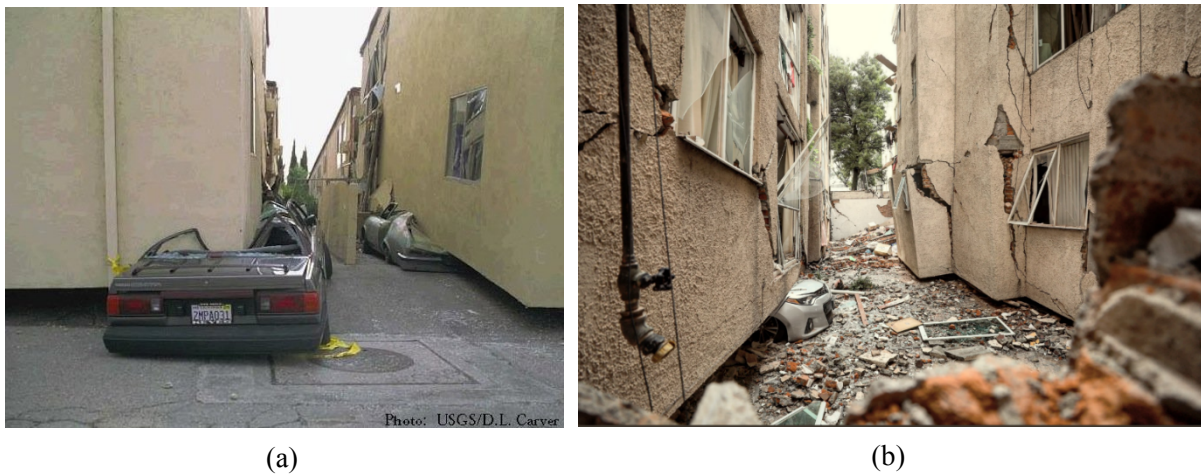
Figure 9 (a) Collapsed multistory apartment building with soft first story in the Northridge Earthquake in 1994 (USGS/ D. L. Carver); and (b) Residential building at Tokio 517, Portales Norte after Sep. 19, 2017 (The Huffpost 2017).

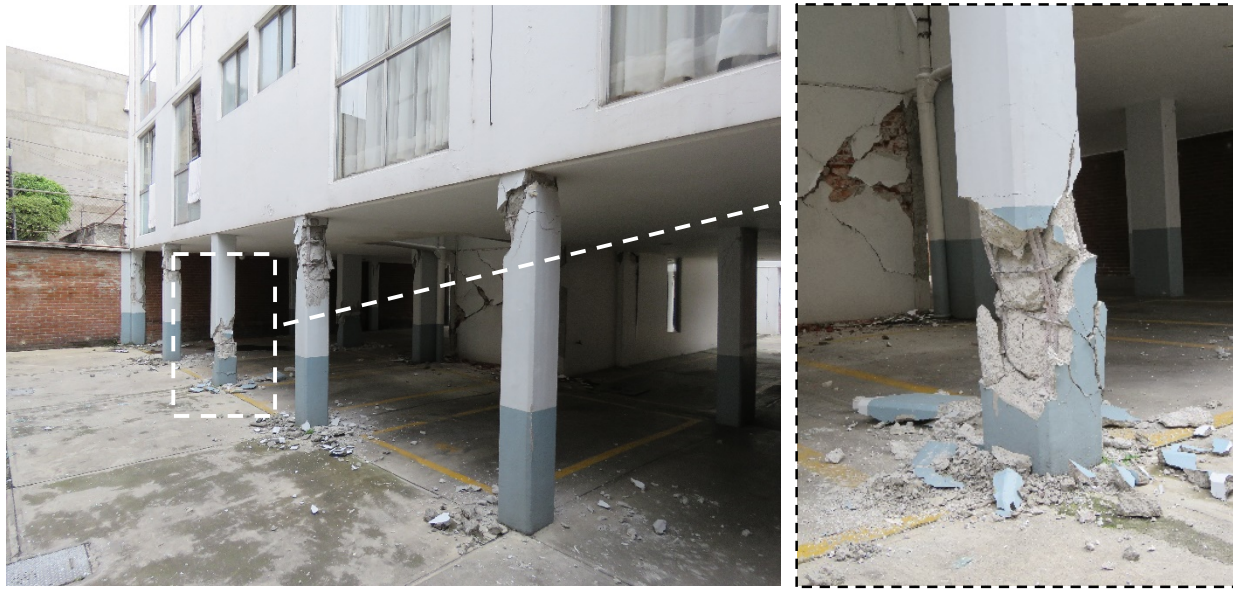
As mentioned before, the damage progression in building with soft first story often initiates with the failure of one or more columns in the first floor due to the concentration of lateral deformations (interstory drifts) at this level. Unless the reinforced concrete columns have an adequate amount and adequately placed transverse reinforcement (stirrups) to develop ductile flexural plastic hinges, the columns suffer brittle shear failures. An example is shown in figure 10, where practically all of the columns in the ground level of a five-story building had failed in shear and the building was on the verge of collapse.

Figure 10. Shear failures in columns in a RC flat slab building with a soft first story at Paz Montes de Oca 93, Col. Gral Anaya (photos by Pablo Heresi).
