EERI Earthquake Reconnaissance Report:

M6.4 Albania Earthquake on November 26, 2019

Volume 1: Executive Summary

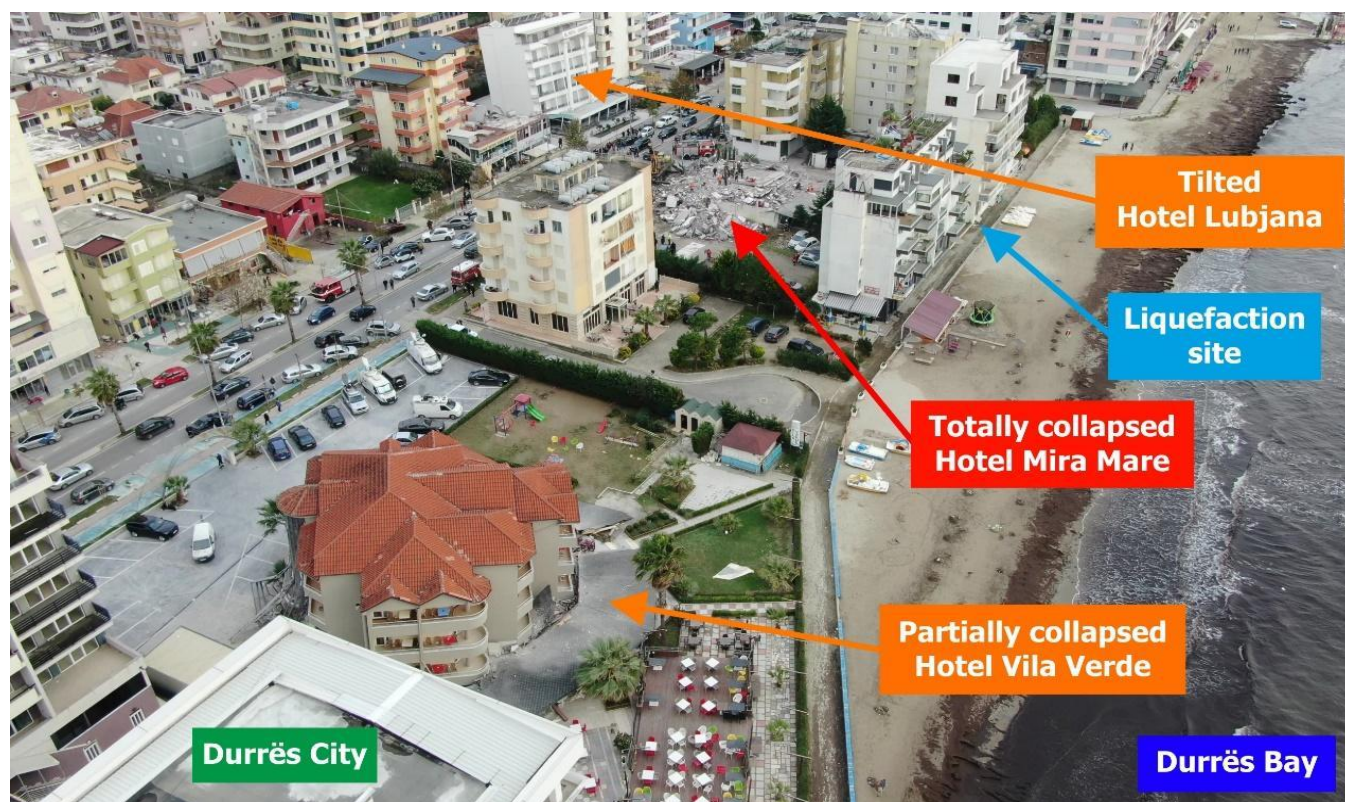
characteristic of these liquefaction-affected sites is the occurrence of recent Holocene deposits, including marshy, lagoonal, and river deposits. The main types of phenomena observed in the liquefaction-affected sites included individual sand boils, the ejection of liquefied material from ground cracks, the arrangement of sand boils along ground cracks, and water and sand fountains in still waters. The liquefaction observed in coastal Durrës affected an urban area at sites in close proximity to totally or partially collapsed hotels (Figure 3). In the Rinia-Fllakë Lagoon, liquefaction caused slight damage to the electric power supply system.

Figure 3. The liquefaction site in the southern part of Durrës was close to three hotels that experienced extensive structural damage: the totally collapsed Mira Mare Hotel, the partially collapsed Vila Verde hotel, and the Lubjana hotel (drone source: Lekkas et al., 2019).⁶

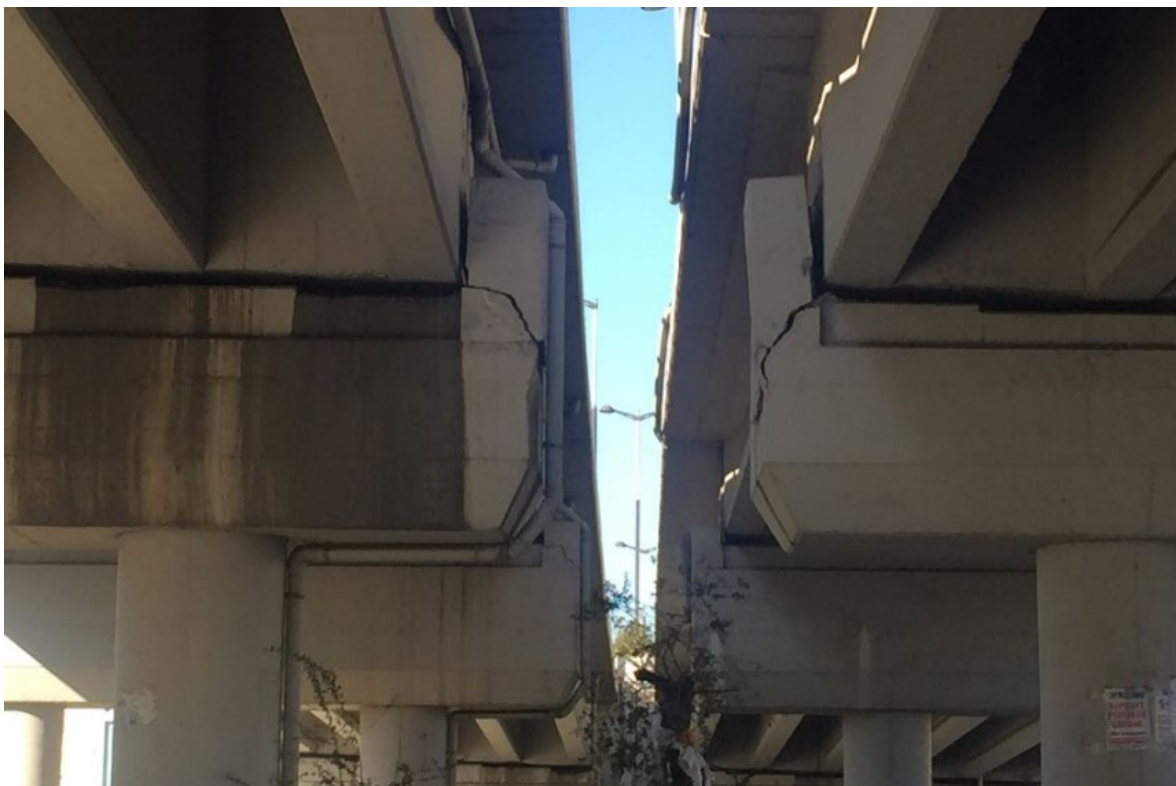
Figure 4. A damaged highway overpass near Durrës (photo: J. Bothara)

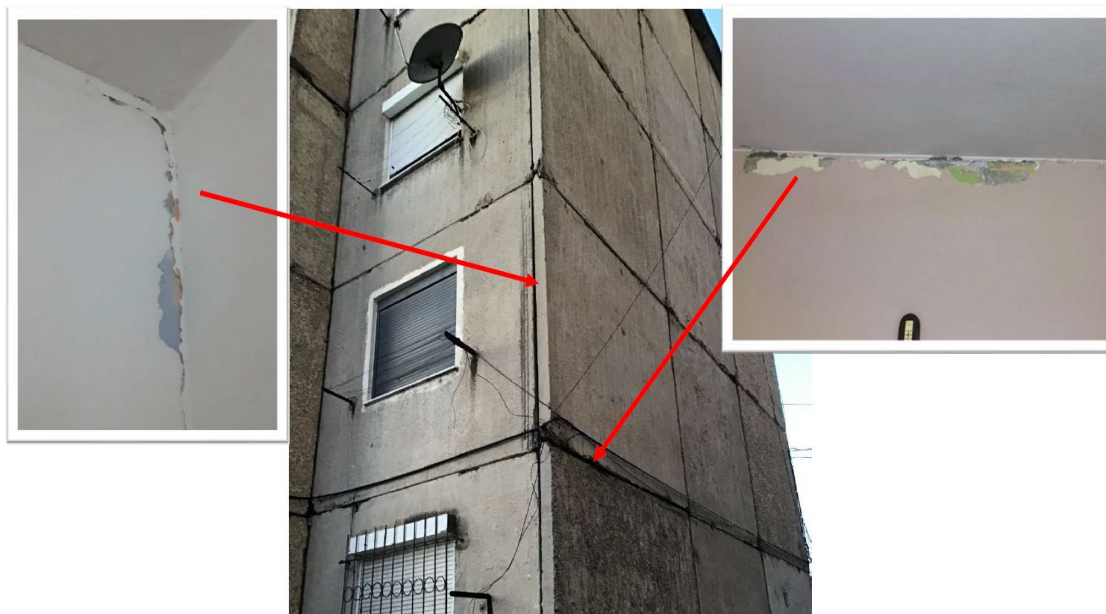
Although a significant number of large-panel buildings were exposed to the earthquake, they performed well; that is, they either remained undamaged or experienced minor damage. Satisfactory seismic performance of large-panel buildings can be attributed to significant redundancies due to a large amount of structural walls, particularly in a transverse (short) direction. These are also rigid structures characterized by short fundamental periods of vibration, which usually experience less damage in earthquakes, especially in soft-soil areas, than flexible structures characterized by longer fundamental periods (such as prefabricated reinforced concrete frame buildings). It was observed that the damage was concentrated within panel connections, whereas the panels remained undamaged (Figure 11). It is expected that, if experienced to a higher seismic demand, a failure mechanism for these buildings would be characterized by more extensive damage of the connections due to shear-induced sliding behavior (“strong panels-weak joints”), whereas the panels would remain mostly undamaged.

Figure 11. Cracking pattern at the interface between horizontal and vertical panels and also at the wall intersections in a building in Tirana (photos: M. Guri).

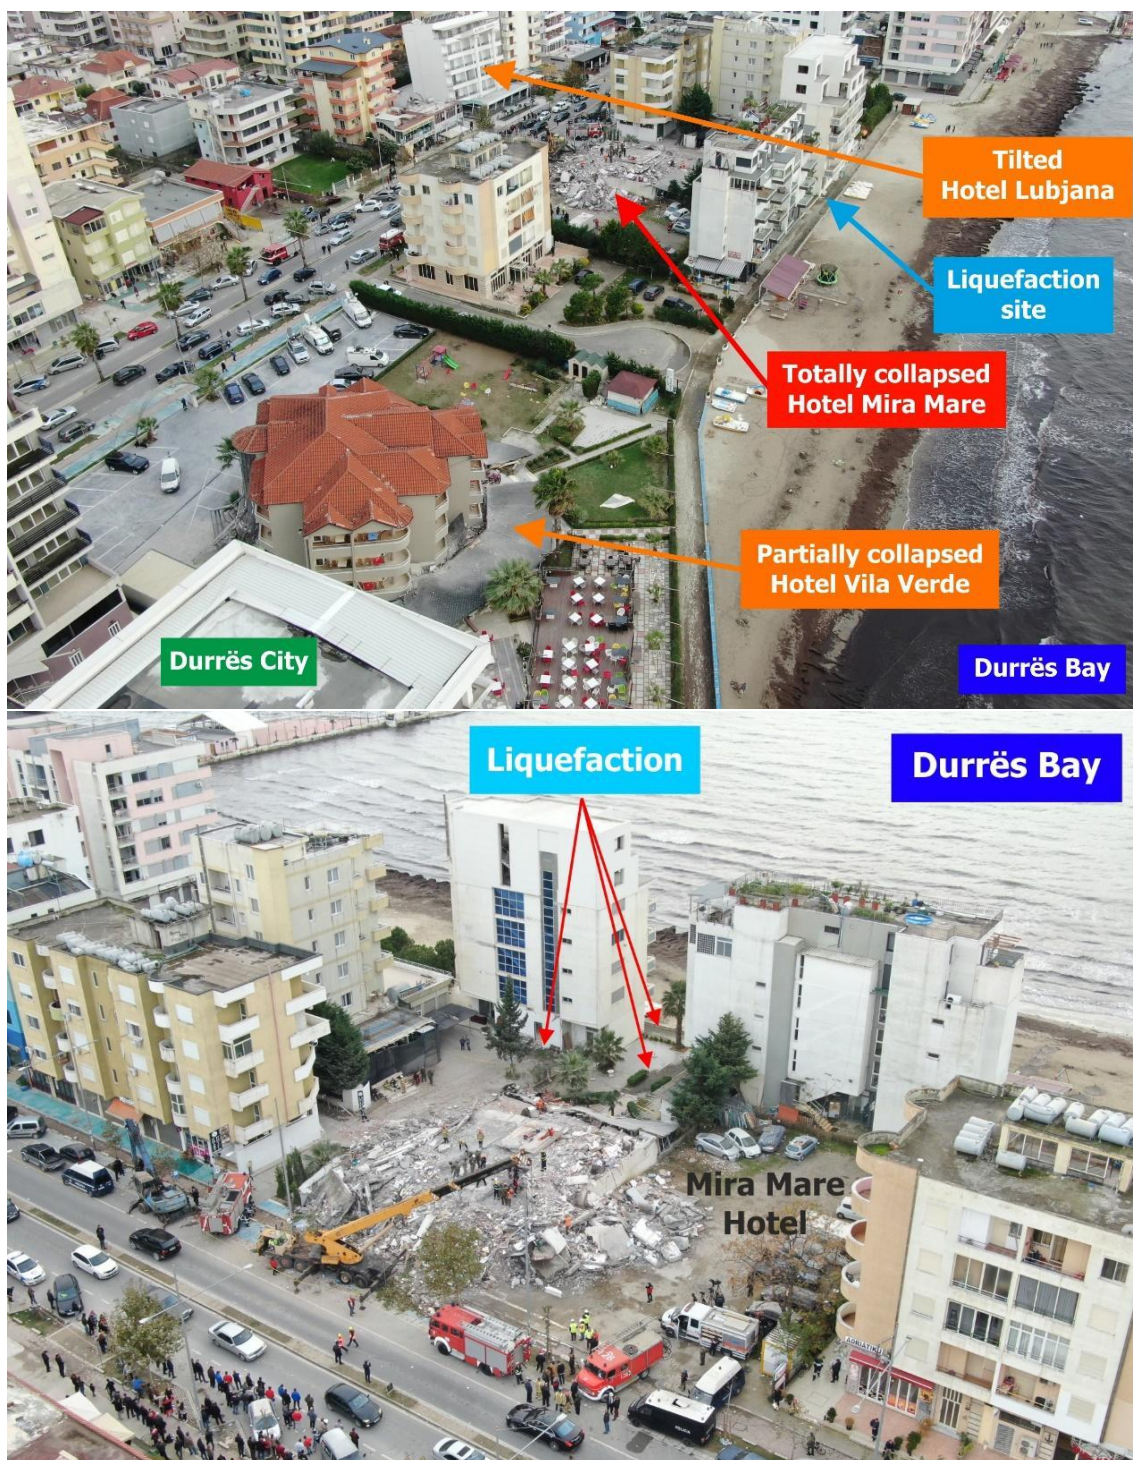
Figure 44. The liquefaction site in the southern part of Durrës was close to three hotels that suffered very heavy structural damage: the totally collapsed Mira Mare Hotel, the partially collapsed Vila Verde hotel, and the tilted Lubjana hotel (source: Spyridon Mavroulis, Efthymios Lekkas, and Panayotis Carydis; Lekkas et al., 2019b).

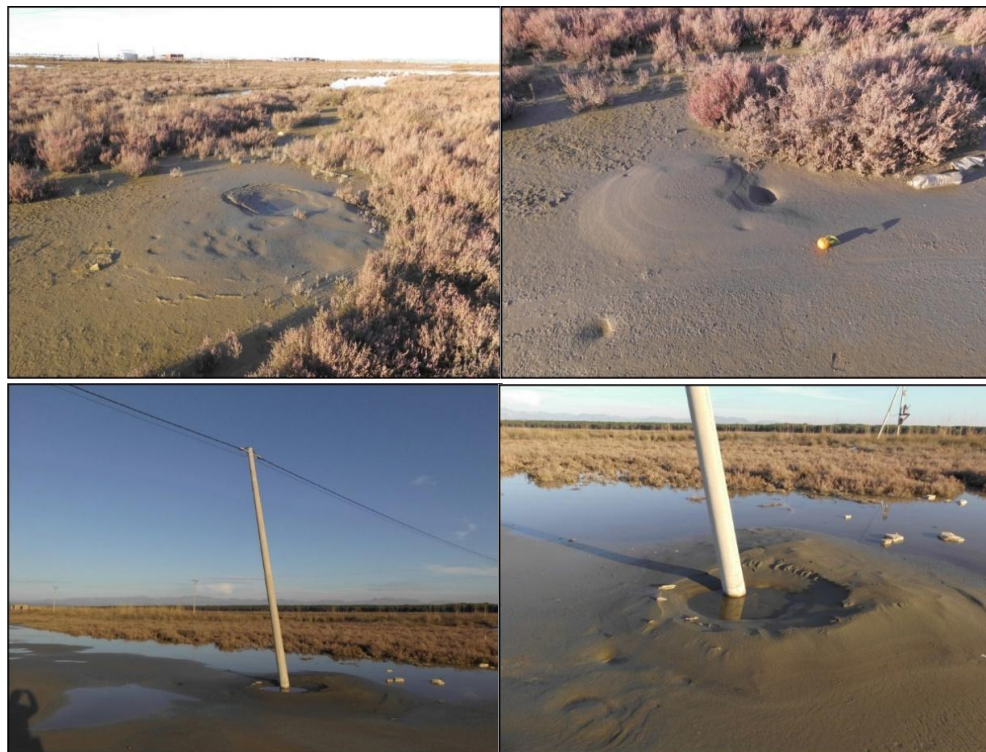
Figure 46. Liquefaction phenomena in the first site of the central part of the Rinia-Fllakë Lagoon. Individual sand boils were formed by the ejection of liquefied material. They resulted in tilting of electric pillars (source: Spyridon Mavroulis, Efthymios Lekkas, and Panayotis Carydis).

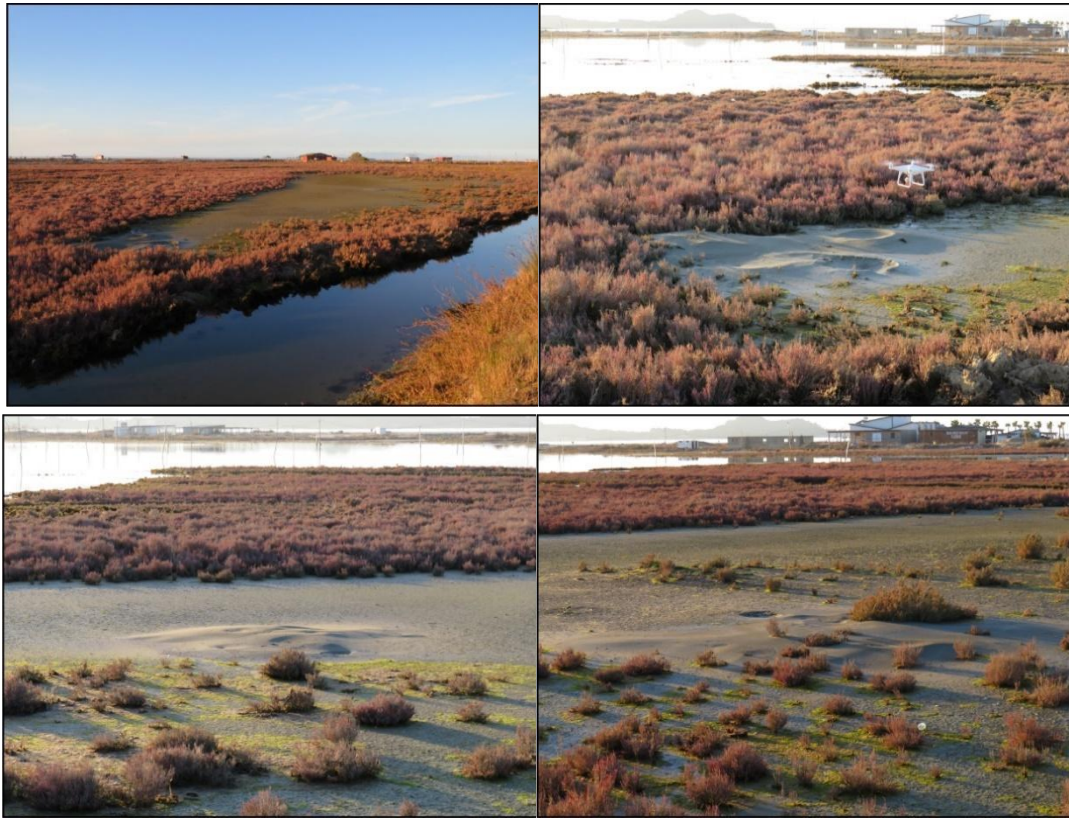
Figure 47. Liquefaction phenomena in the second site of the central part of the Rinia-Fllakë Lagoon. Sand boils were observed close to an adjacent canal of the lagoon (source: Spyridon Mavroutis, Efthymios Lekkas, and Panayotis Carydis).

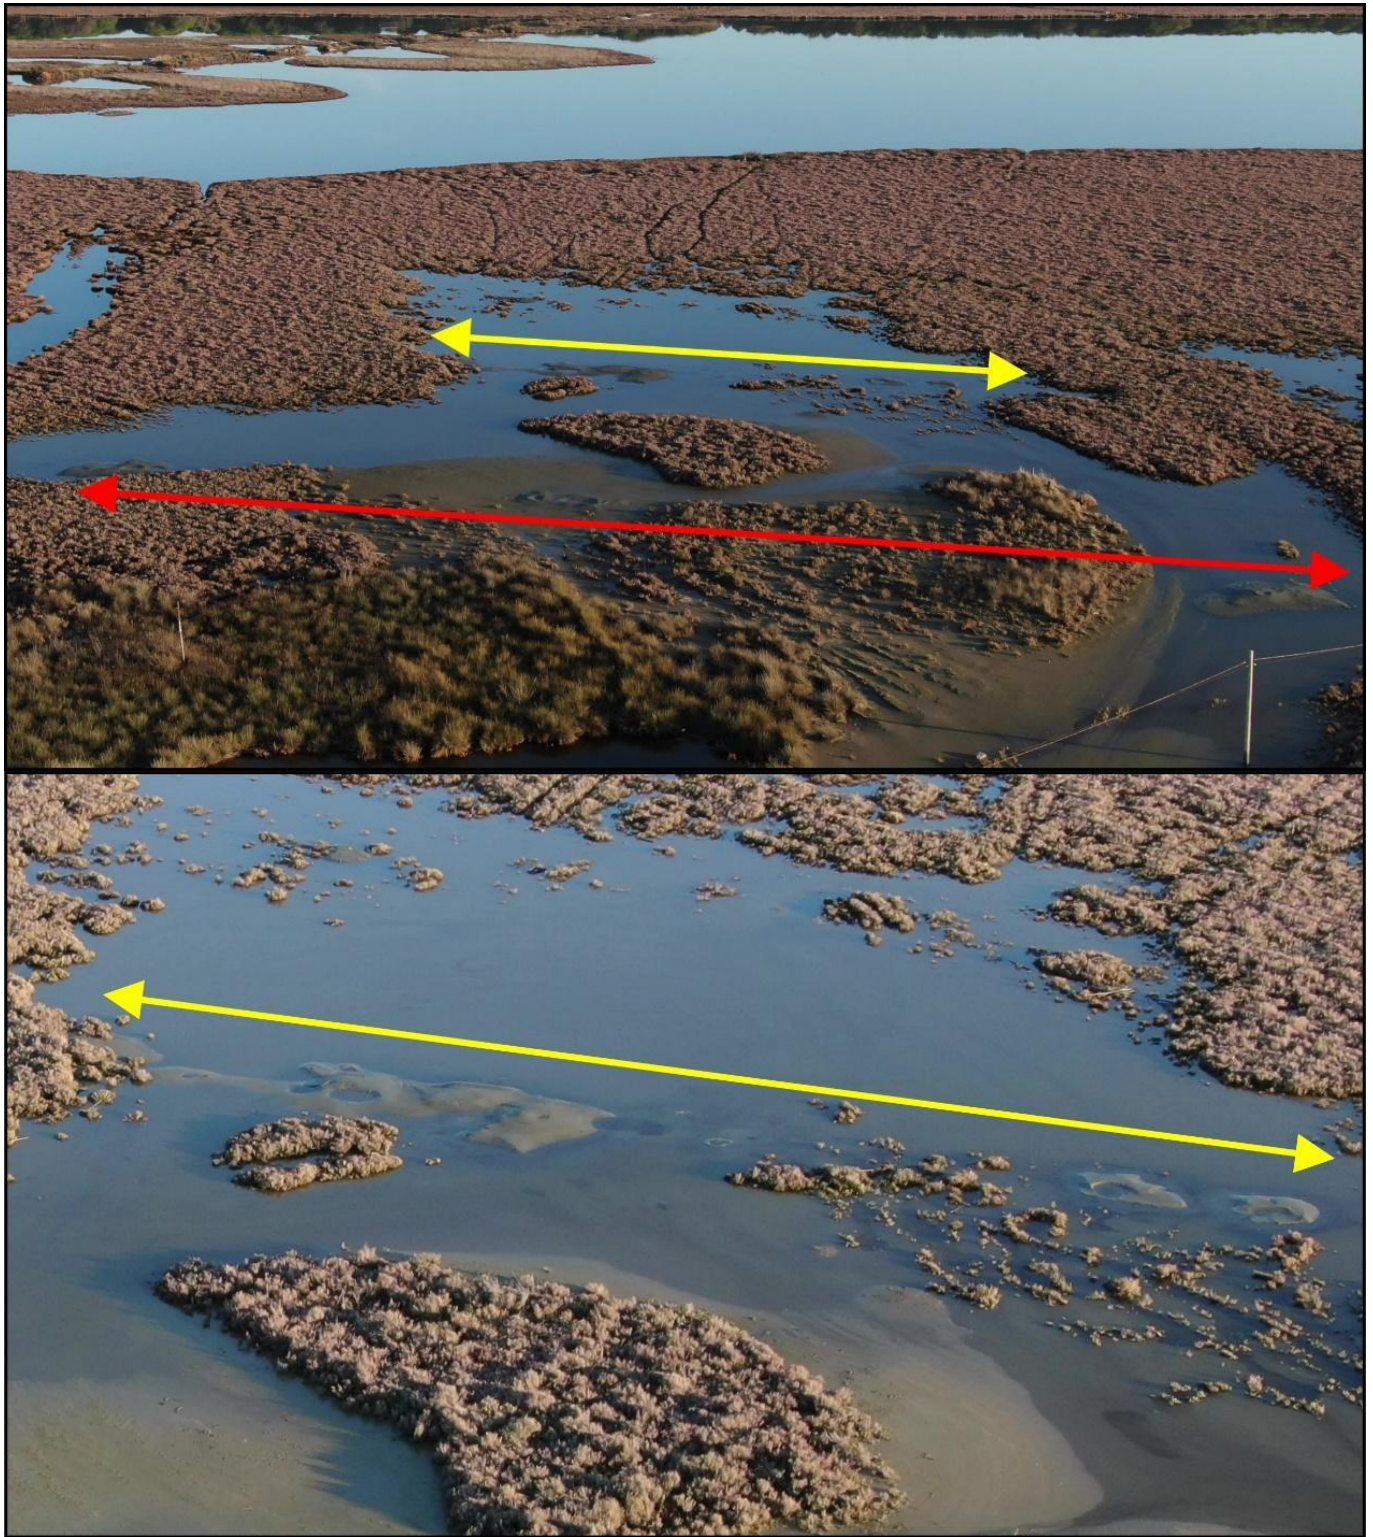
Figure 48. Liquefaction phenomena in the third site of the central part of the Rinia-Flakë Lagoon. The elongated/aligned multiple sand boils were observed along almost N-S trending ground cracks. Yellow and red arrows indicate the N-S direction of ground cracks (source: Spyridon Mavroulis, Efthymios Lekkas, and Panayotis Carydis).

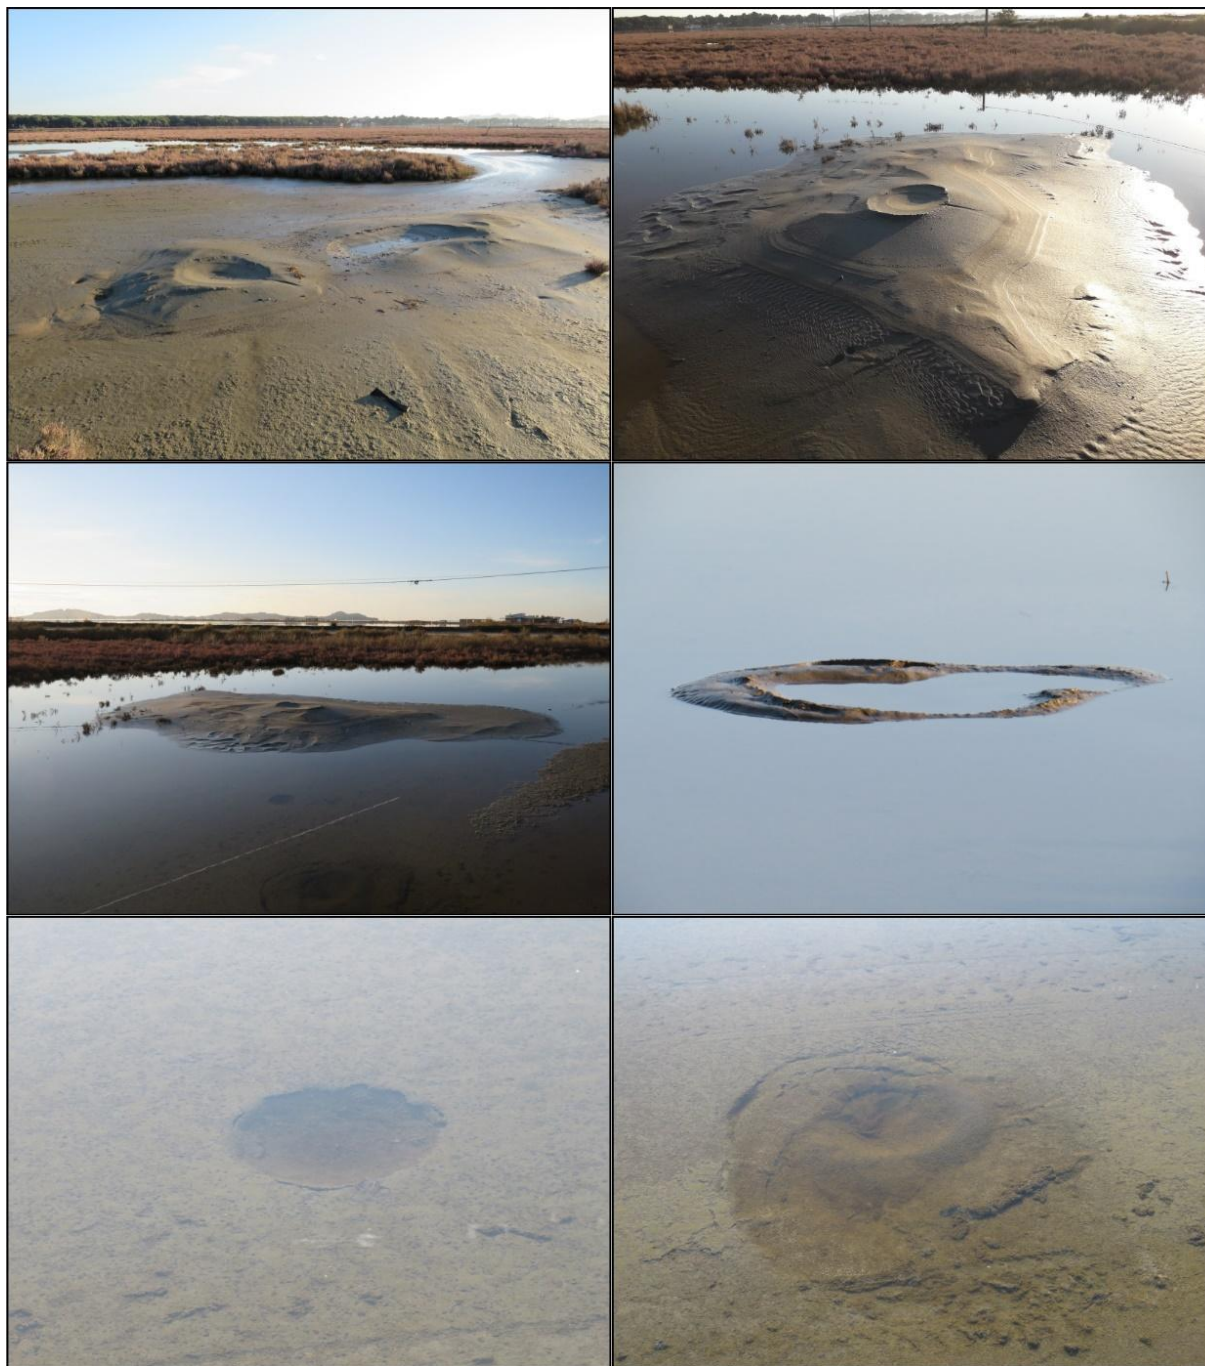
Figure 49. Typical forms of liquefaction phenomena in the third site of the central part of the Rinia-Fllakë Lagoon. They consisted of sand boils generated not only in dry but also in shallow parts of the lagoon (source: Spyridon Mavroulis, Efthymios Lekkas, and Panayotis Carydis).

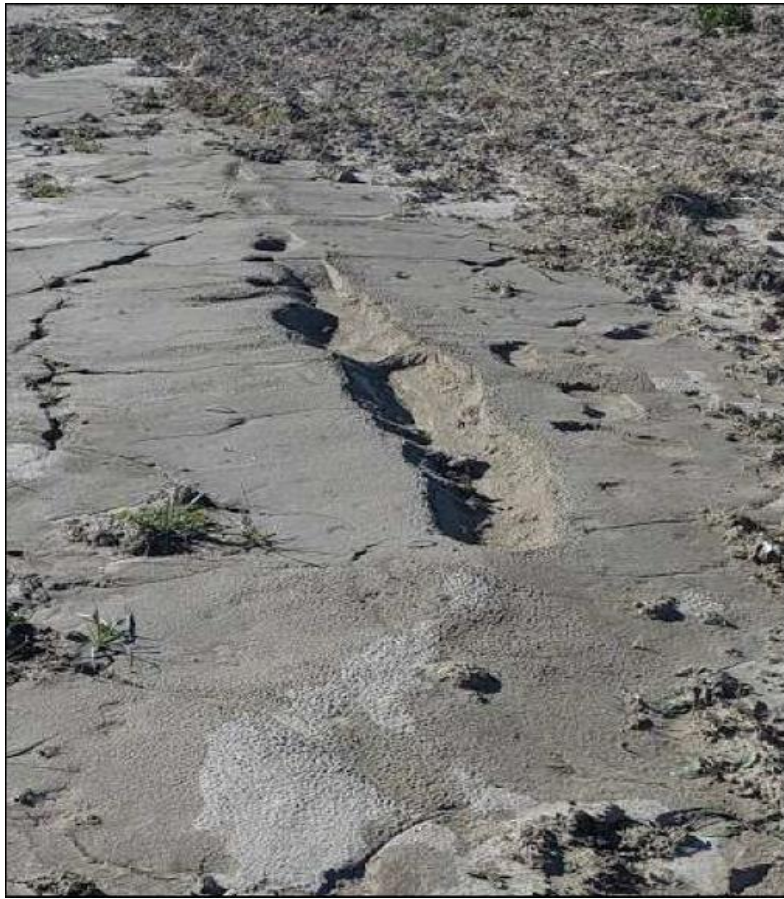
Figure 50. Ejection of liquefied material was generated along ENE-WSW trending ground cracks in fields of the Erzen River mouth. (Source: Mavroulis et al., 2019)

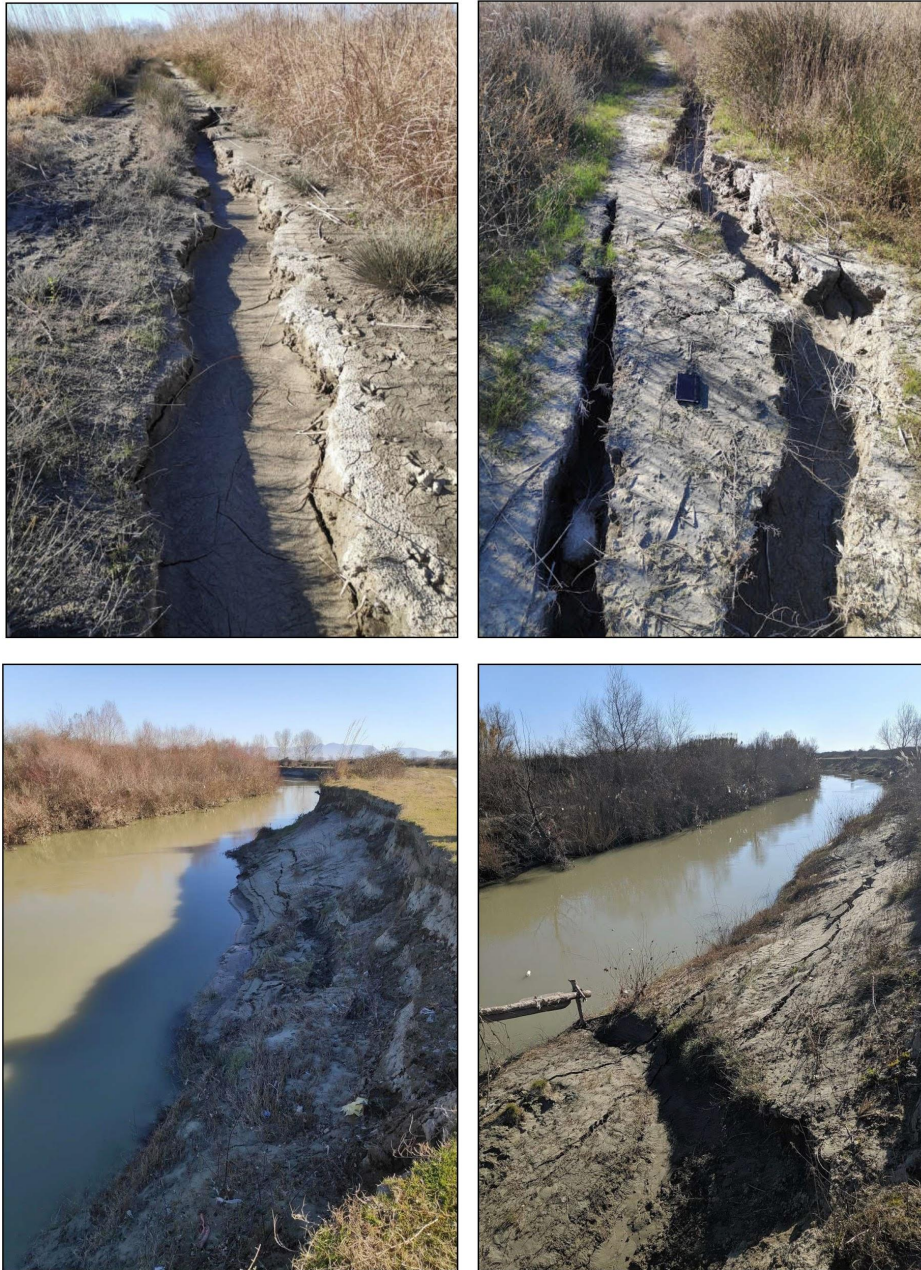
Figure 51: Lateral spreading close to the Erzen River mouth. They were observed along its southern banks (source: Pavlides et al., 2020).

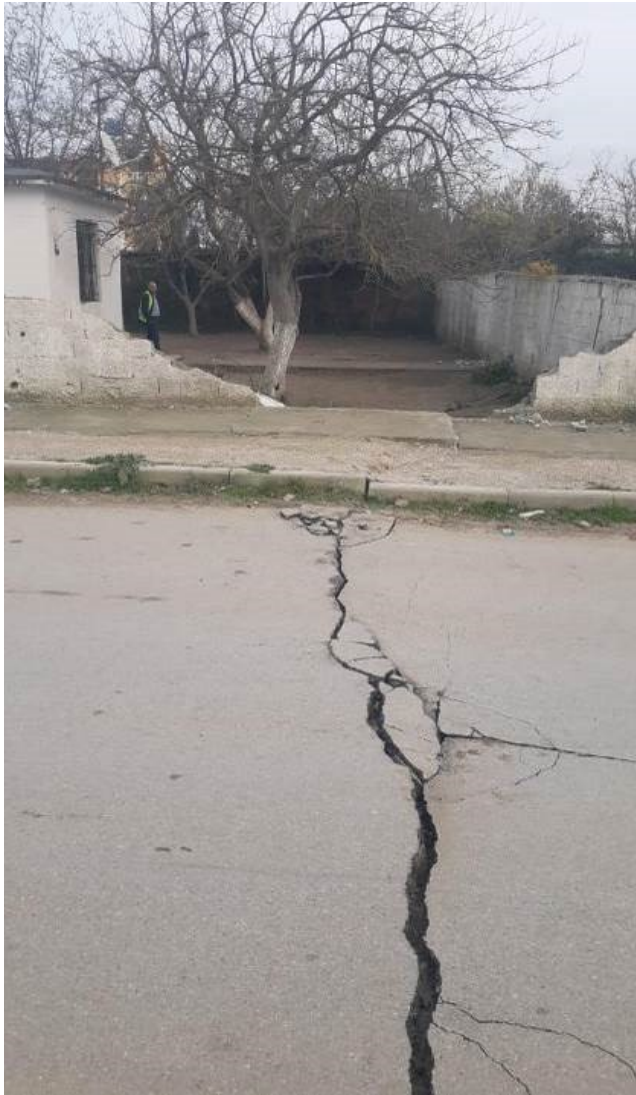
Figure 1. Damage to the road in front of the drainage pumping station in Hamallaj (41.486820, 19.517701), Durrës. The photographs show the same damage from each side of road (source: Altin Sula).

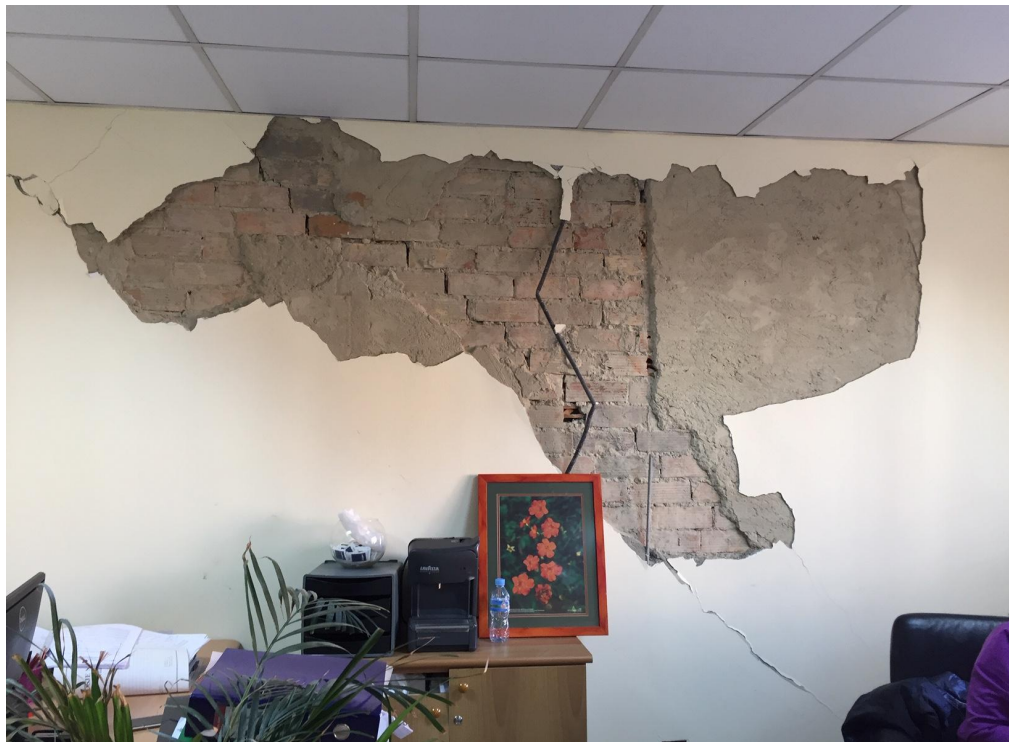
Figure 3. Damage suffered by a municipal building (source: Jitendra Bothara).

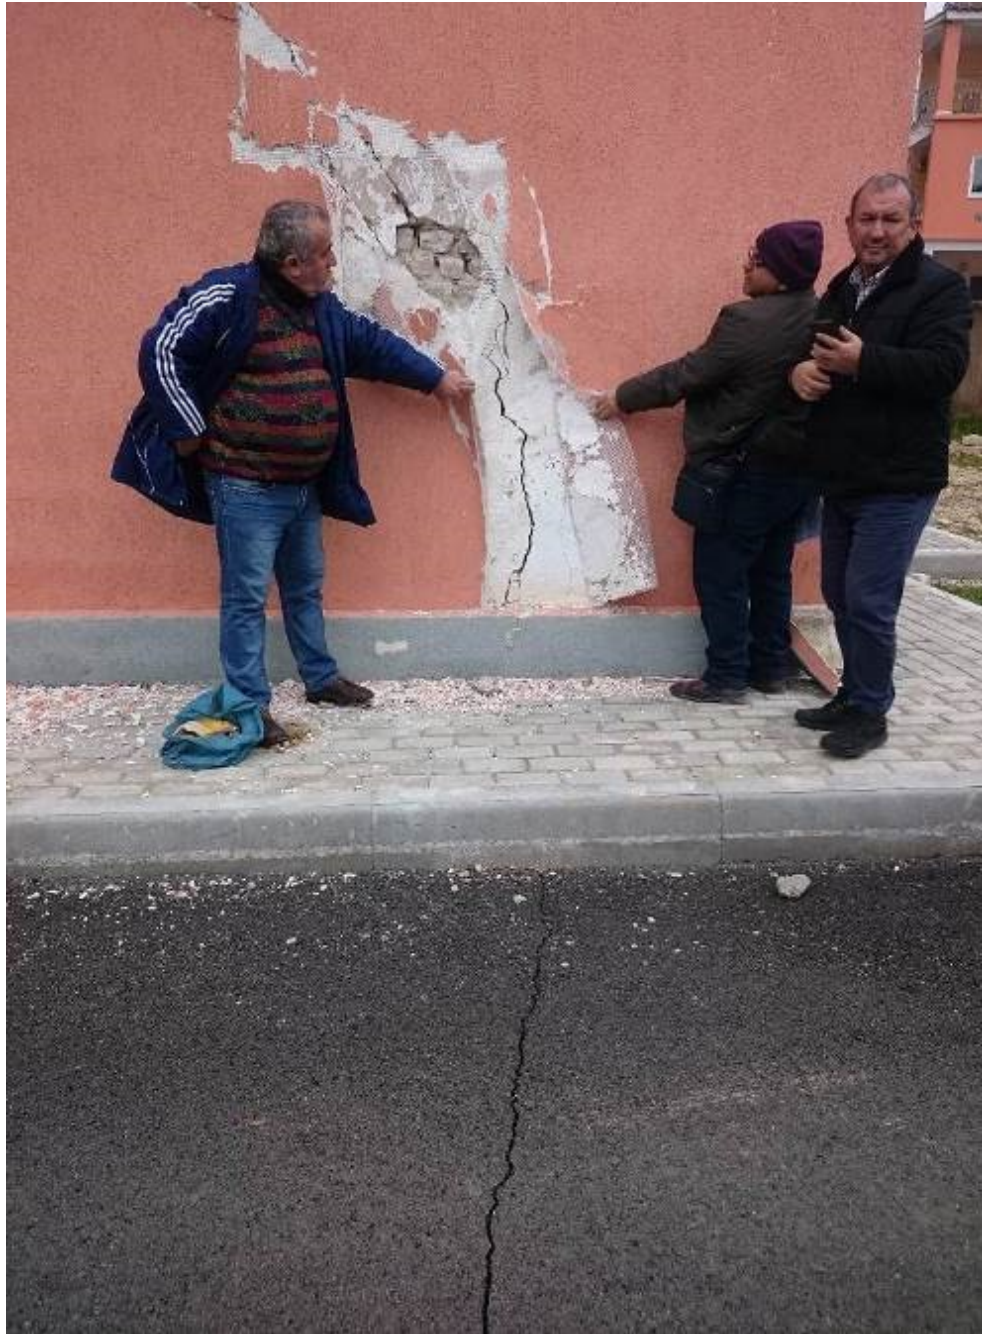
Figure 5. Cracking damage to pavement of Durrës-Tirana highway in Marikaj. The crack was likely caused by ground displacement because of a nearby ditch. Note the extension of the crack to the adjoining building (source: Hysain Bilgin and Altin Bidaj).

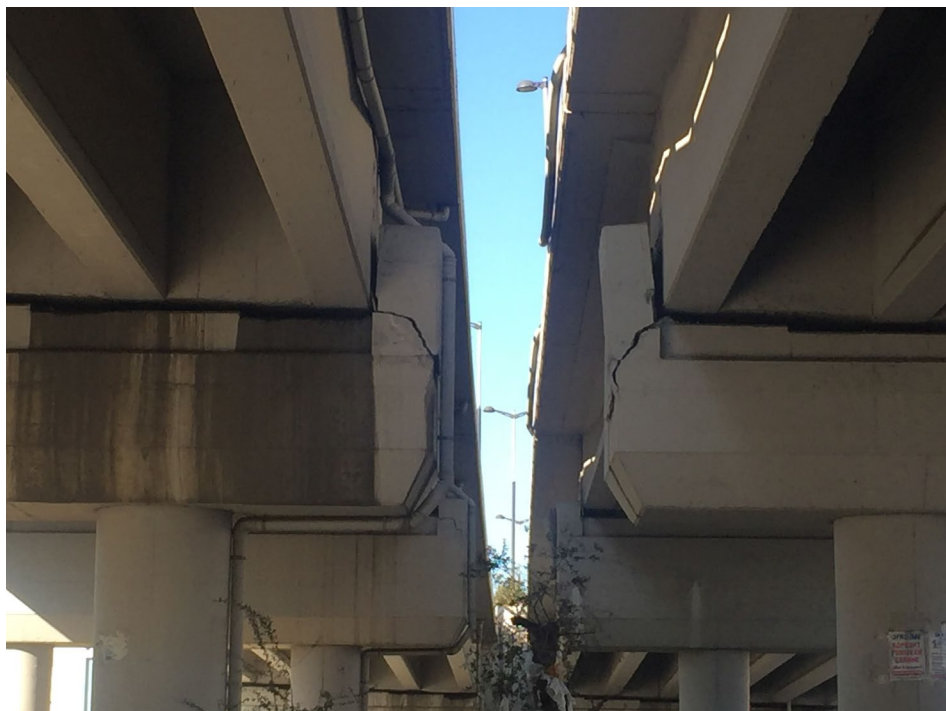
Figure 6. Damage to highway overpass near Durrës (41.324108, 19.483383) (source: Jitendra Bothara).

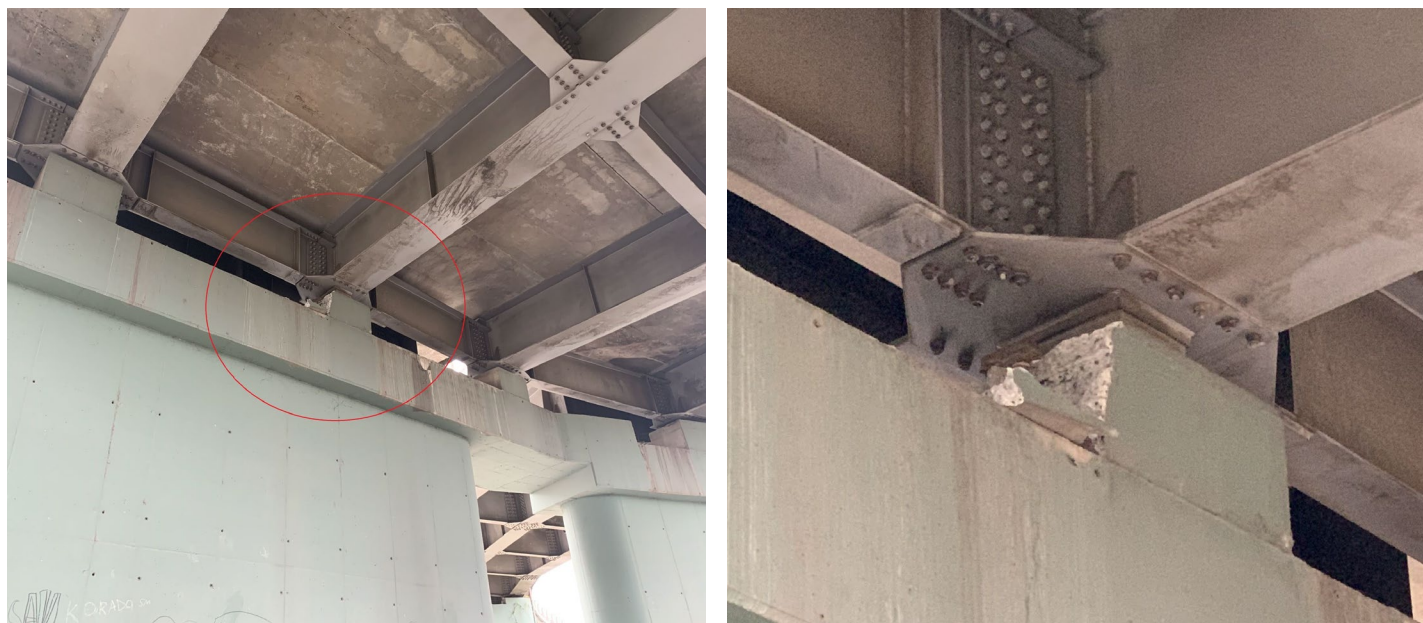
Figure 7. Minor damage to seating of bridge deck for the Dajlani Overpass (41.317032, 19.470297) (source: Markel Baballëku).

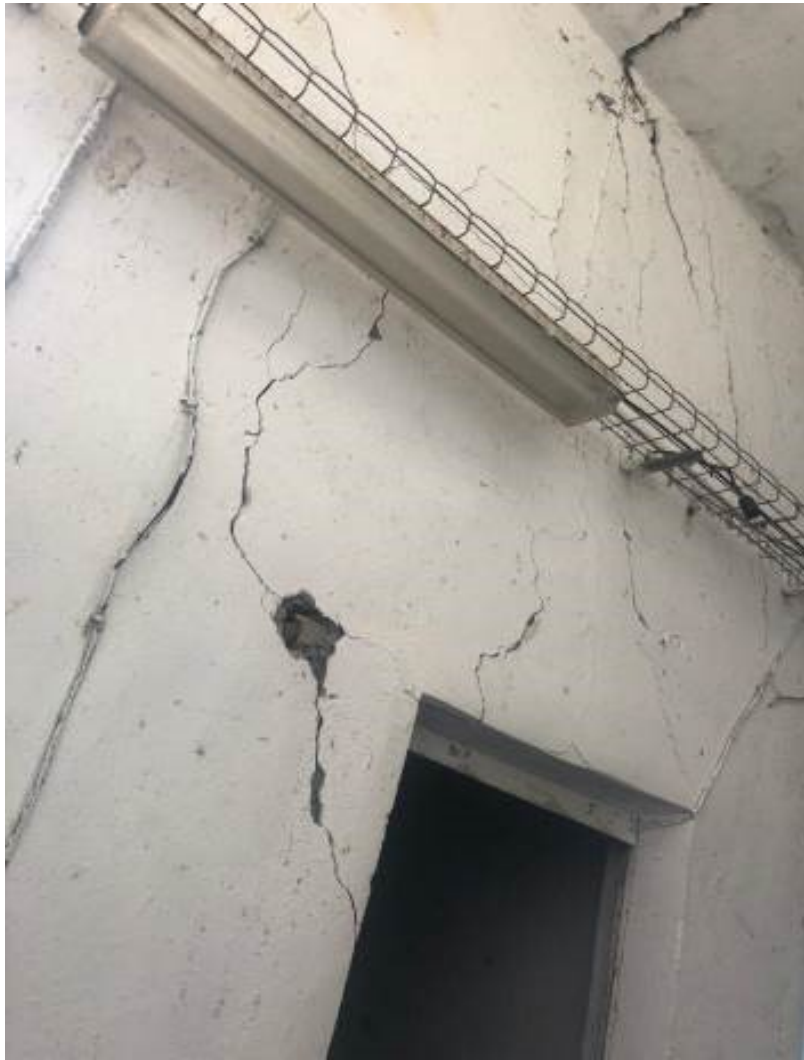
Figure 9. Damage to a pumping station, Laç, Kurbin (41.644272, 19.682648) (source: Markel Baballëku).

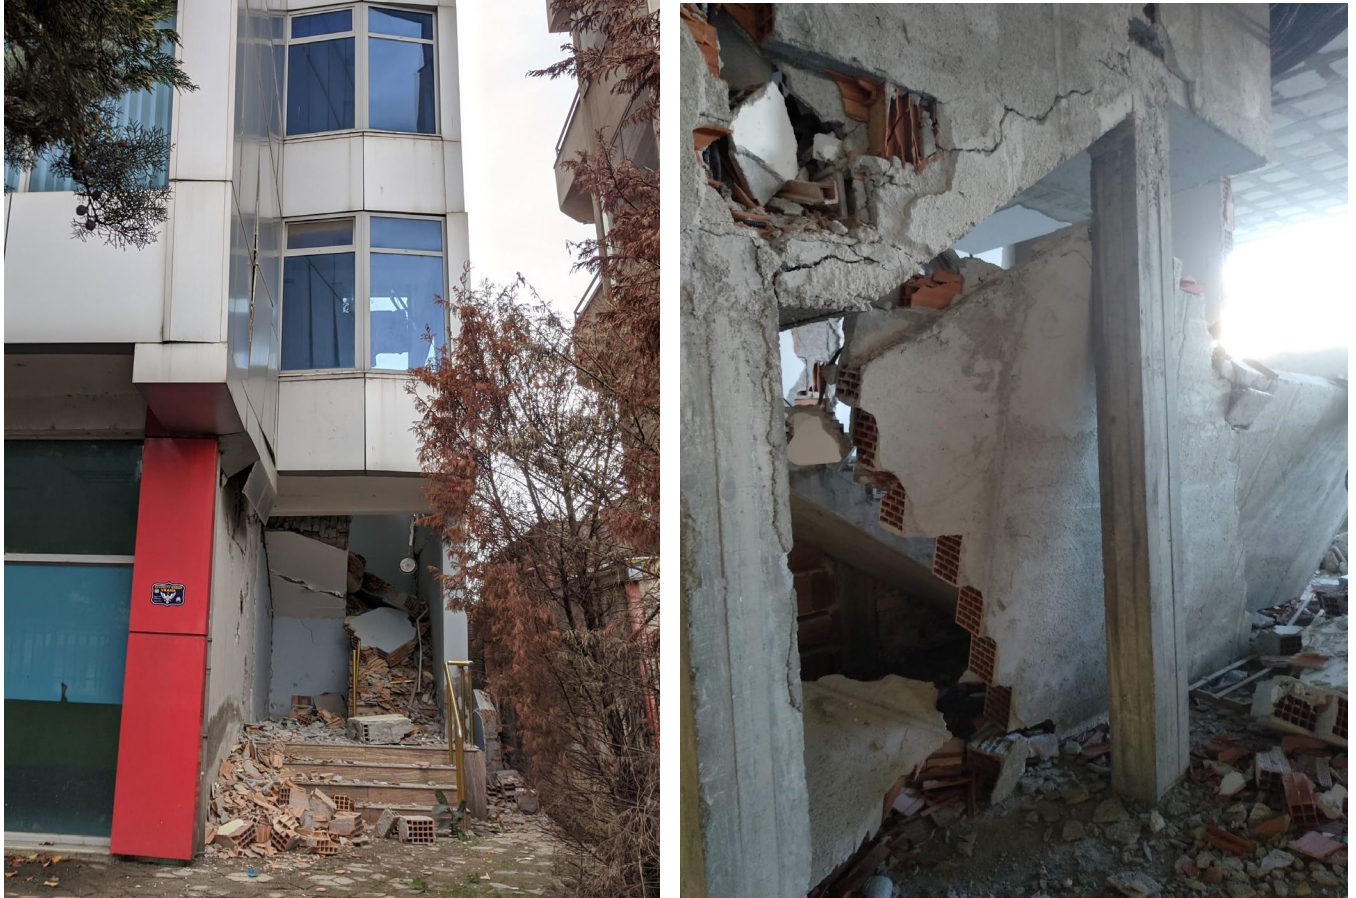
Figure 11. Masonry infill debris blocking stairs (source: McKenney, 2019; Nikolić-Brzev et al., 2020).^{7,8}

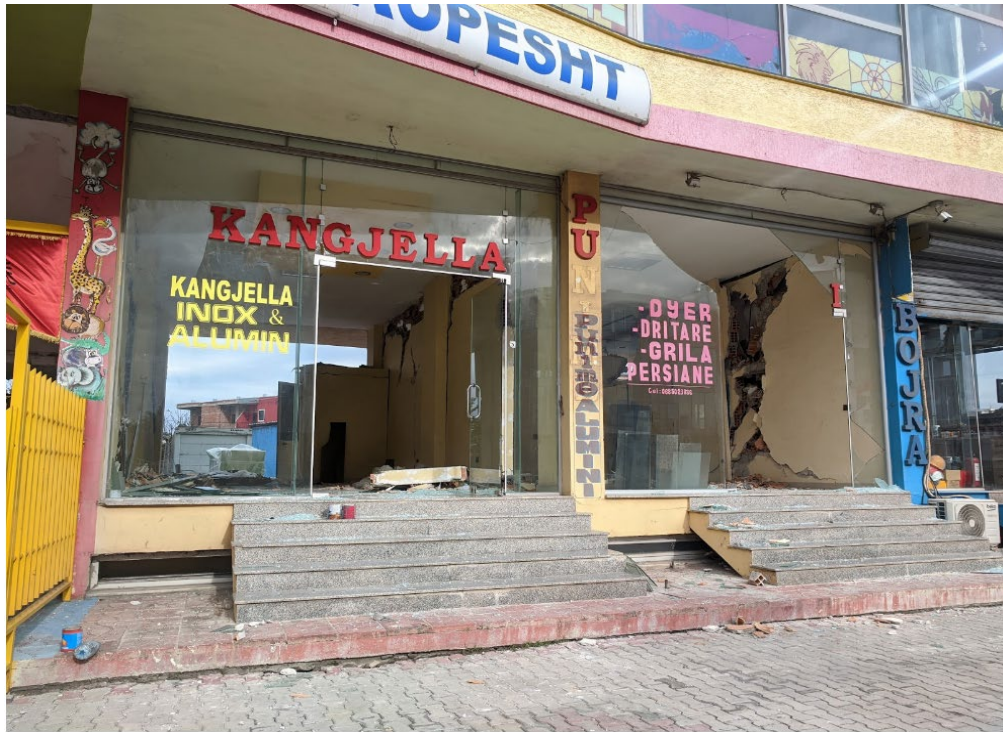
Figure 16. Business interruption due to masonry infill damage (source: McKenney, 2019).

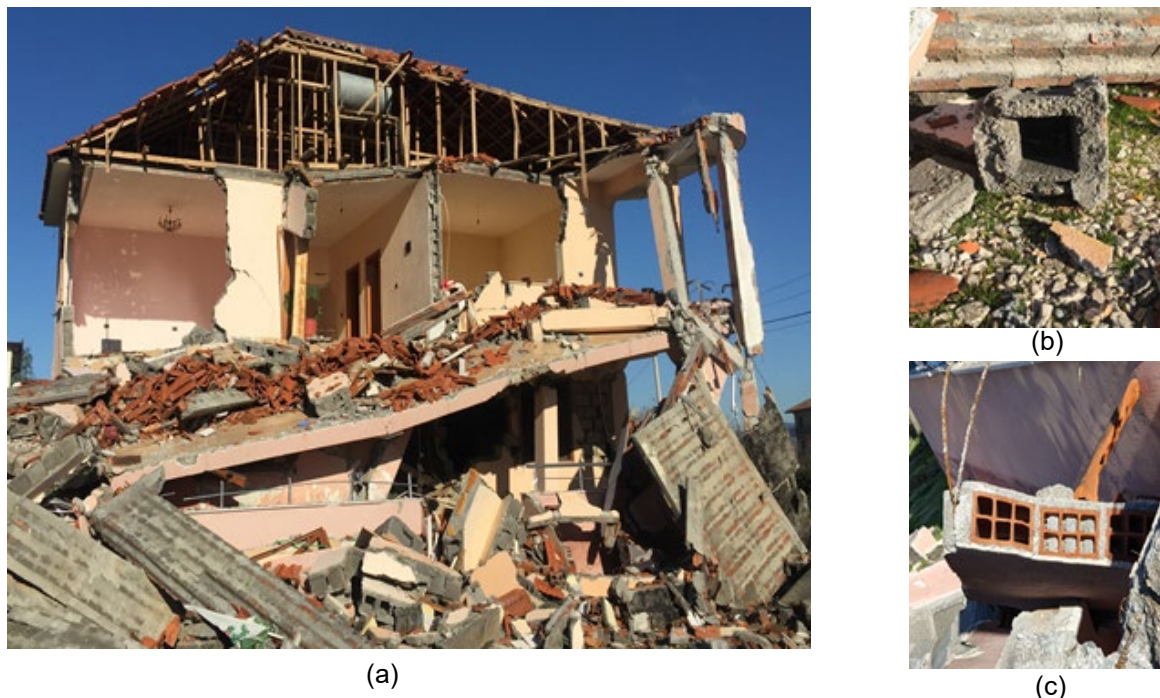
Figure 26. Single-family URM house in the Bubq village: (a) a collapse that occurred due to torsion of the portico on the ground floor, (b) URM walls with hollow concrete blocks, and (c) a cast-in-situ reinforced concrete slab at the ground floor level and reinforced concrete waffle slab with clay blocks at the second floor level (photos: EEFIT).

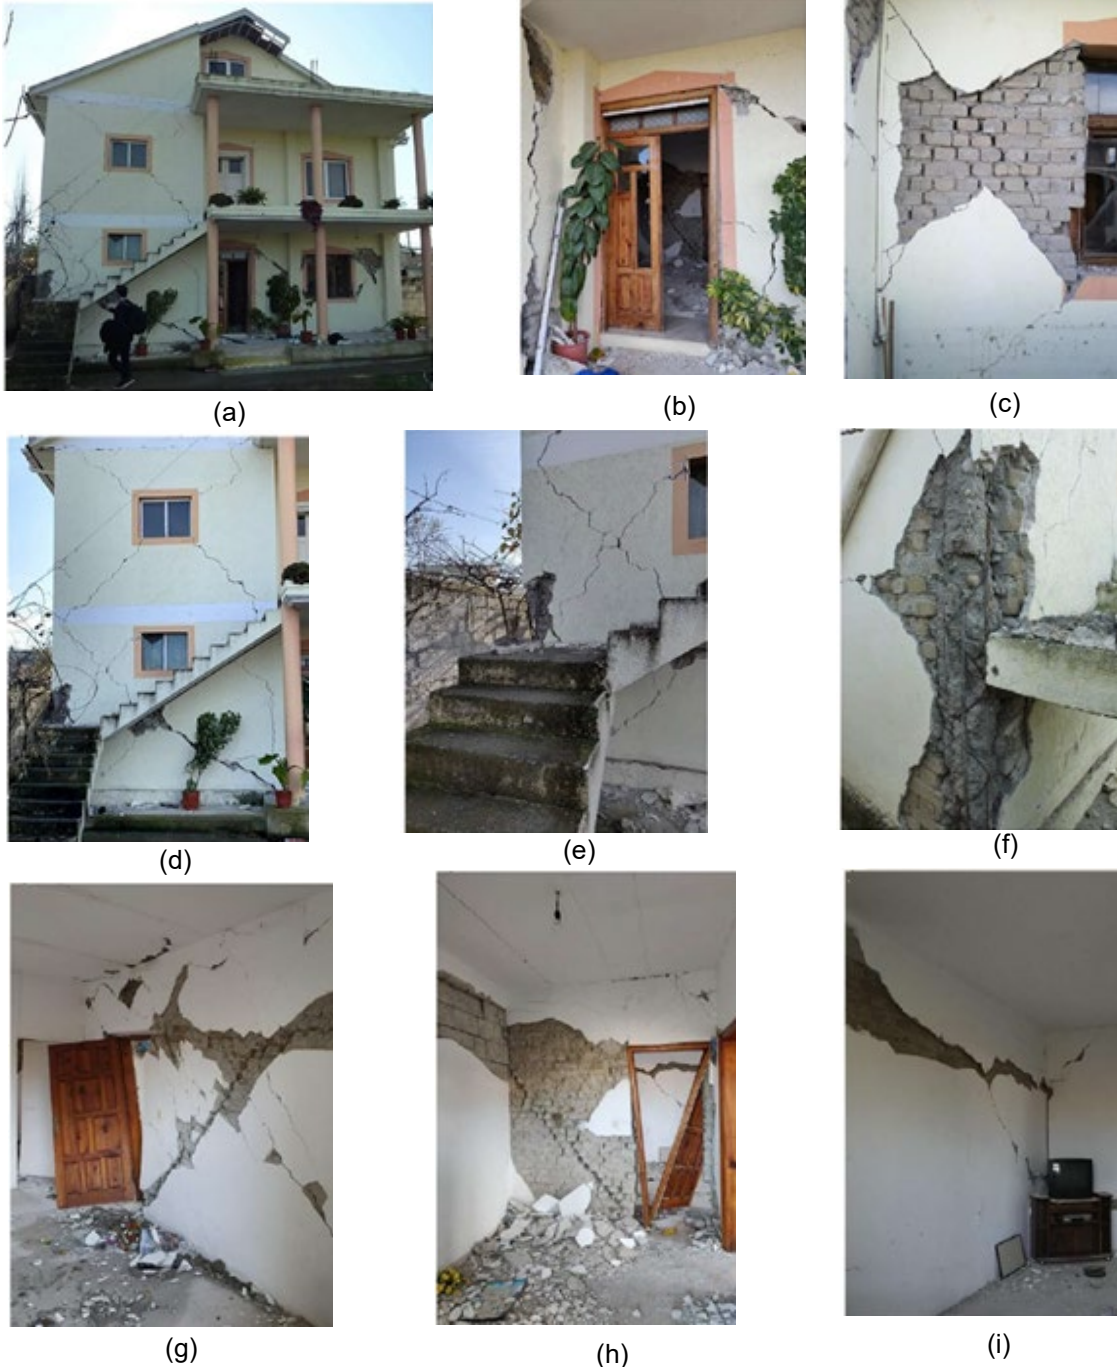
Figure 27. Severely damaged three-story confined masonry building in Thumanë (photos: HAEE).
