EERI Earthquake Reconnaissance Report:

M6.4 Albania Earthquake on November 26, 2019

Volume 1: Executive Summary

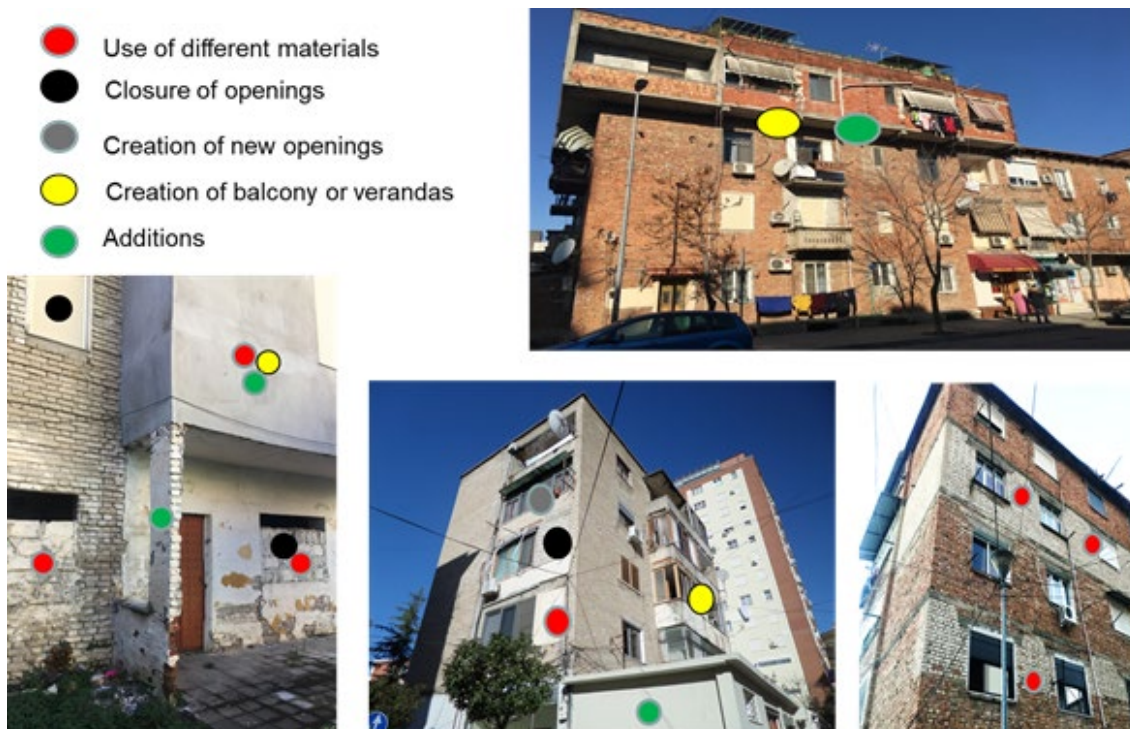
Figure 29. Irregular elevations created by unauthorized interventions on URM buildings in Durrës (photos: EEFIT).

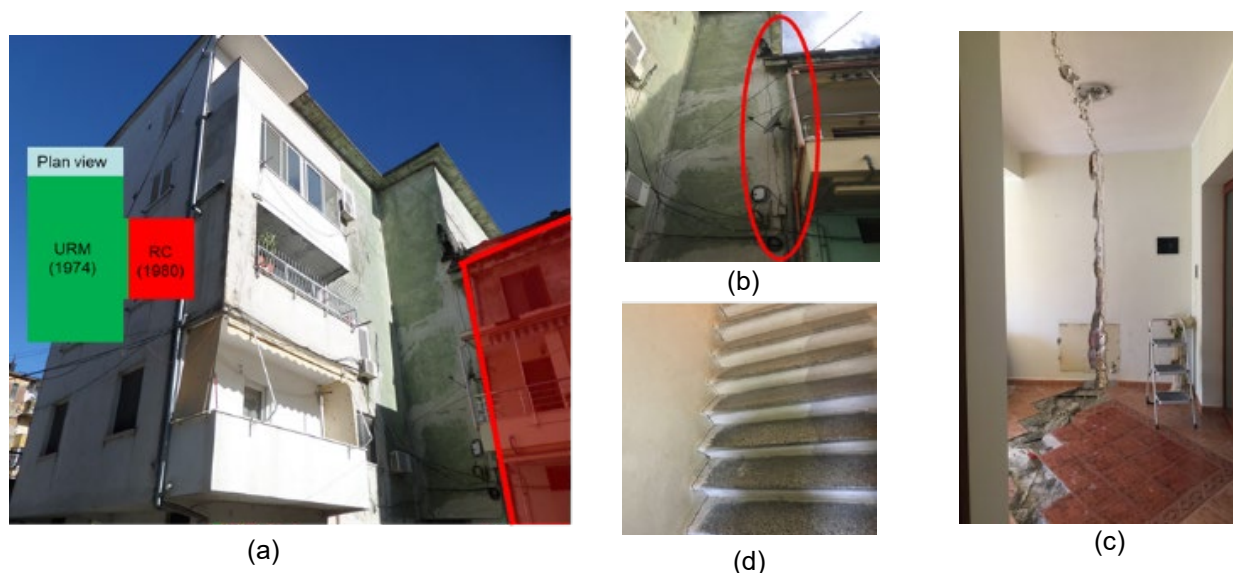
Figure 31. Damage patterns in mid-rise URM buildings: (a) five-story communist-era URM buildings made of silicate bricks and hollow core precast concrete slabs inspected in Lezhë (red tagged by local engineers), (b) pounding damage between the URM building and reinforced concrete building, (c) a gap opening, and d) detachment of the staircase (photos: EEFIT).

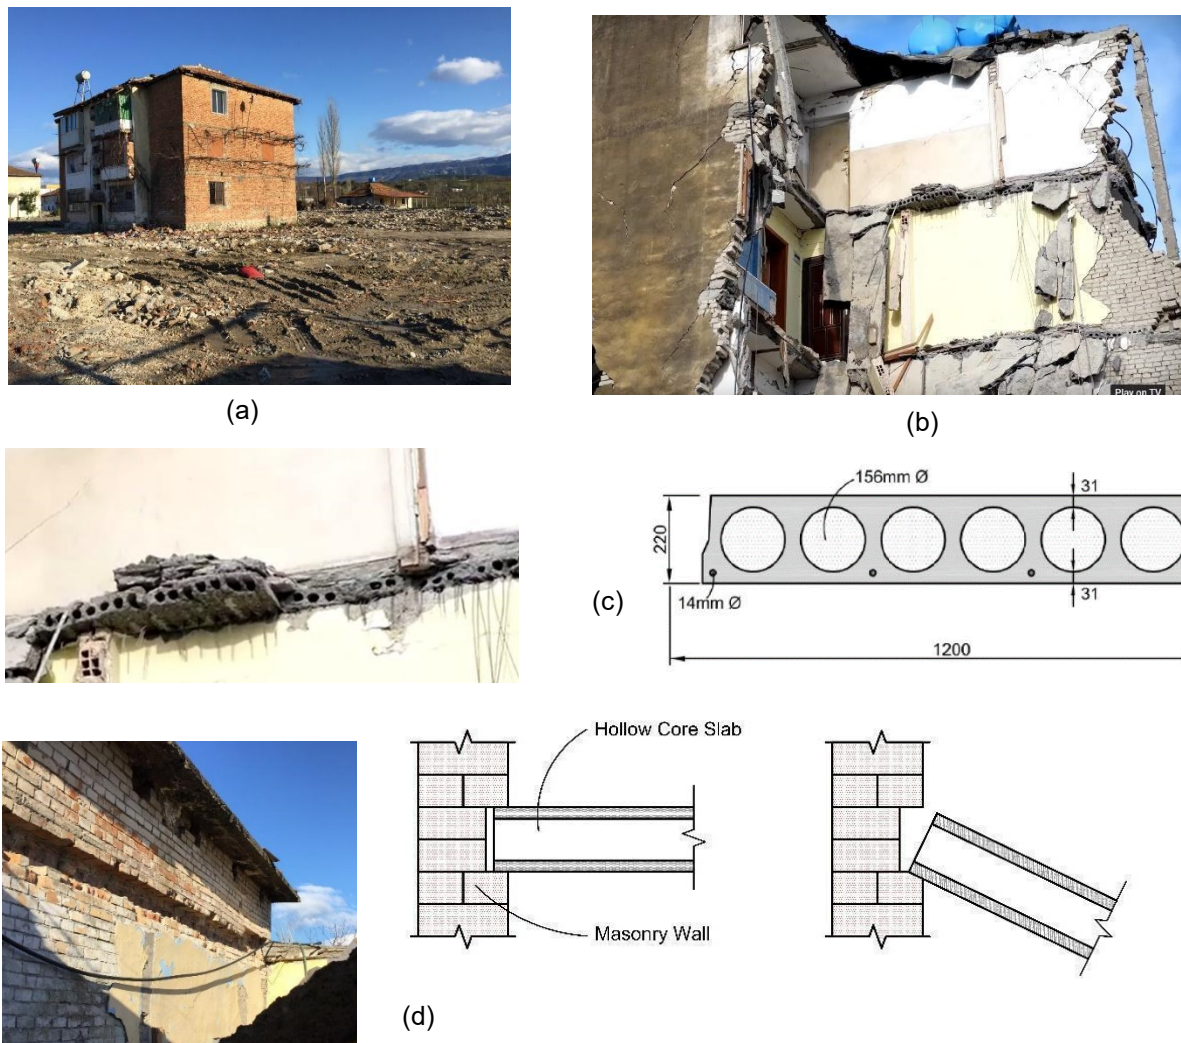
Figure 32. Collapse of mid-rise URM buildings in Thumanë: (a) an undamaged three-story URM building adjacent to the site of collapsed and demolished five-story building, (b) a partial collapse before the demolition (source: TV7 Albania (<https://www.youtube.com/watch?v=2RXiG1KHC7k>), (c) details of hollow core reinforced concrete slabs, and d) detail of floor-to-wall connection (source: SUZI-SAAE).

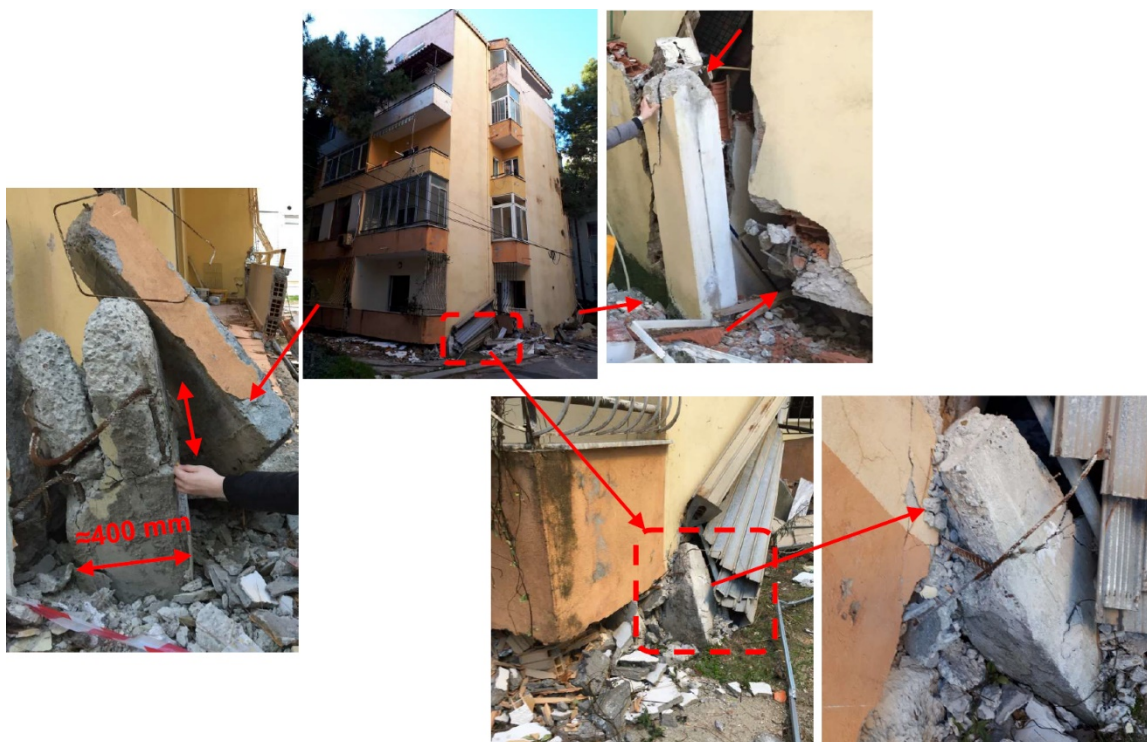
Figure 35. Collapsed building with hybrid confined masonry and reinforced concrete frame system in Shkëmbi i Kavajës in south Durrës: details of reinforced concrete frame structure at the ground floor level (photos: SUZI-SAEI).

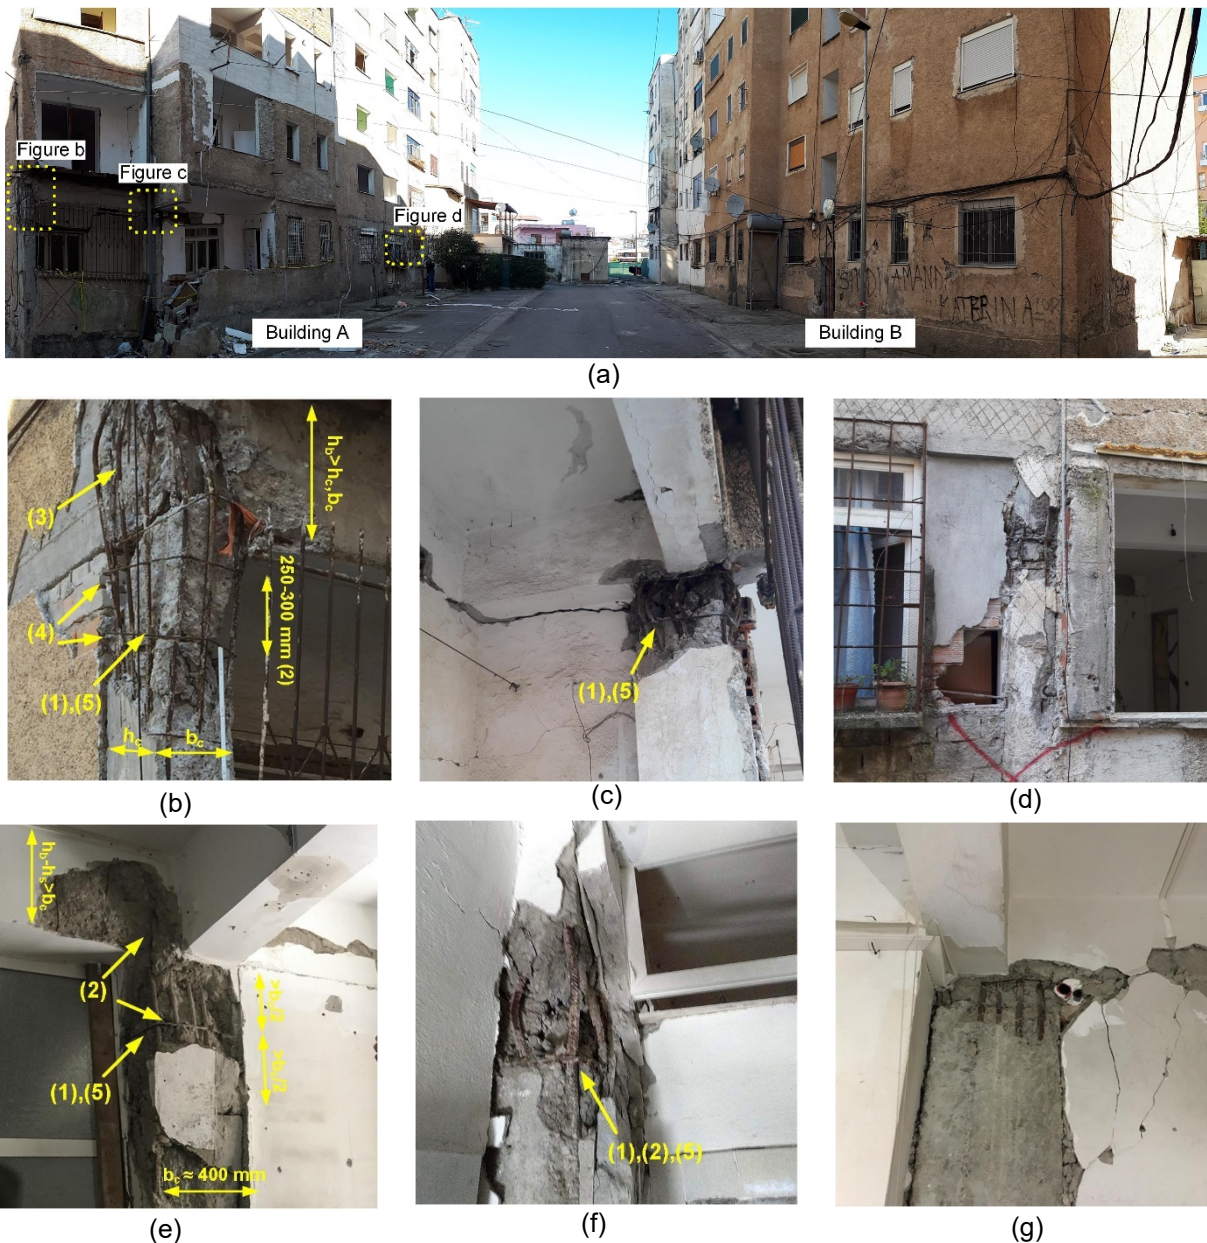
Figure 49. Damage patterns in two 6-story reinforced concrete frame buildings in Durrës: (a) a street view showing the buildings; (b), (c), (d) damage of reinforced concrete columns in Building A; (e), (f), (g) damage of reinforced concrete columns and beams in Building B (photos: SUZI-SAE).)

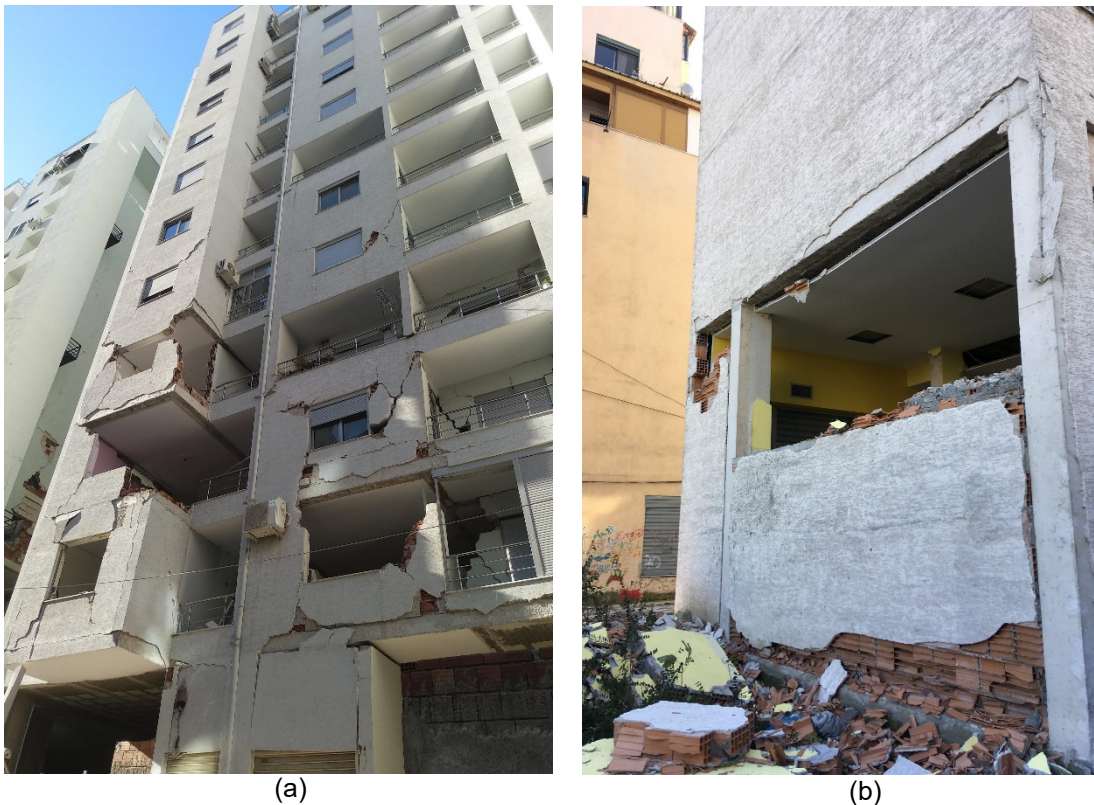
Figure 58. Damage of masonry infills in Durrës (photos: SUZI-SAE).

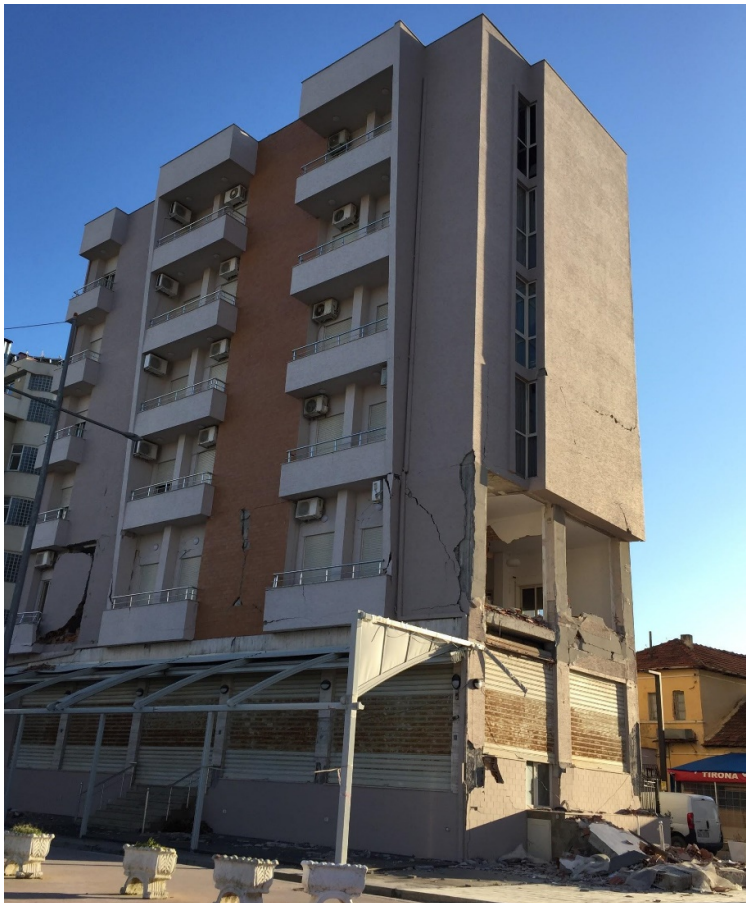
Figure 62. Damage and out-of-plane collapse of infill walls of a reinforced concrete building in Durrës (photo: SUZI-SAE).

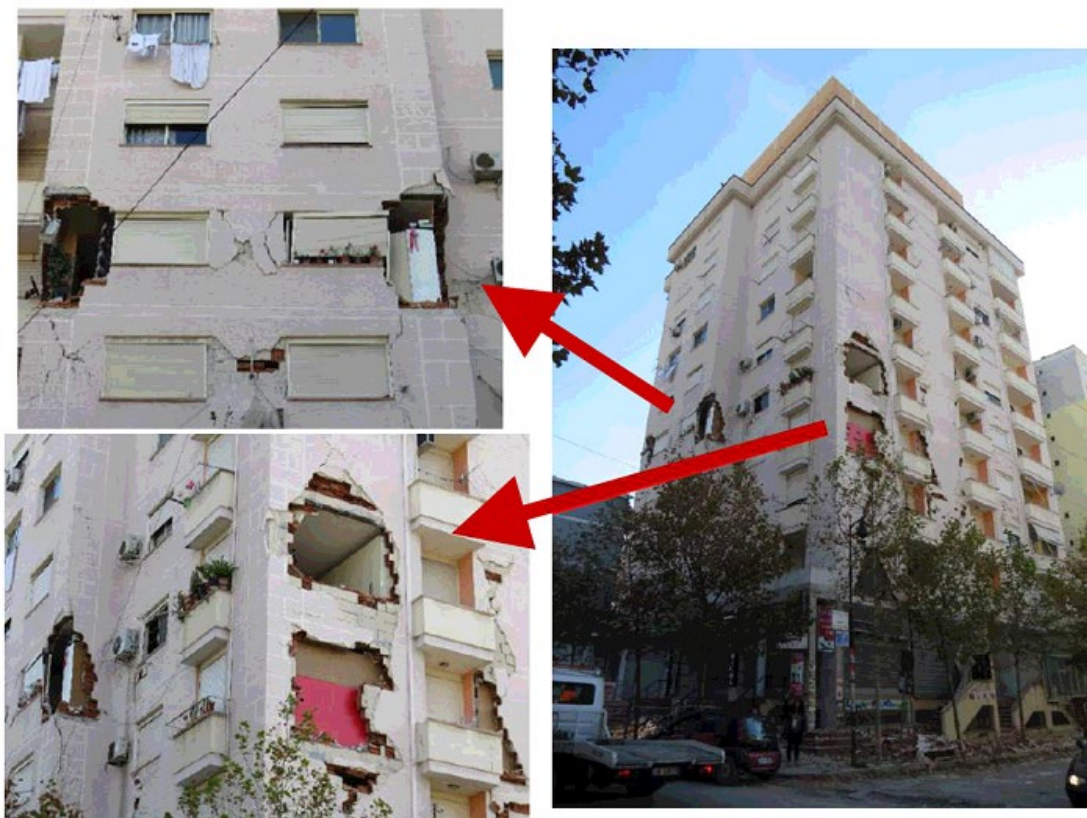
Figure 64. Damage and out-of-plane failure of infill walls in Durrës (Lekkas et al., 2019).

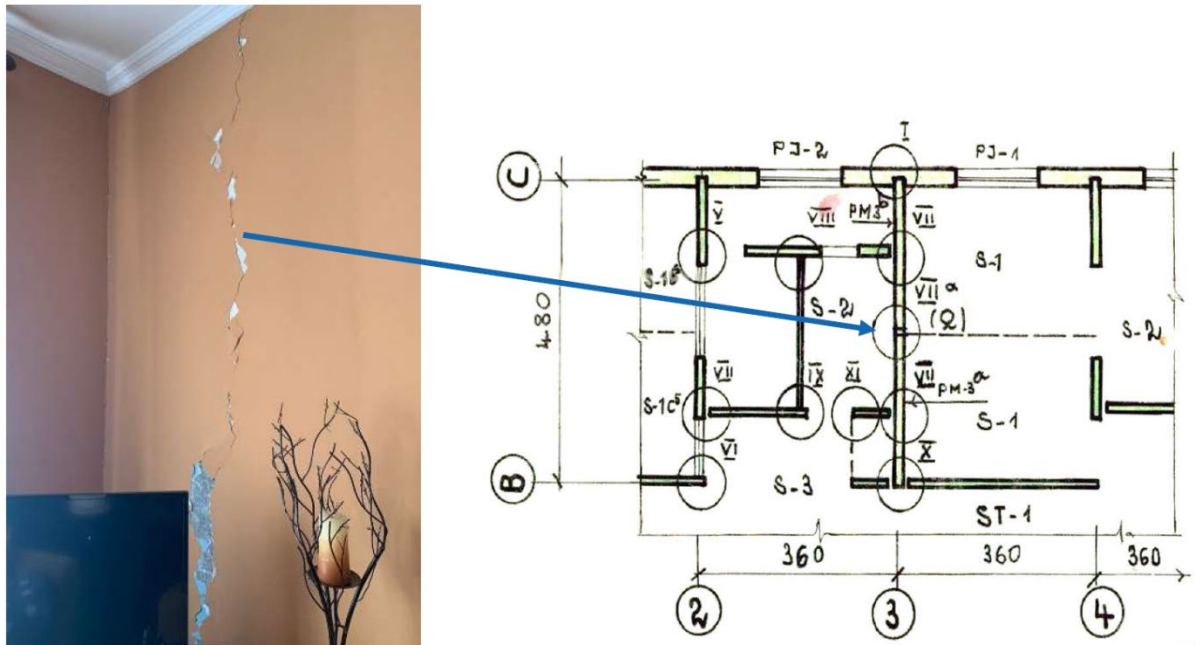
Figure 79. Cracking pattern at the interface between adjacent vertical panels (Kombinat area in Tirana) (photos: Merita Guri).

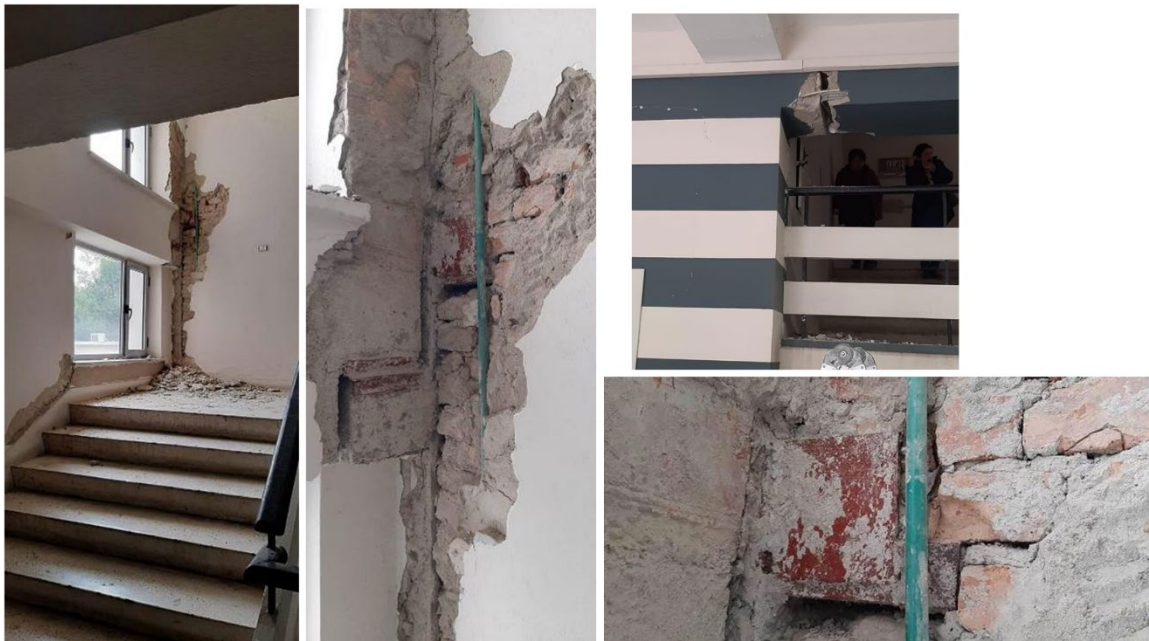
Figure 87. Damage of the National Territory Planning Agency building in Tirana. Frame damage was caused by the frame-infill interaction (photos: Markel Baballëku and T. Dano).

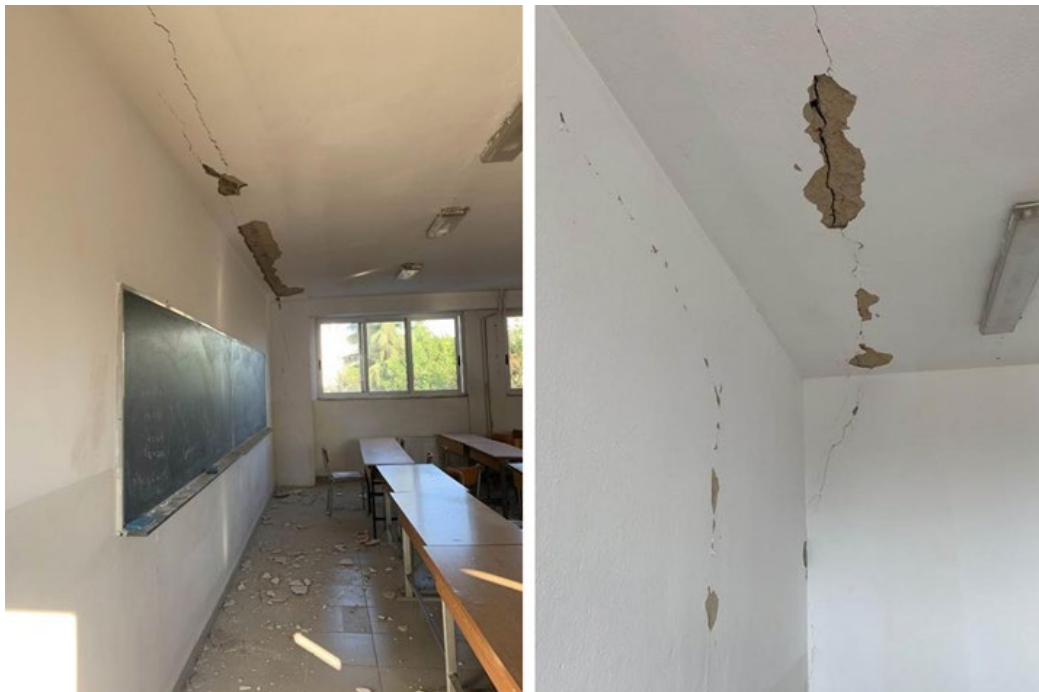
Figure 90. Sliding-induced cracking at the interface between prefabricated reinforced concrete slab panels in the FIN Building at the Polytechnic University of Tirana (photos: Markel Baballëku).

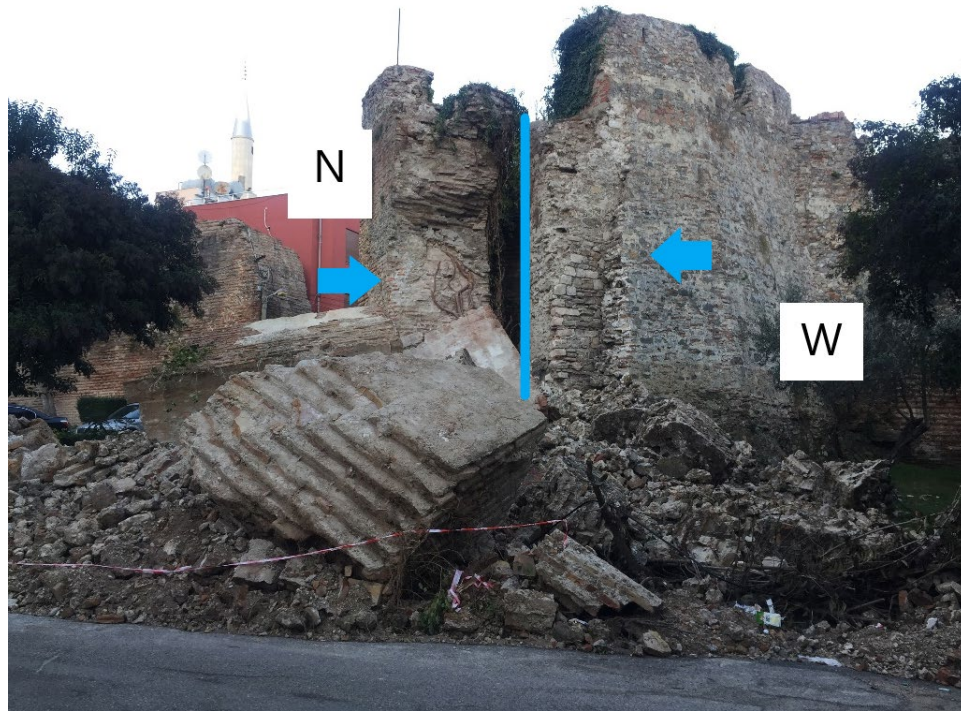
Figure 105. View of the north (N) and west façade (W) of the damaged tower at Durrës Castle (photo: EEFIT).

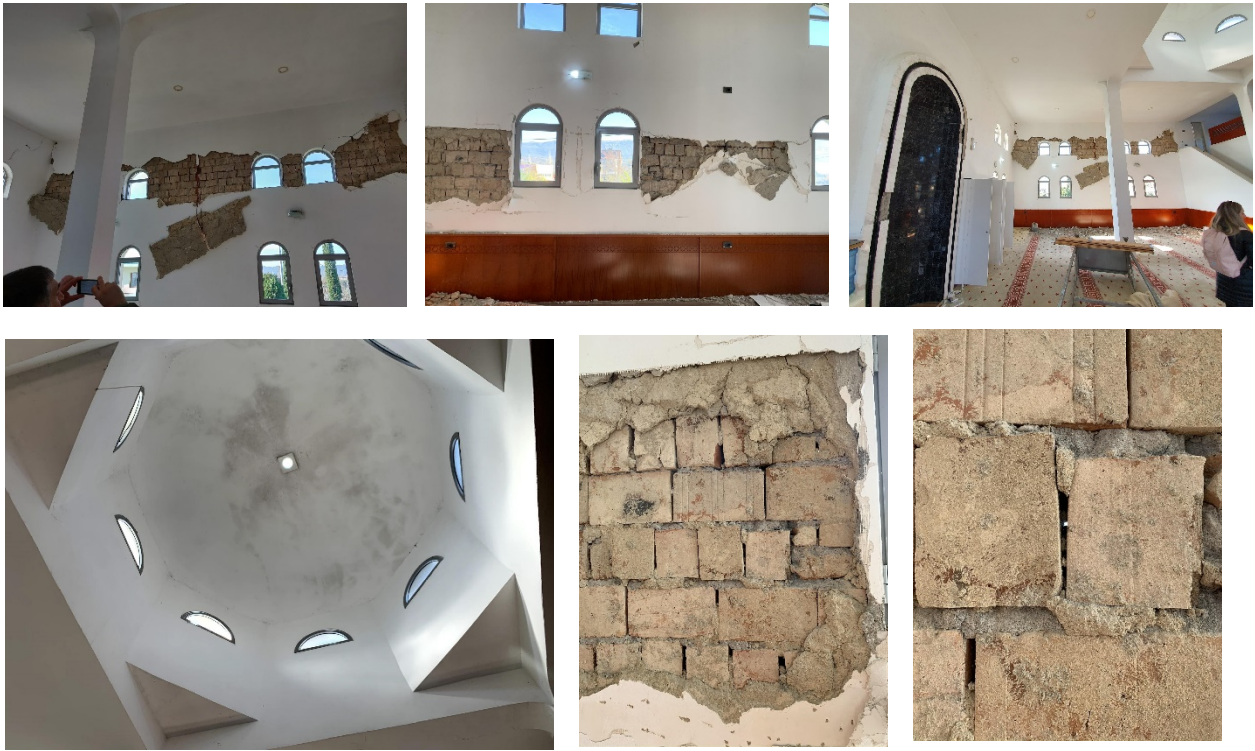
Figure 117. Interior view of the mosque in Thumanë showing damage in masonry walls and the dome (photos: HAEE).

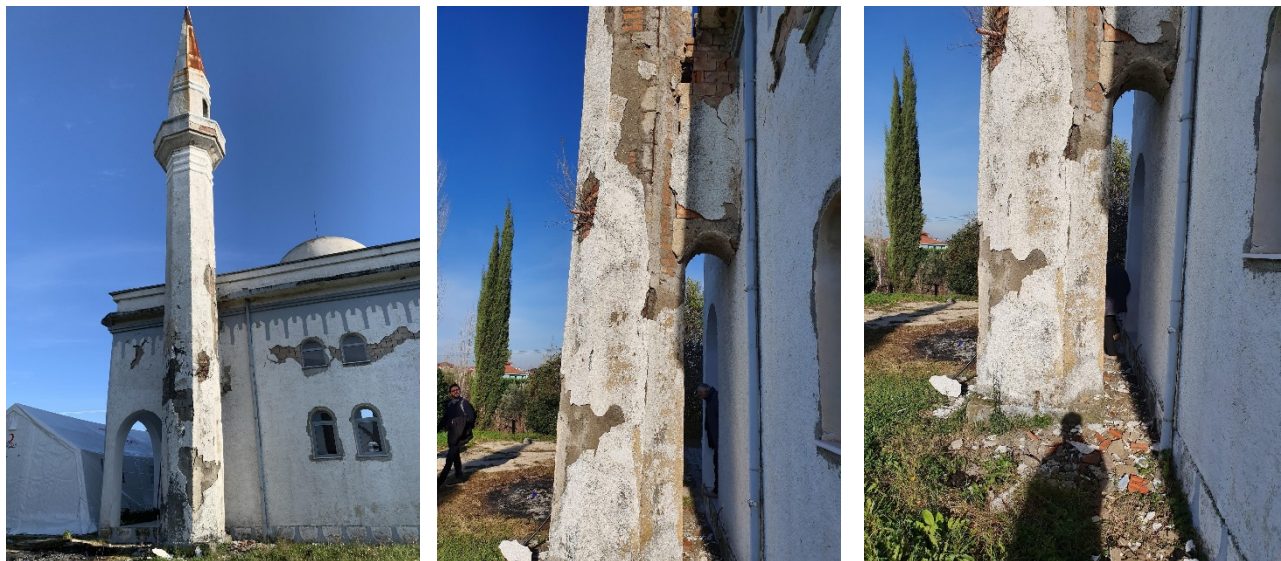
Figure 118. Major damage of mosque in Thumanë (photos: HAEE).

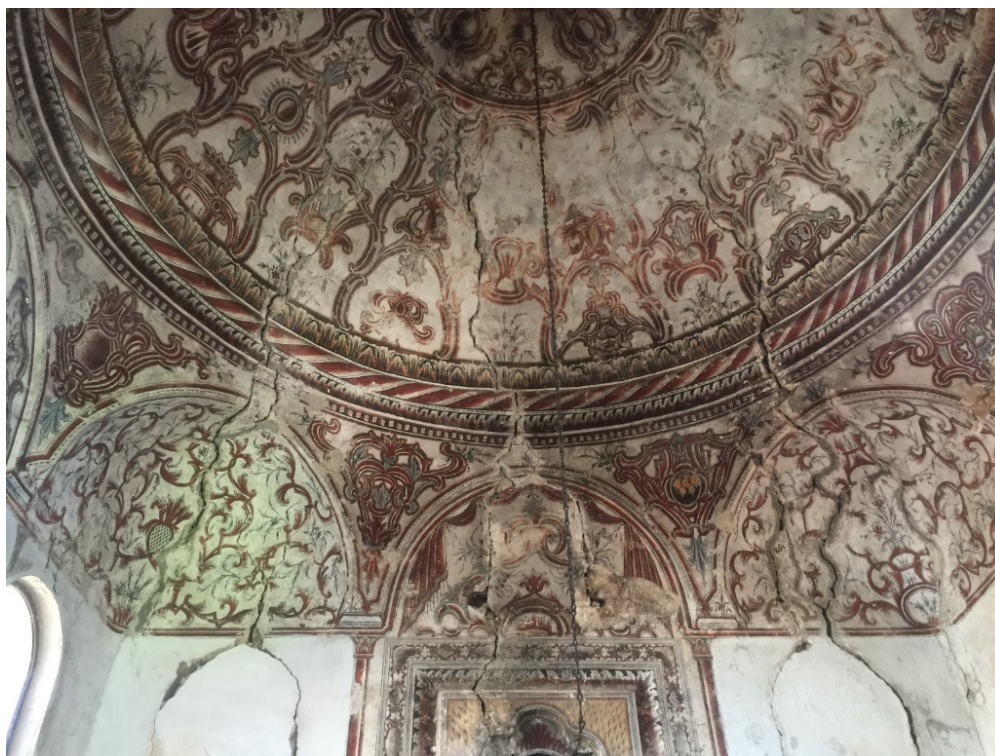
Figure 121. Cracking pattern in the dome (photo: EEFIT).
