# THE SAGUENAY, QUÉBEC, CANADA, EARTHQUAKE OF 25 NOVEMBER 1988

## DAMAGE DUE TO THE 25 NOVEMBER 1988 SAGUENAY, QUÉBEC, CANADA EARTHQUAKE

CANADIAN STRONG-MOTION DATA FOR SAGUENAY, QUÉBEC, EARTHQUAKE, 25 NOVEMBER 1988

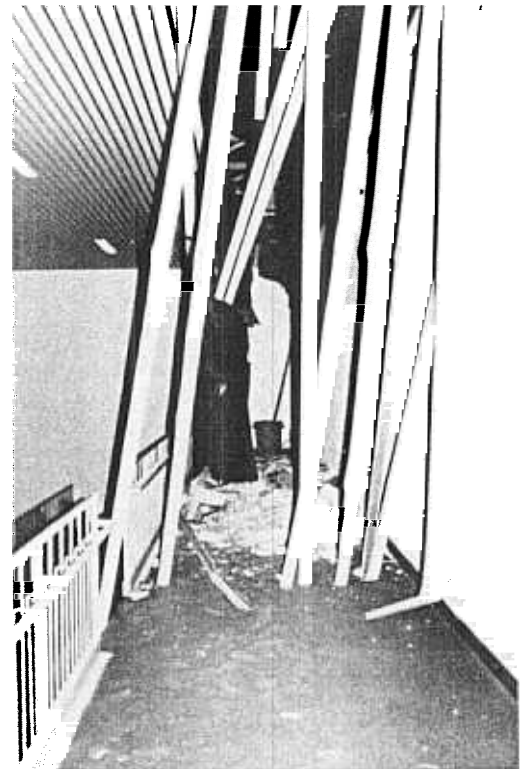
Residual displacements of about 12 mm (0.5 in.) were observed at the expansion joints in Dominique Racine Secondary School in Chicoutimi. This school also displayed many examples of unreinforced masonry blocks that had toppled from the top of the walls and fell through the ceiling panels, as shown in Figure 1. Similar problems occurred in the secondary school in the town of La Baie. Severe cracking of unreinforced masonry walls also occurred in the two-storey Georges Vanier Primary School in La Baie. This damage to the unreinforced masonry walls was accentuated by a poor structural system.

Figure 1: Debris from fallen masonry blocks in Dominique Racine Secondary School, Chicoutimi (Québec).

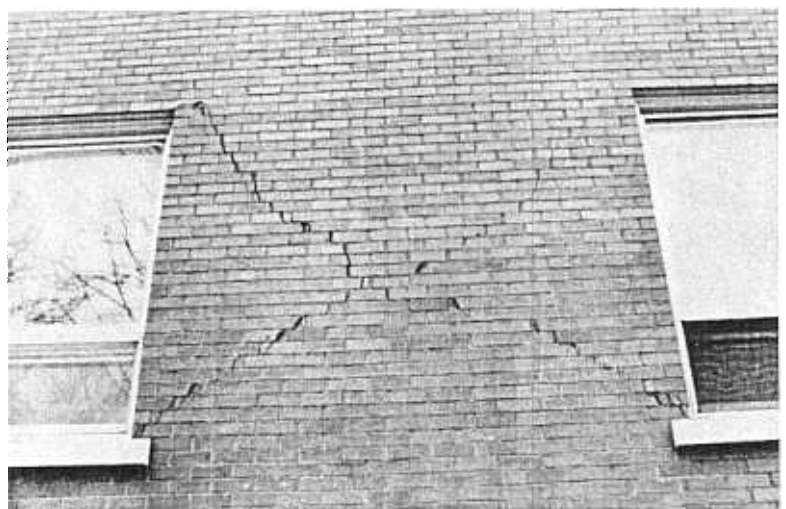
Two masonry chimneys collapsed on two wings of the Saint-François-d'Assise Hospital, Québec City. Plaster walls were severely damaged, particularly in the stairwells of one of the older wings. The emergency generating system functioned without any problems during the two-hour power outage. One of the elevator counterweights had been derailed from its guides during the earthquake, which led to a shear failure in a reinforced concrete beam when the elevator was put back into service, two hours after the earthquake. The separate seven-storey Notre-Dame Pavilion of this same hospital complex consisted of a steel frame with a brick masonry cladding. Figure 2 shows the diagonal shear cracking that occurred between the window openings in the wall at the ground floor level.

Figure 2: Diagonal cracks in brick wall of Notre-Dame Pavilion, Saint-François-d'Assise Hospital, Québec City (Québec).

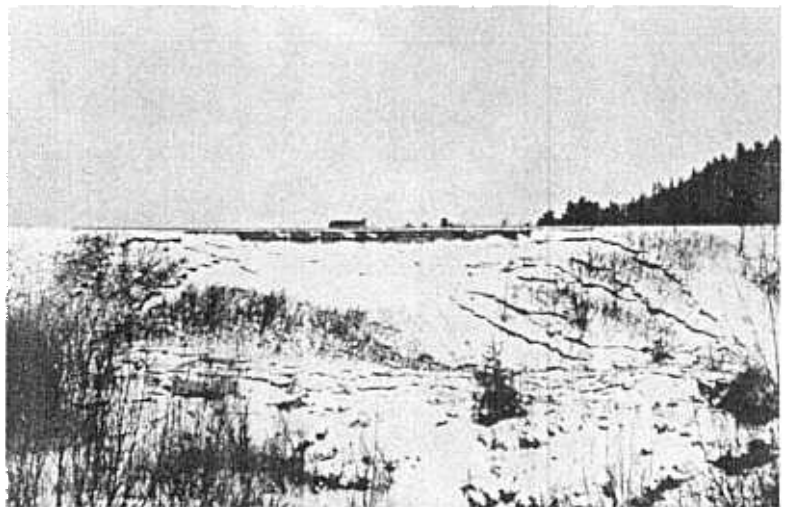
At least six highway embankment failures and several natural slope landslides were reported. Figure 4 shows a highway embankment failure on Route 138, just east of Ste-Anne-de-Baupré (about 120 km south of the epicenter). The embankment consisted of medium to fine sand, with a total height of 24 m (78 ft.) and a slope of 1.5 horizontal to 1.0 vertical. It is believed that liquefaction played an important role in this embankment failure. The slope failure took place over a stretch of about 60 m (200 ft.).

Figure 4: Overall view of embankment failure (60 m long) near Ste-Anne-de-Baupré (Québec).

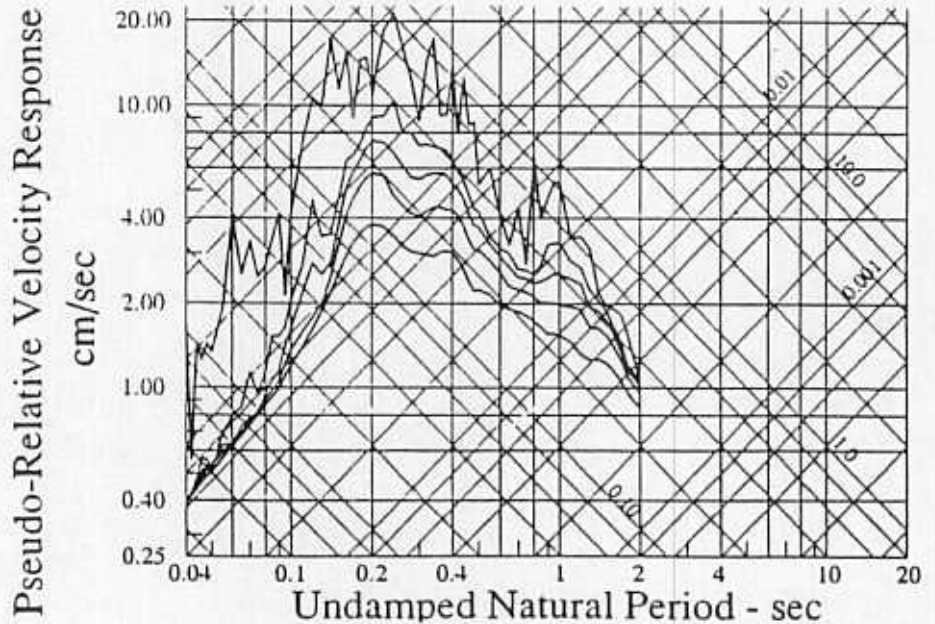
Response spectrum of the N0 component of the Dickey record.

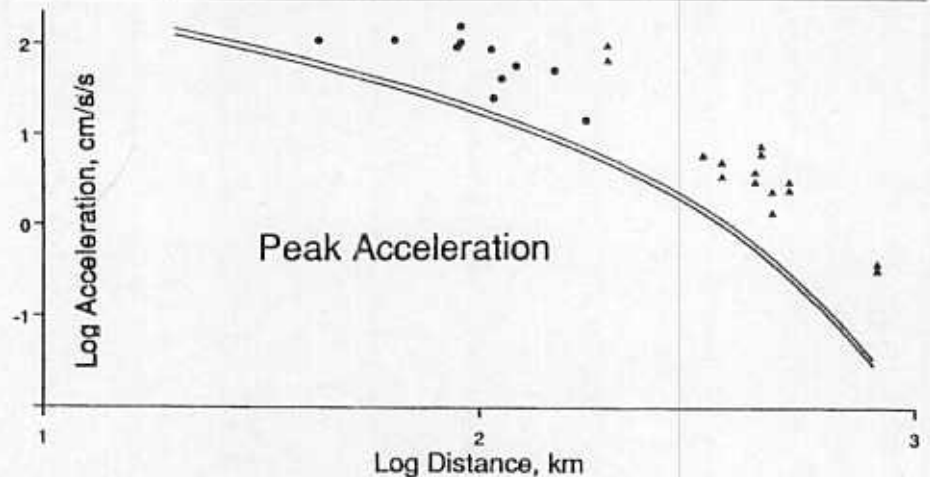
Peak horizontal accelerations from CGS data (circles) and NCEER (triangles). Western US acceleration data are typically represented by Joyner and Boore (for M=6.3 and 6.0) but not to distances as far as shown here.
