Preliminary Statistics of Collapsed Buildings in Mexico City in the September 19, 2017 Puebla-Morelos Earthquake

Francisco Galvis, Eduardo Miranda, Pablo Heresi, Héctor Dávalos and José Ramón Silos

John A. Blume Earthquake Engineering Center
Department of Civil and Environmental Engineering
Stanford University

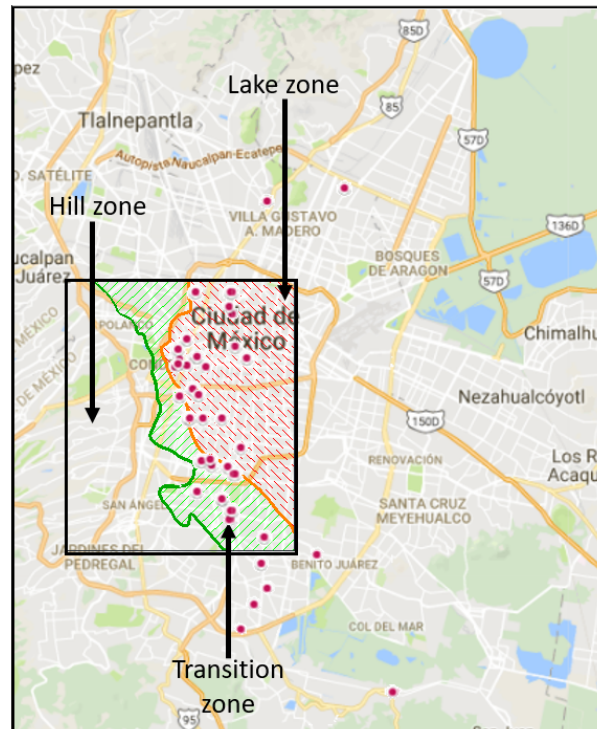
Figure 1 presents the microzonation that was included in the 1976 Mexico City code in which the city was divided into three zones according to local soil conditions: Hill zone, Transition zone, and Lake zone. This soil microzonation was commonly used in structural design prior to the 1985 Michoacán earthquake which demonstrated, once again, the need of a better characterization of soil types and of more stringent structural design requirements (Meli and Miranda 1985). This figure also shows with magenta markers the location of 44 collapsed structures caused by the 2017 Puebla-Morelos earthquake, which will be described in the next section. It is clear that collapsed occurred in either the Transition zone or the zone of shallower deposits of the Lake zone.

Figure 1. Microzonation of Mexico City in the 1976 code. Magenta markers indicate the location of collapsed structures during the 2017 Puebla-Morelos earthquake.

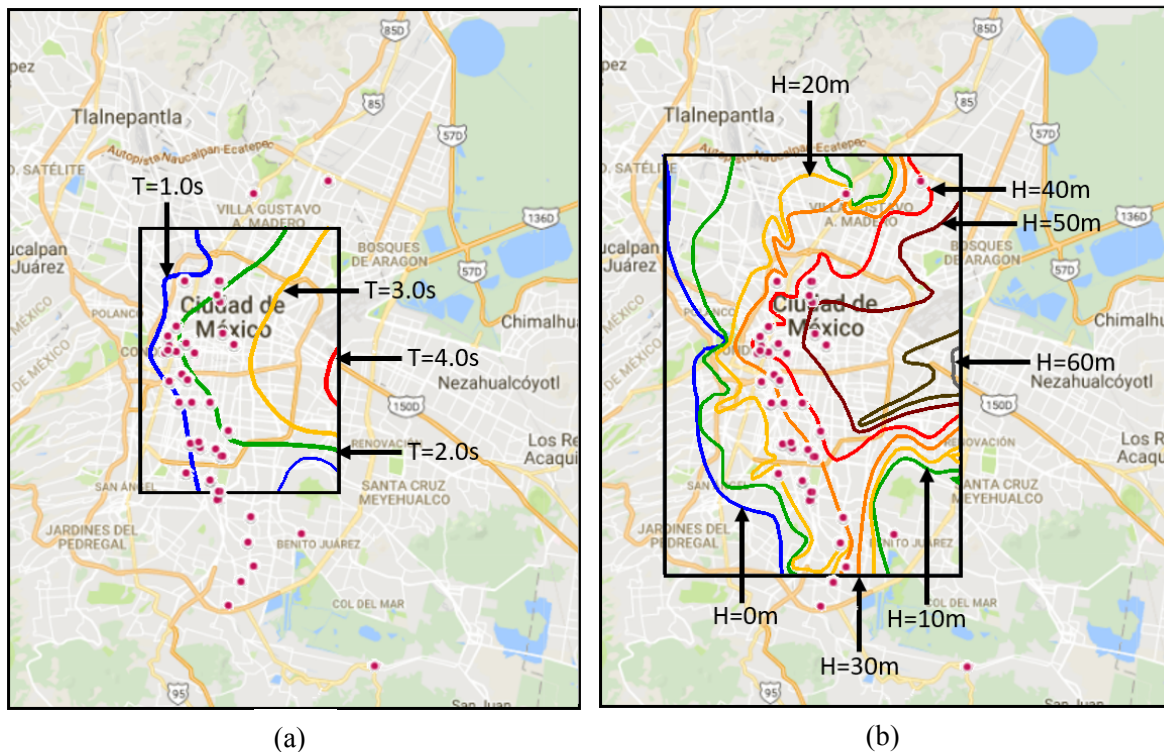
Figure 2. (a) Soil deposit isoperiods in Mexico City according the 1987 seismic code. (b) Clay deposits isodepths in Mexico City according the 1987 seismic code. Magenta markers indicate collapsed structures during the 2017 Puebla-Morelos earthquake.

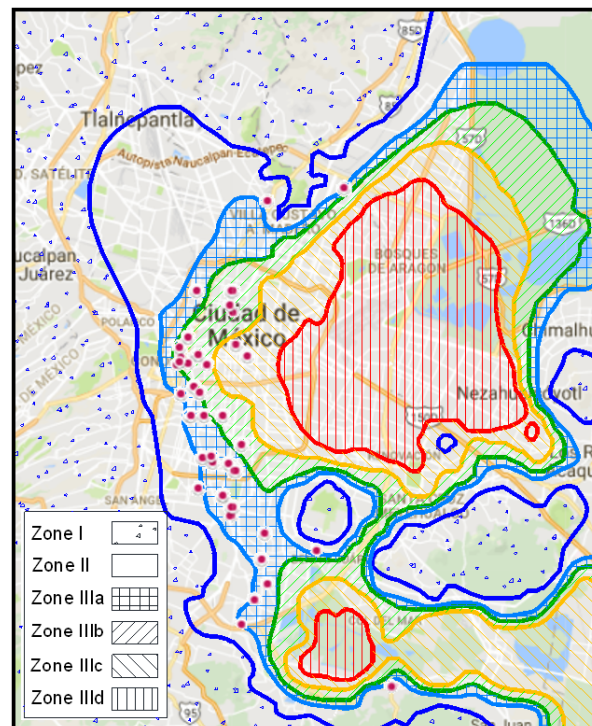
The current seismic design code in Mexico City was introduced in 2004 in which several modifications from the 1987 version were made (NTCS-04 2004). One of those modifications corresponds to the subdivision of the 1987 zone III into four subzones. Therefore, the determination of design forces for structures in Mexico City is currently obtained using six different zones. Figure 3 presents the current microzonation of the city along with the markers that indicate the location of the collapsed buildings during the $M_w 7.1$ 2017 Puebla-Morelos earthquake. In this case, it is observed that the collapsed structures concentrate in zones IIIa and IIIb of the current code.

Figure 3. Soil types microzonation according to the Mexico City 2004 seismic design code.

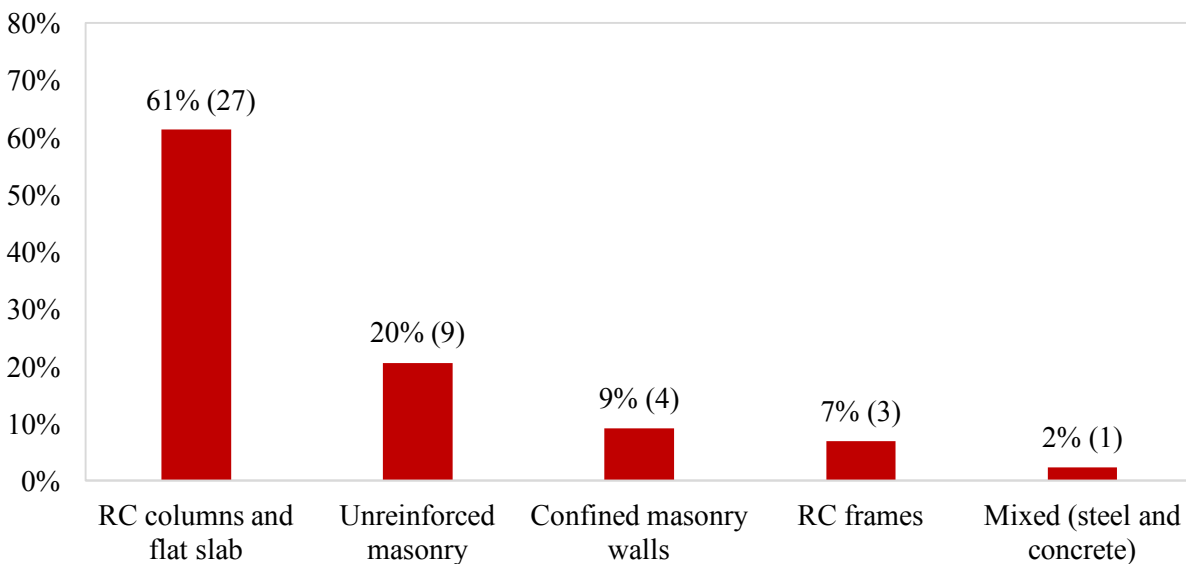
Figure 5 presents a histogram of the structural systems of the collapsed buildings. It is worth noticing that the structural system of more than 60% of the 44 collapses corresponds to a reinforced concrete (RC) column and flat slab system. This percentage is even higher than the observed in the 1985 earthquake which corresponded to 43.3% (91/210) (Meli and Miranda, 1985). The flat slab system is a system was developed in the early 1900s as a “beamless” primarily aimed at carrying gravity (vertical) loads and to facilitate construction by simplifying the formwork. However, when used as a lateral resisting system, the system is characterized by a very low lateral stiffness and prone to experiencing punching shear failures and soon after the slab-to-column connection loses its vertical carrying capacity it leads to a partial or total collapse of the building. During the 1985 earthquake 91 buildings with this structural system collapsed. In the emergency code that was issued a few days after the 1985 earthquake design forces for this structural system were greatly increased in order to disincentivize its use, however unfortunately it is still allowed by the code and continues to be used in buildings constructed after 1985. An example of the total collapse of one of these flat-slab reinforced concrete buildings is shown in Figure 6.

Figure 5. Distribution of structural systems for collapsed buildings in the 2017 earthquake.

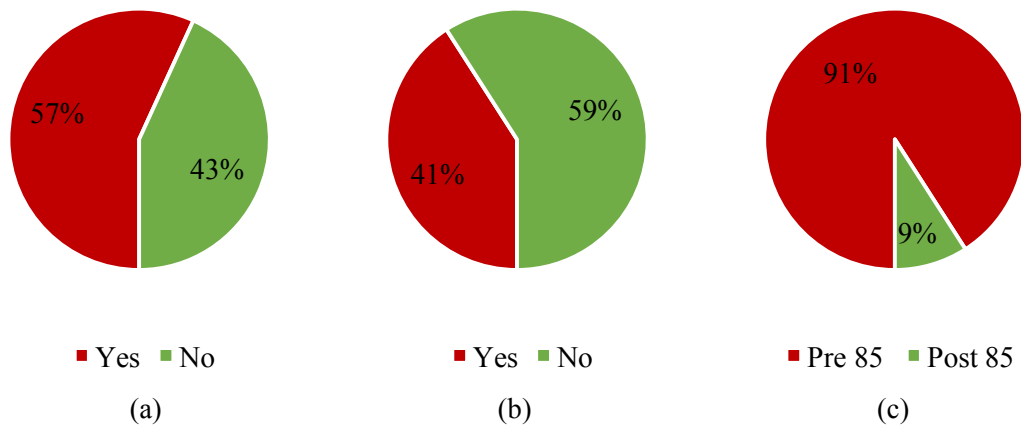
Figure 7(a) shows that 57% of the collapsed buildings were soft-story structures. A soft story is produced when one story, which is typically the ground level, has a lateral strength and lateral stiffness that it is significantly smaller than the other stories. This structural deficiency is usually produced by the presence of parking garage in the ground level while upper stories have many infill masonry walls making them laterally stronger and stiffer. During an earthquake, lateral deformations concentrate in the soft story which combined with inadequate reinforcing detailing leads to shear failures in the columns. Once shear failures are produced the column typically loses its vertical carrying capacity and a collapse is produced. This structural deficiency could have been the main reason triggering their collapse. An example of the collapse of this type of structure is shown in Figure 8. This failure has been observed in several previous earthquakes. For instance, the 1994 Northridge earthquake evidenced the vulnerability of wooden multistory buildings with a soft first story (Figure 9(a)). Likewise, the Puebla-Morelos earthquake triggered the same type of collapse in flat slab concrete structures with soft stories (Figure 9(b)). Soft stories were identified as the primary reason that lead to the collapse of 8% of the building in the 1985 earthquake (Meli and Miranda 1985) but the percentage of collapsed building with this structural deficiency was now significantly higher.

Figure 7. (a) Soft story buildings; (b) Corner buildings; and (c) Approximate building age

Figure 7(b) also shows that 59% of the collapsed structures were buildings located at corners of a building block. These buildings often have masonry infills in two sides facing neighboring structures but not on the two sides facing the street, leading to motions with stronger torsional response (rotation of floor systems about a vertical axis). Collapse of buildings located in corners was also a prevalent problem in the 1985 Michoacán earthquake where 42% of collapsed buildings were located on a block corner (Meli and Miranda 1985). It is important to note that in this earthquake one fourth of the collapsed structures (11 out of 44) had both structural deficiencies, soft story and located were corner buildings.

With respect to the age of construction, Figure 7(c) shows that approximately 90% of the collapsed buildings were built prior to the 1985 earthquake. This suggests that most structures following post-85 code regulations performed reasonably well, but further study is necessary. On the other hand, it is very concerning that the cause of collapse of many pre-85 buildings was the same as 32 years ago. This suggests a lack of structural evaluation following the 1985 earthquake and/or an inadequate implementation of effective retrofit strategies. Furthermore, the possibility of cumulative damage, in particular lateral stiffness

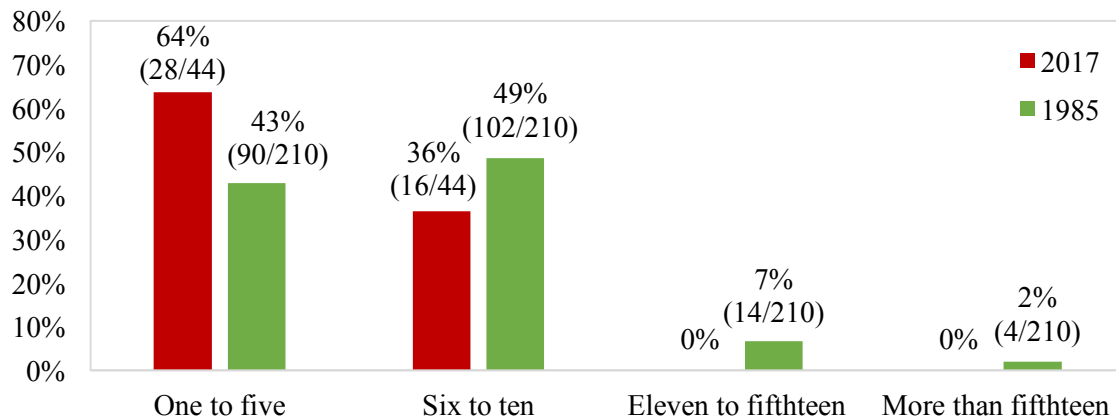
Figure 12 shows a comparison of the distributions of the number of stories of collapsed structures in the 1985 and 2017 earthquakes. It is evident that the 1985 earthquake had a greater impact on taller structures than the 2017 event. This observation is in agreement with the difference in frequency content from events resulting from the difference in magnitudes and considerably different source-to-site distances. As mentioned before, closer events, such as the 2017 earthquake, have more high-frequency content and therefore are expected to have a higher impact on shorter period structures than those that were affected during the large magnitude distant 1985 earthquake.

Figure 12. Distribution of the number of stories of the collapsed buildings for the 1985 and the 2017 Earthquakes
