EERI Earthquake Reconnaissance Report:

M6.4 Albania Earthquake on November 26, 2019

Volume 1: Executive Summary

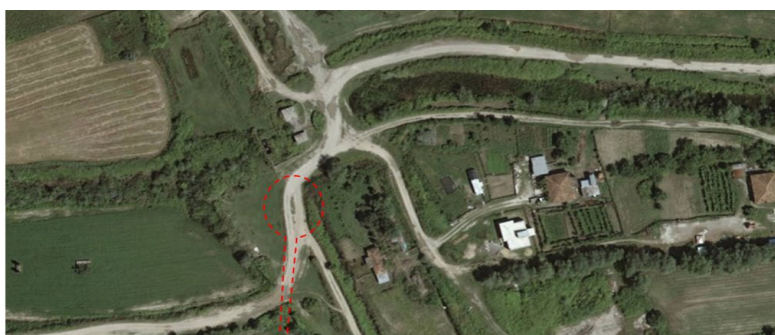
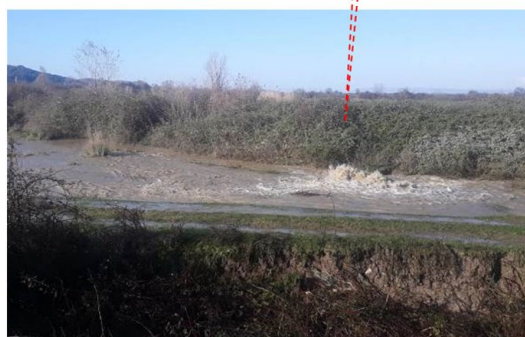
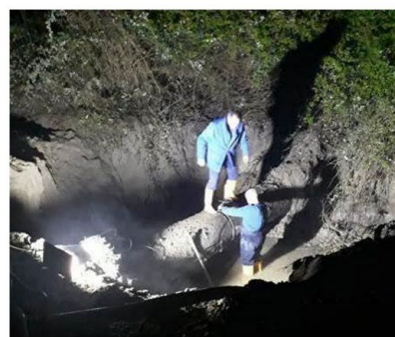
Post-earthquake observations show that the water, sanitation, and solid waste management facilities/ systems suffered minimal damage or losses, though there was an extensive network of piped supply and sewer systems in the area. The earthquake caused damage to a sewage treatment plant and water supply pipes near Durrës (Figure 5) and one pumping station in Lezha. The damage to the pipeline was fixed within a day. Four water supply depots also suffered damage in Tirana.

Location of damaged water supply pipeline

Close view of pipeline

Damaged pipeline under repair

Figure 5. Damage to a water supply pipeline near Ishem, Durrës (photos: M. Baballëku).

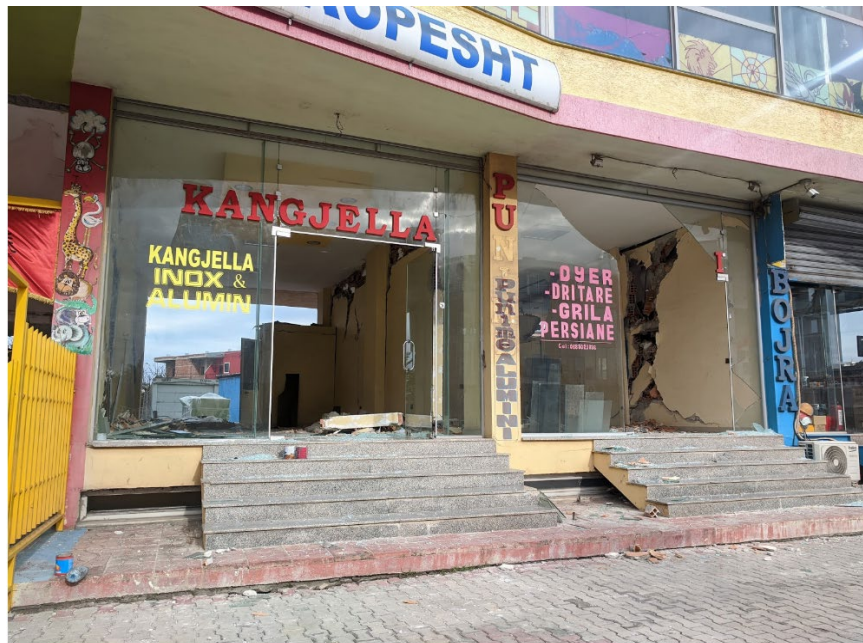
In many cases, business interruption was caused by damaged infill walls in reinforced concrete buildings in which lower floors are often occupied by businesses (Figure 6). Infill wall damage was dominant in the lower floors of multistory buildings and limited access to the stairs, thereby hindering evacuation of the tenants (Figure 7). Business interruption losses are estimated at over 5 million euros.

Figure 6. Business interruption due to nonstructural damage in Durrës (photo: C. McKenney, 2019).⁹

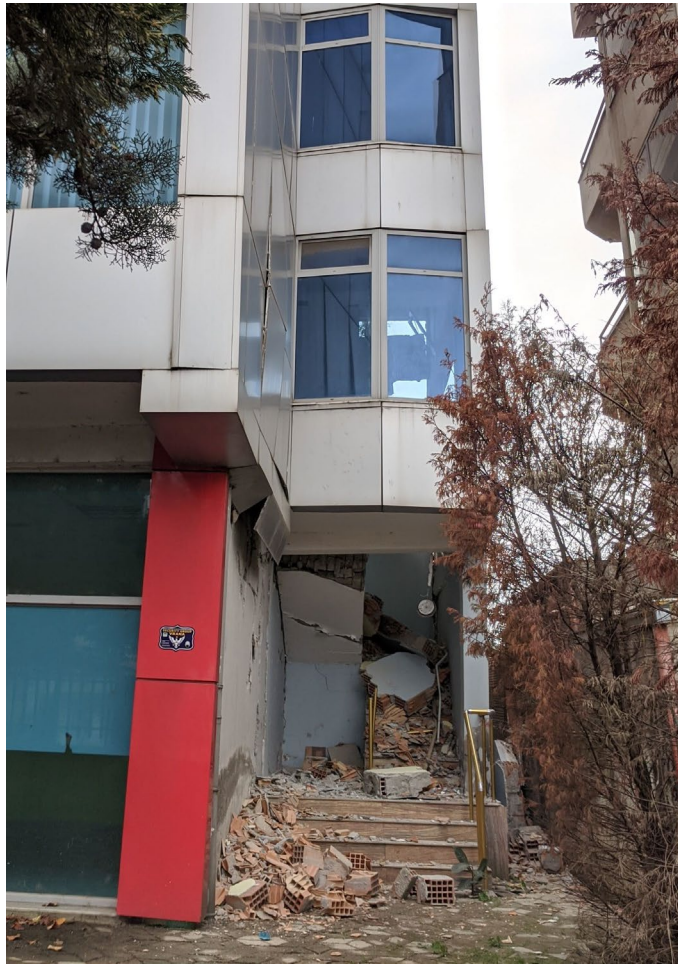
Figure 7. Masonry infill debris blocking stairs in Durrës (source: C. McKenney, 2019).

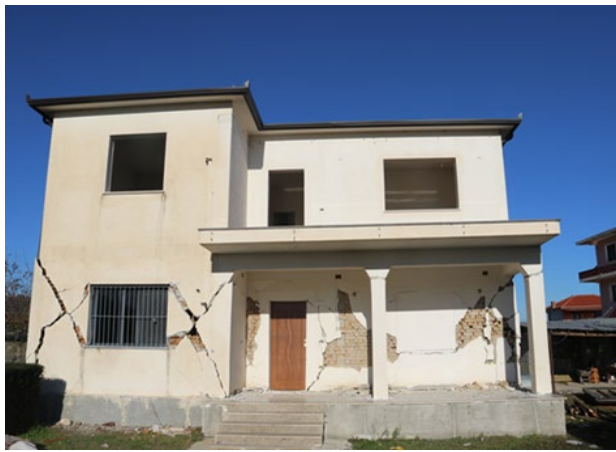
The majority of masonry buildings that were exposed to the earthquake were low-rise, single-family buildings, which constitute a significant portion of the building stock in Albania. These were mostly two-story, nonengineered, unreinforced masonry buildings designed and constructed by builders. In many cases, the damage was caused by building extensions (e.g., the construction of additional floors, irregular plan shapes (e.g., L-shapes), and/or use of low-strength masonry units (usually fired clay bricks)). Collapse was uncommon, but it was observed that buildings constructed using hollow, concrete blocks experienced more significant damage and even collapsed in a few cases. Only a few damaged confined masonry buildings were observed, so it is expected that most buildings of this typology remained undamaged. A severely damaged, unreinforced, single-family masonry building is shown in Figure 8(a)).

Figure 8. (a) low-rise masonry building in Bubq (source: (EEFIT, 2020; Freddi et al., 2021)^{14,15} and (b) a collapsed multi-story masonry building in Thumanë (source: <https://www.youtube.com/watch?v=2RXiG1KHC7k>).

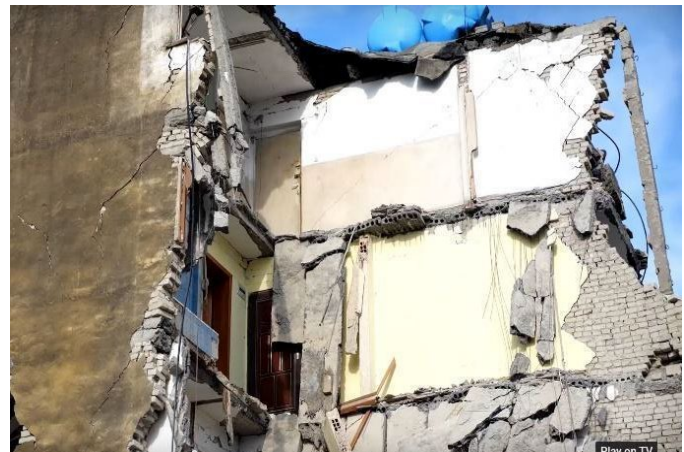
(b)

Although prefabricated hollow core reinforced concrete slabs were widely used in the construction of Albanian masonry schools, especially those built based on template designs, failures such as those encountered in residential masonry buildings in Thumanë (Figure 8(b)) were not observed. This can be explained by a few factors, including the higher lateral stiffness of school buildings compared to otherwise similar residential buildings due to building height limits for schools (a maximum of four stories), a higher importance factor applied in the seismic design of schools, and the use of higher quality workmanship and materials. It is worth noting that, in general, past renovations of existing school buildings in Albania have not been focused primarily on seismic safety but on the improvement of conditions for use (heating, architectural aspects, replacement of deteriorated materials, etc.).

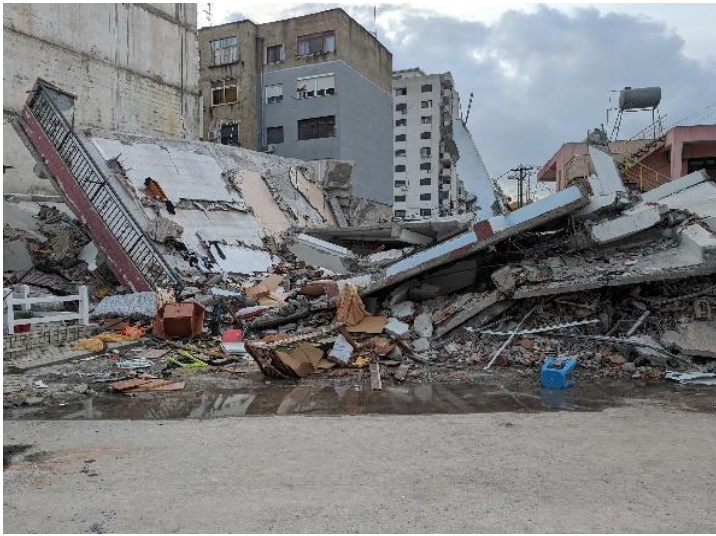
Some reinforced concrete buildings, typically up to 6 stories high, experienced severe damage or collapse. Among the collapsed buildings were hotels and apartment buildings located in Durrës (Figure 9(a)). In many cases, the combination of an open ground floor with upper stories stiffened by infill walls created the conditions for a soft-story mechanism. Seismic vulnerability of these buildings was likely aggravated by the fact that many of these buildings were built as a result of informal developments and are considered as nonengineered or inadequately engineered.

Figure 9. Performance of cast-in-place reinforced concrete buildings like (a) a collapsed residential six-story building in Durrës (photo: Ch. McKenney) and (b) the extensive damage to infill and partition walls in a multi-story building in Durrës (source: Nikolić-Brzev et al., 2020).¹⁶

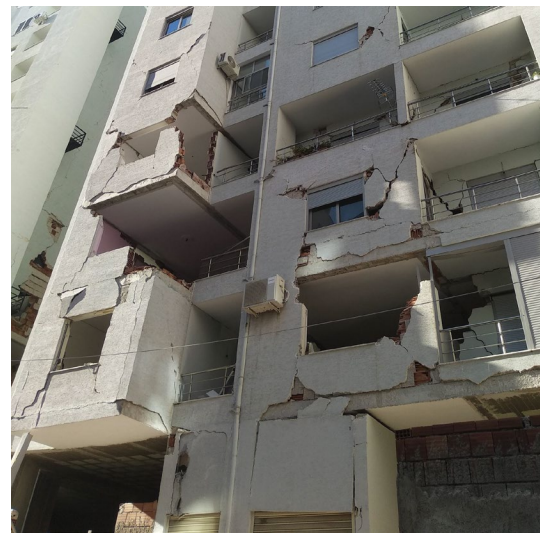
(b)

The damage of taller reinforced concrete buildings was widespread over a large area, including the capital Tirana. The most common damage pattern was cracking of the infill walls (Figure 9(b)), but in some cases, complete failure and collapse of the infills occurred due to excessive drifts and combined in-plane and out-of-plane seismic effects. Excessive lateral drifts and flexibility of these buildings can be attributed to the extensive use of wide/shallow beams in floor construction (sometimes over the entire floor, including perimeter frames) and the inadequate amount of shear walls. The design of flexible structures in the earthquake-affected area might have been the result of the fact that the seismic design code KTP N.2-89 (Academy of Sciences and Ministry for Construction, 1989) does not provide specific guidance for limiting damage by the control of inter-story drifts. Excessive lateral drifts also gave rise to other issues such as the interaction between adjacent building blocks.

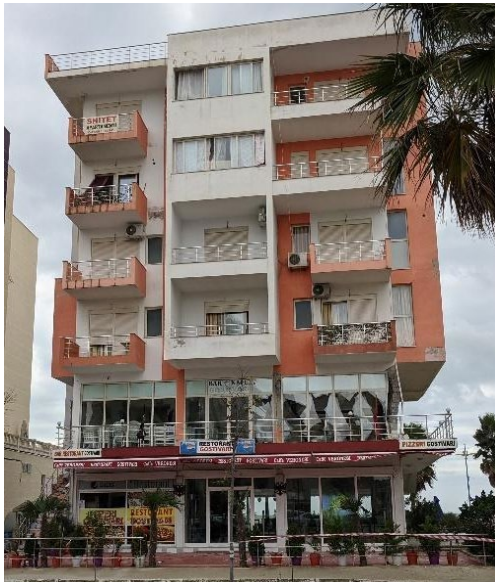
Other structural damage in taller, reinforced concrete buildings can be explained by irregularities in plan configurations and elevations, detailing of steel reinforcement, geotechnical effects, and the poor quality of materials. In terms of regularity, the current design code KTP N.2-89 imposes rather strict requirements about the overall building shape, but the earthquake showed that special attention is needed for the distribution of shear walls and infills inside buildings. The combination of flexible reinforced concrete structures with masonry infills that are considered as nonstructural elements during design caused unintended irregularities in the plans, which led to a torsional response during seismic excitation, and the elevations, which led to large demands on certain vertical elements and the formation of soft-story mechanisms, short columns, etc. Such an interaction of the infills with the reinforced concrete frames was likely a major contributor to some of the collapses and member failures in reinforced concrete buildings, especially in the Durrës area. In the example shown in Figure 10(a), the lower two stories of the building did not have stiff infills and suffered significant structural damage, whereas the upper stories had masonry infill walls. Figure 10(b) shows a reinforced concrete column that experienced damage due to poor detailing and interaction with infill walls (which were likely not considered in the design).

Figure 10. Structural damage in cast-in-place reinforced concrete buildings in (a) a building in Durrës with structural damage concentrated in the lower two stories and the stiff infills in the upper stories (photo: Ch. McKenney) and (b) a damaged column with poor detailing (photo: M. Baballëku).

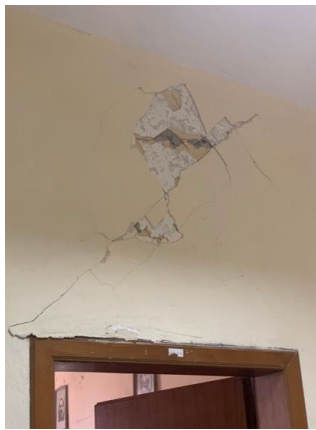
- diagonal cracking of loadbearing masonry walls and damages near window/door openings in severely damaged masonry schools (Figure 12(a) and (b));
- damage to buildings with extensions (e.g., addition of stories, extension of floor areas, and new openings or closures of existing openings) without seismic design considerations;
- light cracking of masonry walls and damage to plaster, parapets and other nonstructural elements;
- pounding of adjacent building blocks due to inadequate seismic joints;
- deterioration of materials and lack of maintenance; and
- a few reinforced concrete school buildings with damage patterns similar to those observed in residential buildings, including damage to infills and structural damage to columns (Figure 12(c)).

Figure 12. Damage patterns in school facilities, including (a) cracking above classroom doors in a masonry school building in Shijak, (b) structural damage of masonry walls in a school building in Thumanë, and (c) a damaged reinforced concrete column in a reinforced concrete school building in Durrës (photos: M. Baballëku).

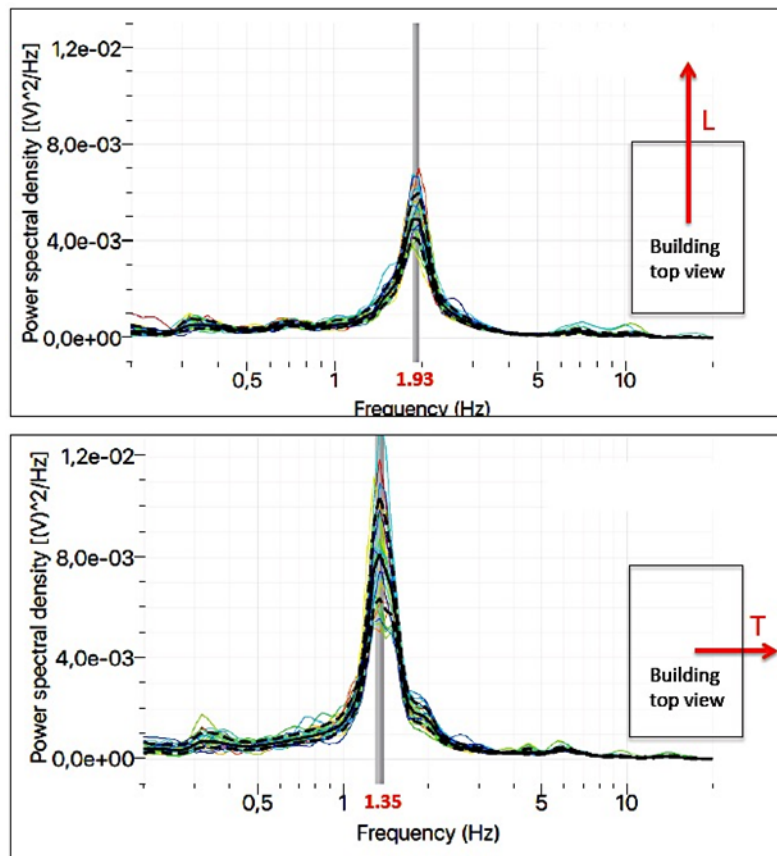
Ambient noise was recorded in both the longitudinal and the transversal directions of the building. The power spectral density in both directions is presented in Figure 26. The fundamental frequencies of the building in both the longitudinal and transversal directions were observed to be 1.93 Hz and 1.35 Hz, respectively. As expected, in the longitudinal direction, the building appears stiffer than transversal direction. However, in both directions, the fundamental period ranges between 0.52 seconds to 0.75 seconds, which fall in the period range in which the recorded spectral acceleration exhibited the highest values.

Figure 26. Power spectral density based on ambient noise measurements at the top of the 10-story building (source: Theodoulidis et al., 2020).

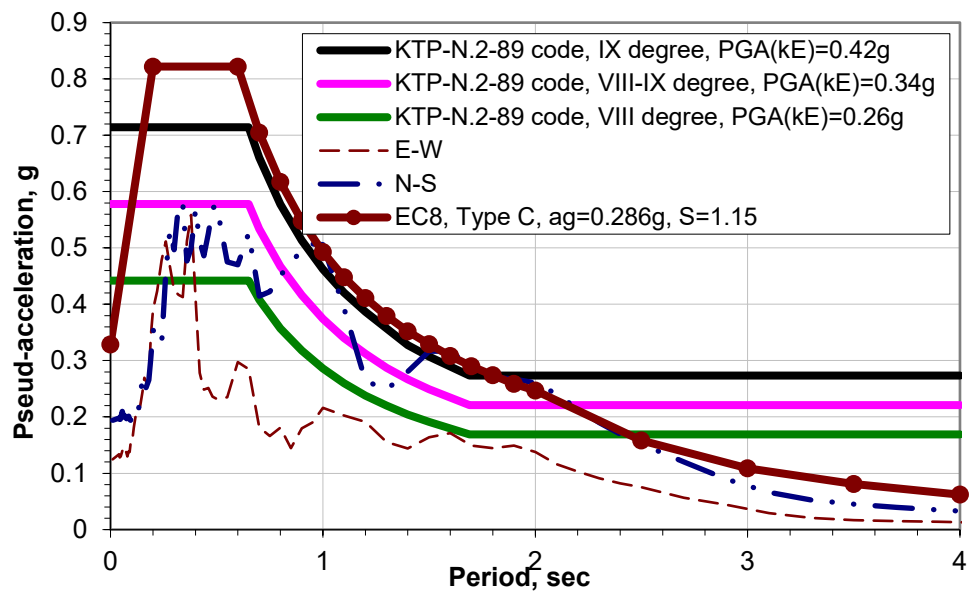
Figure 31. Elastic spectra according to KTP-N.2-89 and EC8 codes with the 5% damped horizontal pseudoacceleration response spectra at the DURR station from the M6.4 event (source: DS, IGEWE).

From Figure 31, it can be seen that the recorded spectral acceleration in Durrës was high relative to the KTP-N.2-89 code elastic spectra for seismic intensity VIII: it was at least 500 cm/s/s for a wide range of periods between 0.3 seconds and 1.0 second, possibly with a decisive impact on a wide range of buildings, especially mid-rise structures (5 to 10 stories).

For both Durrës and Tirana, as shown in Figure 31 and Figure 32, it is apparent that elastic design spectra according to Eurocode 8 are more conservative than those imposed by the KTP-N.2-89 seismic code currently in force in Albania. It should also be noted that the ground type conditions in the DURR station were even worse than those corresponding to Type C Eurocode 8 spectrum, which means that the actual difference between Eurocode 8 and the KTP-N.2-89 was even larger than what is shown in Figure 31 for Durrës.

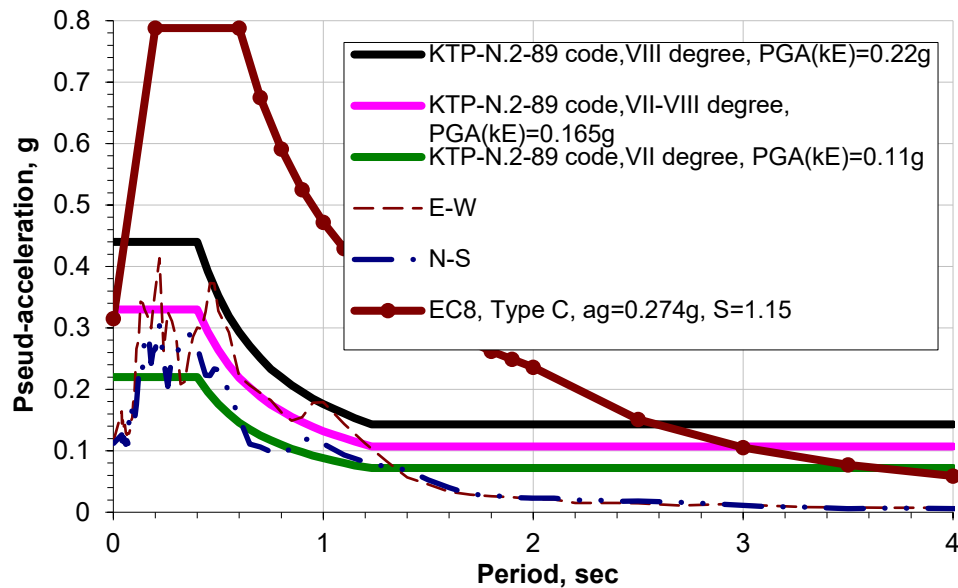
Figure 32. Design spectra according to KTP-N.2-89 and EC8 codes with the 5% damped horizontal pseudoacceleration response spectra recorded at the TIR1 station from the M6.4 event (source: DS, IGEWE).

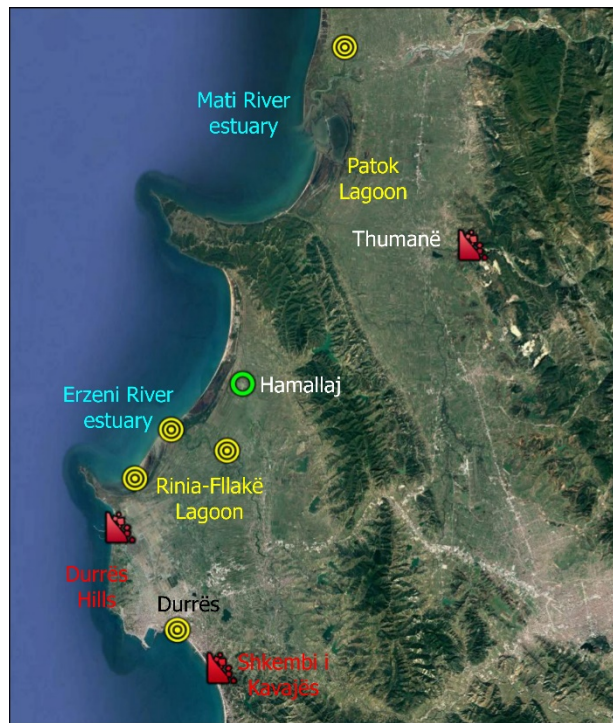
The November 26, 2019 Durrës earthquake-triggered liquefaction phenomena were observed in several sites, including the coastal part of southern Durrës, the central part of the Rinia-Flakë Lagoon, the Erzen River estuary, and the Thumanë area (Figure 42).

Figure 42. Location of sites affected by liquefaction phenomena (highlighted with yellow symbols and location names), slope movements (highlighted with red symbols and location names), and ground cracks (highlighted with green symbols and location names) triggered by the earthquake of November 26. (Source: Mavroulis et al., 2019)⁵²

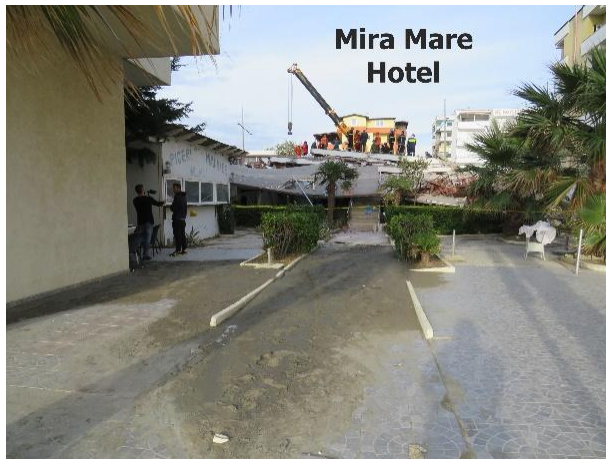
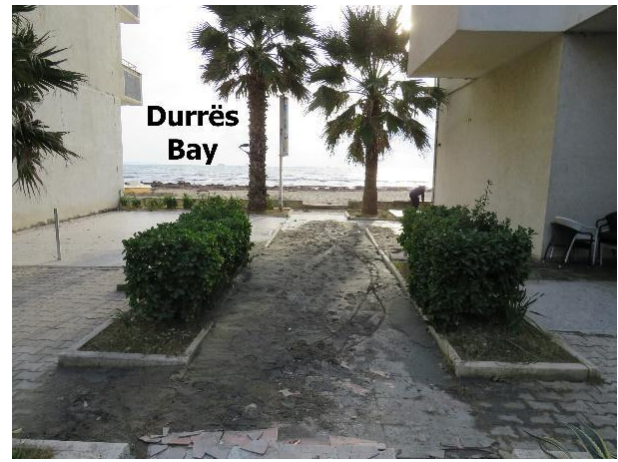
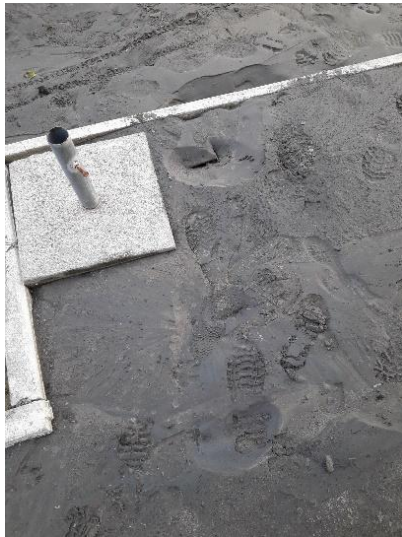
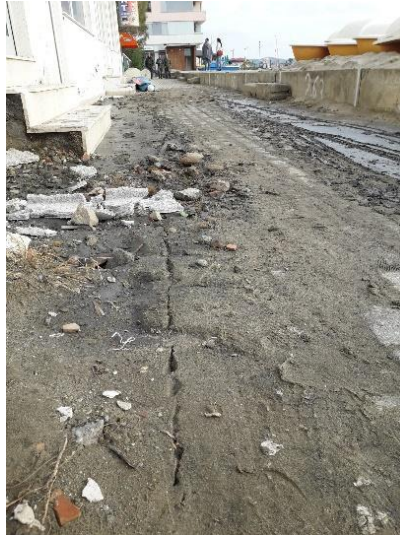
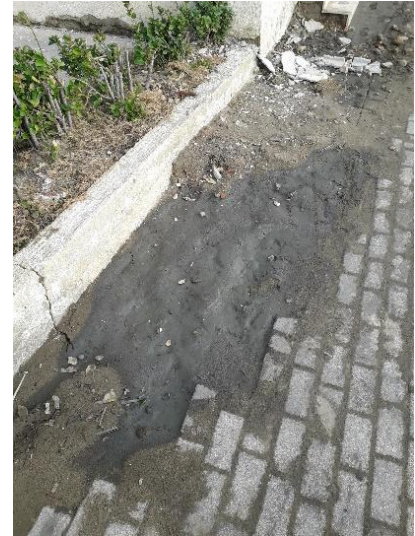
Liquefaction phenomena were triggered in the southern coastal part of Durrës at a distance of 2 km east of the port and almost 16 km south of the epicenter (Figure 42). They were observed west of the coastal road named SH4 leading from Durrës to Shkëmbi i Kavajës. Effects included the ejection of liquefied material comprising sand, silt, and water from ground cracks generated on the pavement (Figure 43). This material formed sand boils with a diameter of about 20 cm, and pavement were covered with sand and silt (Figure 43). The prevailing lithologies at this site are sands and silts, and the groundwater level is shallow.

Figure 43. *Liquefaction phenomena in the coastal part of southern Durrës. They included sand boils, ejection of liquefied material from ground cracks and pavements covered with sand and silt. This liquefaction site in southern Durrës was observed close to the collapsed Mira Mare Hotel. (source: Spyridon Mavroulis, Efthymios Lekkas, and Panayotis Carydis; Lekkas et al., 2019b).*

The liquefaction site was located in an area where structures with reinforced concrete frame and infill brick walls exhibited heavy structural damage, collapse, and tilting. However, the adjacent buildings suffered only nonstructural damage or no damage at all. These heavily damaged structures were the Villa Verde, Mira Mare, and Lubjana hotels (Figure 44). The Mira Mare Hotel, located 30 m from the liquefaction site, entirely collapsed. The Villa Verde hotel, located 100 m from the liquefaction site, suffered partial collapse. The Lubjana hotel, located about 75 m from the liquefaction site, presented tilting due to the failure of the ground floor columns in the backside of the building. All buildings were demolished a few days after the completion of the search and rescue operations, and the rubble was completely removed.

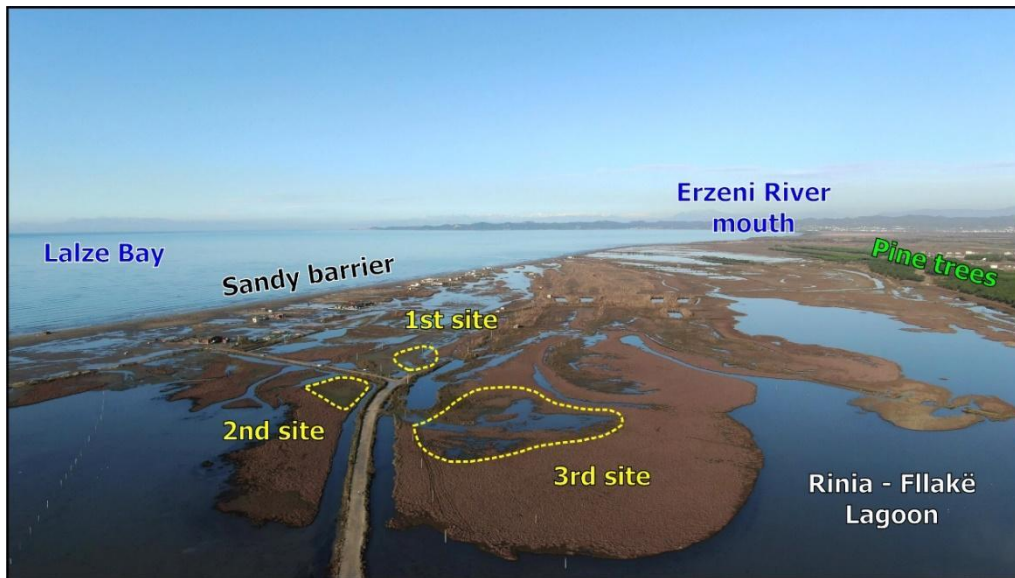
- Individual sand boils were formed by the ejection of liquefied material comprising mainly sand and water on the surface (*Figure 46*, *Figure 47*).
- The alignment of sand boils were observed with elongated/aligned multiple sand boils in the central part along almost N-S trending ground cracks (*Figure 48*, *Figure 49*).
- Water and sand fountains were observed by locals in still waters.

The observed liquefaction phenomena did not cause structural damage due to the fact there are no buildings because of the lagoon. They caused only slight damage to infrastructure, including tilting to electrical pillars (*Figure 46*).

Figure 45. Liquefaction phenomena were generated in three sites in the central part of the Rinia-Fllakë Lagoon (source: Spyridon Mavroulis, Efthymios Lekkas, and Panayotis Carydis).

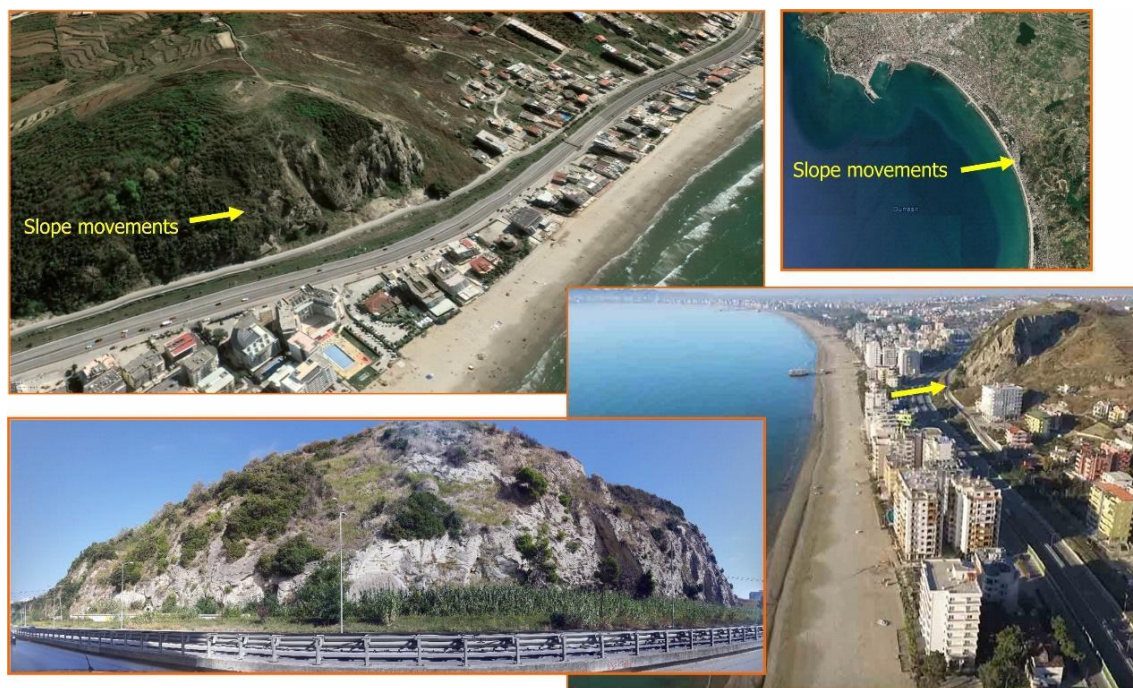
Figure 54. Slopes were induced by the Mw=5.6 foreshock on September 21, 2019, along the road leading from Durrës to Kavajë, located southeast of Durrës (source: Lekkas et al., 2019a).

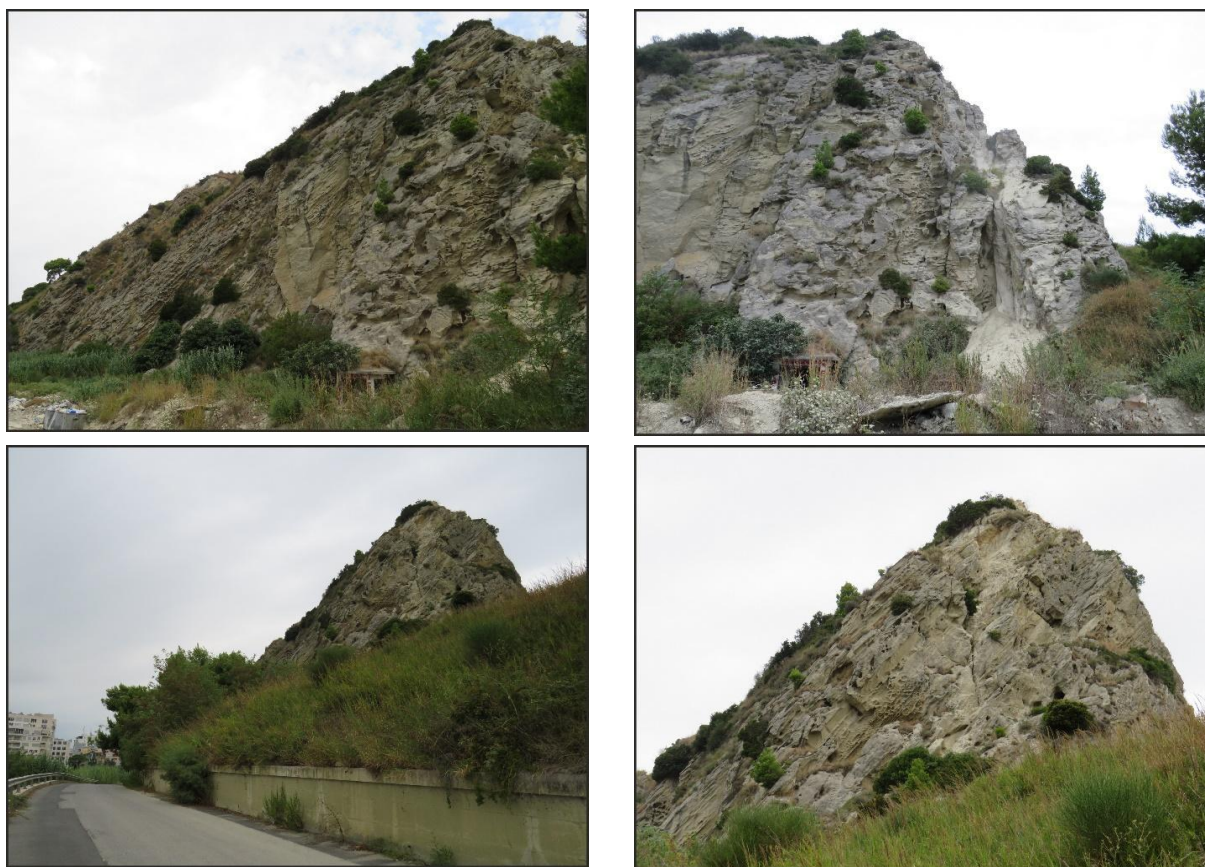
More specifically, landslides were induced by the September foreshock at slopes along the road leading from Durrës to Kavajë (Shkëmbi i Kavajës), located southeast of Durrës (Figure 54). The affected slopes are composed of Pliocene clays, which are intensively faulted (Figure 55). The slope and geological beds dip toward the road, resulting in instability conditions that can generate earthquake-induced slope failures. The mobilized material resulted in temporary traffic disruption without significant effects on the road asphalt surface, vehicles, and drivers. Landslides were also triggered by the November mainshock along the coastal area north of the Shkëmbi i Kavajës area. The mobilized material resulted in destruction of the coastal road and reached the adjacent flat lowland (Figure 56). The affected area is composed of clays along the affected slope and sands along the beach. The generation of the landslide can be attributed to the synergy of the earthquake ground motion with the existing unstable conditions formed by human processes (e.g., the construction of the coastal road) and by natural processes (e.g., the erosive action of the sea waves and winds).

Figure 55. The Shkëmbi i Kavajës (Rock of Kavajë) was affected by the Mw 5.6 foreshock on September 21, 2019. The steep slopes are composed of Pliocene clays, which are faulted (source: Spyridon Mavroulis, Efthymios Lekkas, and Panayotis Carydis).

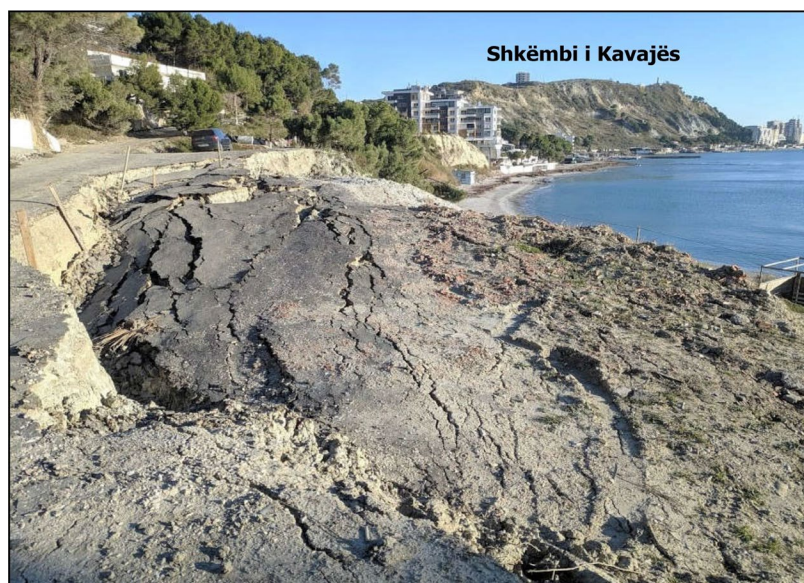
Figure 56. Slope movements were also triggered by the Mw 6.4 earthquake on November 26, 2019. A characteristic example is this coastal site located north of the Shkëmbi i Kavajës (Rock of Kavajë) area, which can be seen in the background (source: Pavlides et al., 2020, modified).

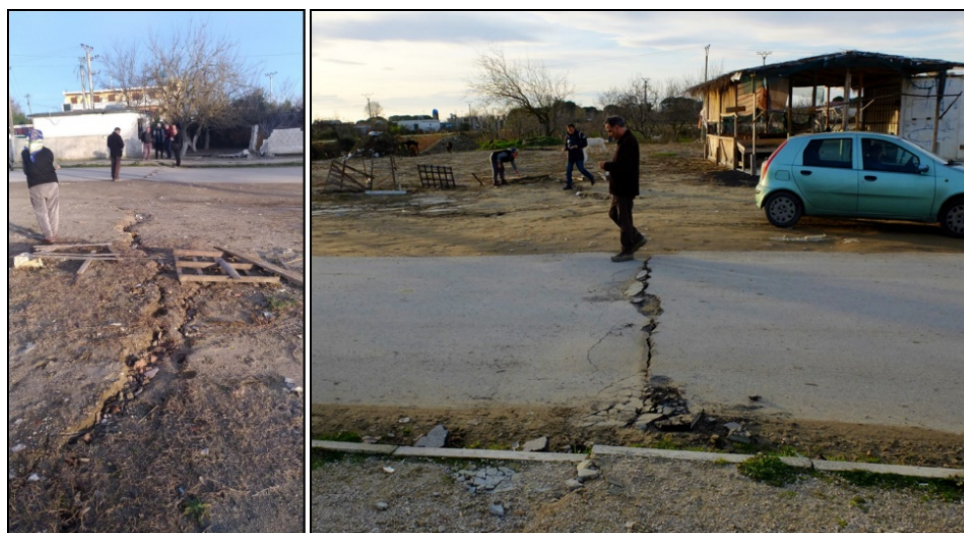
Seismic shaking also caused several typical ground fissures. Vittori et al. (2021) observed cracks along the rim of the southwestern side of Cape Bishtpalla and in the joints of limestones cropping out on the slopes of the Kruja mountainous area located east of Thumanë, a 30 m long and 2 to 10 cm wide arched fracture cutting the road in front of the water pumping station of Hamallaj (Figure 57) and several cracks cutting across the road near the water pumping station of Thumanë.

Figure 57. Ground cracks near the water pumping station of Hamallaj (source: Vittori et al., 2021).

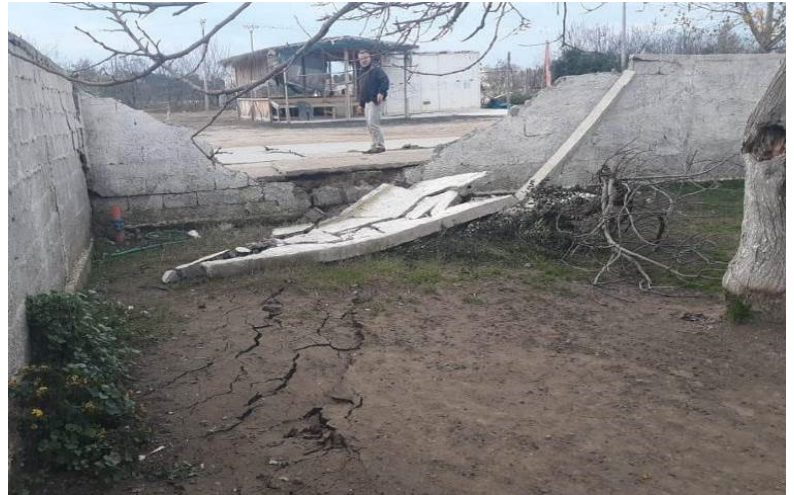
Figure 1. Damage to the road in front of the drainage pumping station in Hamallaj (41.486820, 19.517701), Durrës. The photographs show the same damage from each side of road (source: Altin Sula).

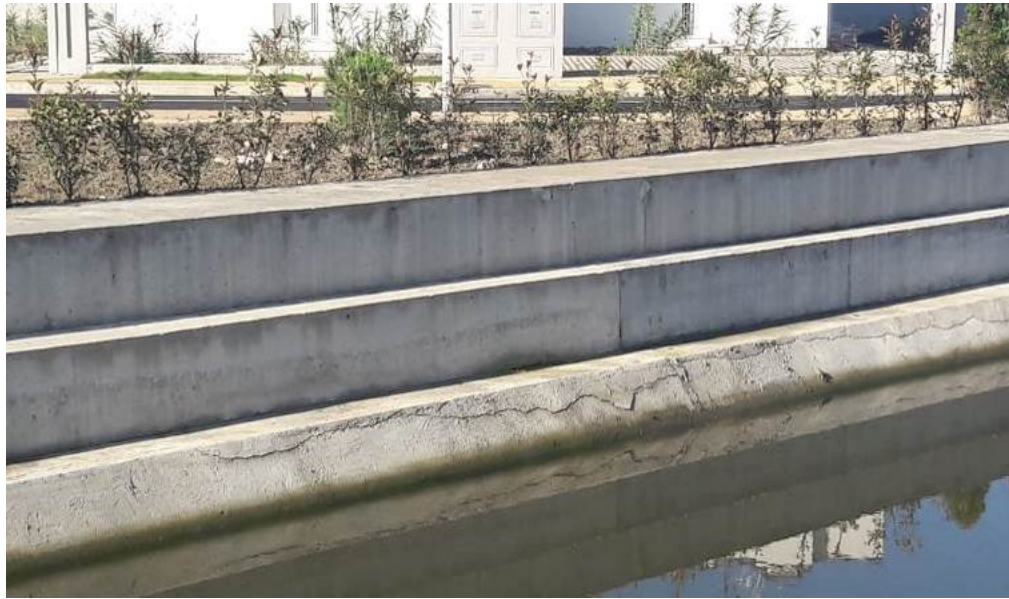
Figure 2. Damage to a water canal in Hamallaj (41.488834, 19.511943), Durrës (source: Markel Baballëku).

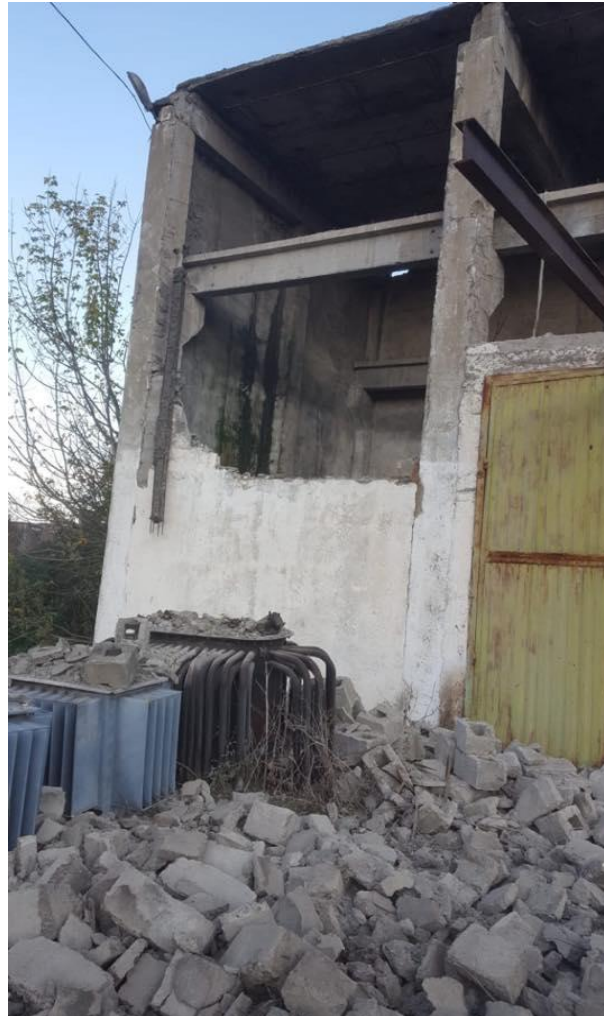
damage to electrical distribution poles, bus bars, insulators, and switches; however, a few of these also suffered severe damage (Figure 4). The earthquake did not affect electrical power generation plants, as these are in the far northeast and northwest of Albania in areas that were not affected by the earthquake. Some 91,642 households lost power supply in the hard-hit areas, out of which approximately 60% were in the Durrës area; however, 80% of the connections were restored within a day utilizing back-up equipment and parts.

Figure 4. Severely damaged electrical substation (source: B. Skenderi, 2019).¹

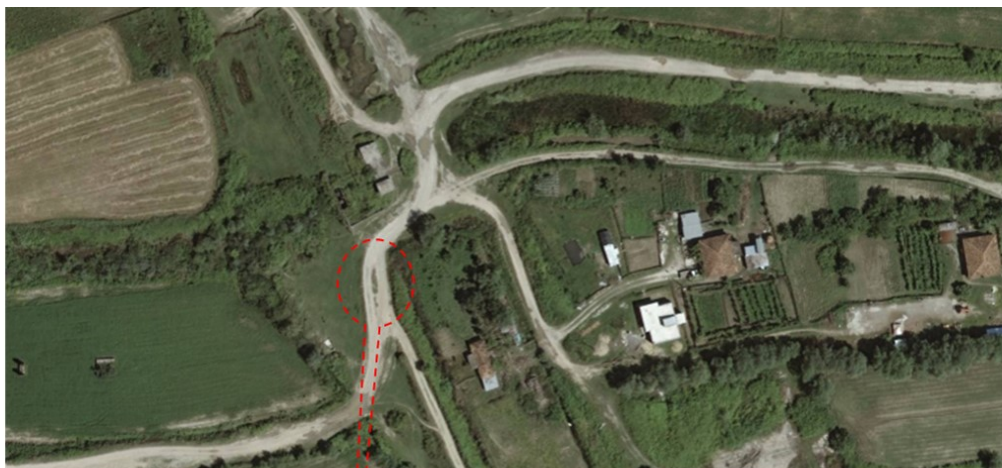
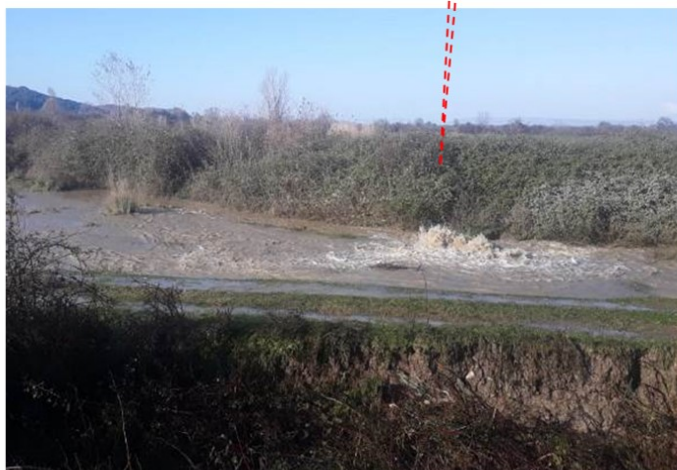
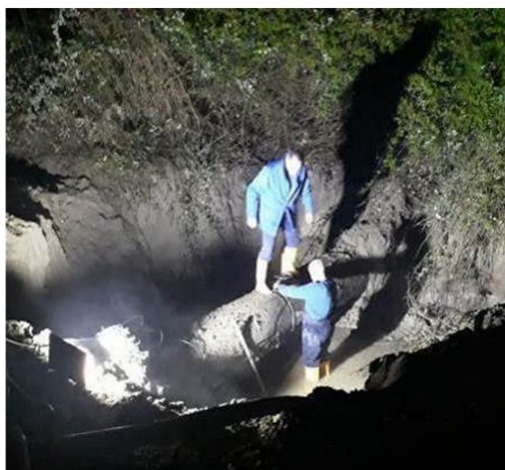
Location of damaged water supply pipeline

Close view of pipeline

Figure 8. Damage to water supply pipeline near Ishem, Durrës County (41.541943, 19.612233) (source: Markel Baballëku).

Damaged pipeline under repair

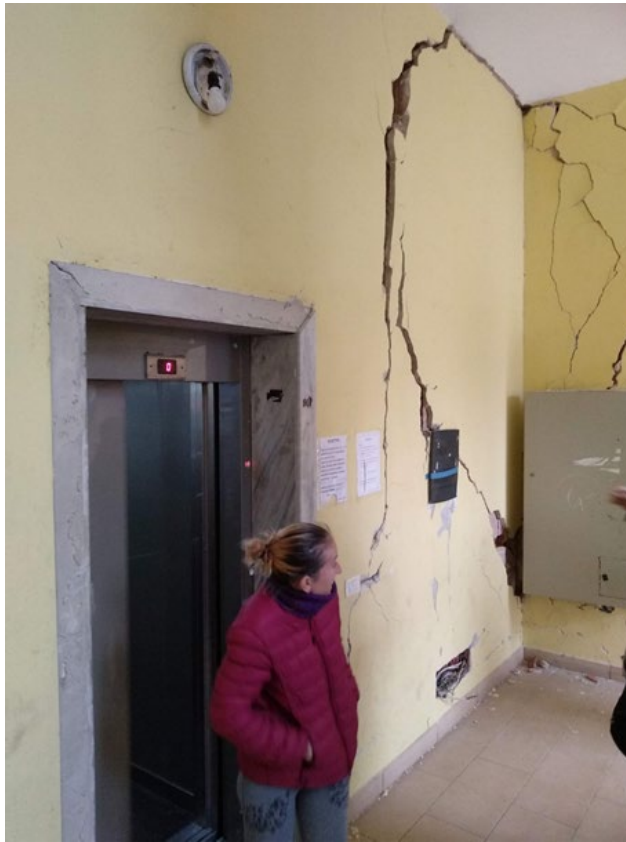
Figure 12. Functional elevators in a building with severe infill damage in Fushë-Krujë (photo: Nikolić-Brzev et al., 2020).

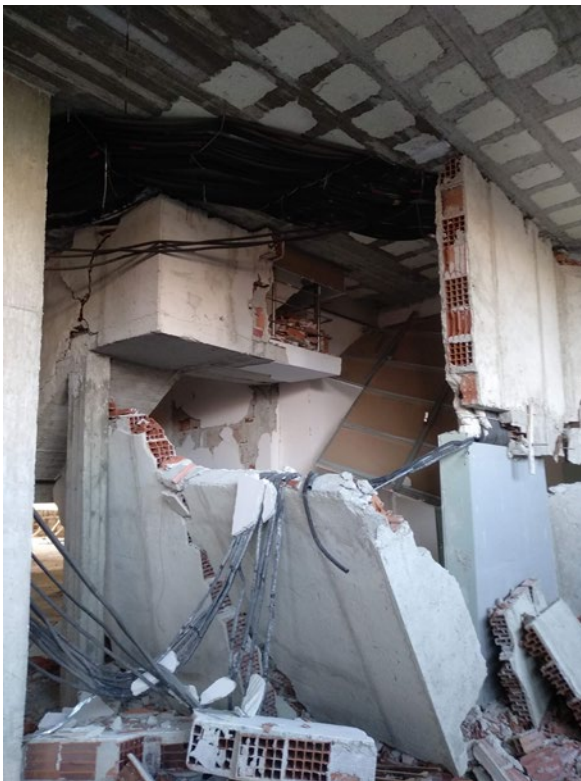
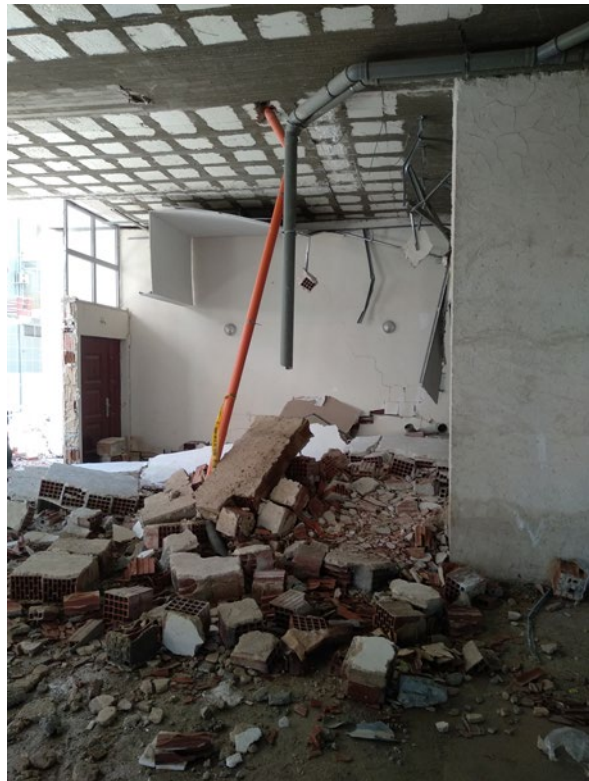
Figure 13. Masonry infill debris damaged the building's electrical and piping infrastructure (source: Nikolić-Brzev et al., 2020).

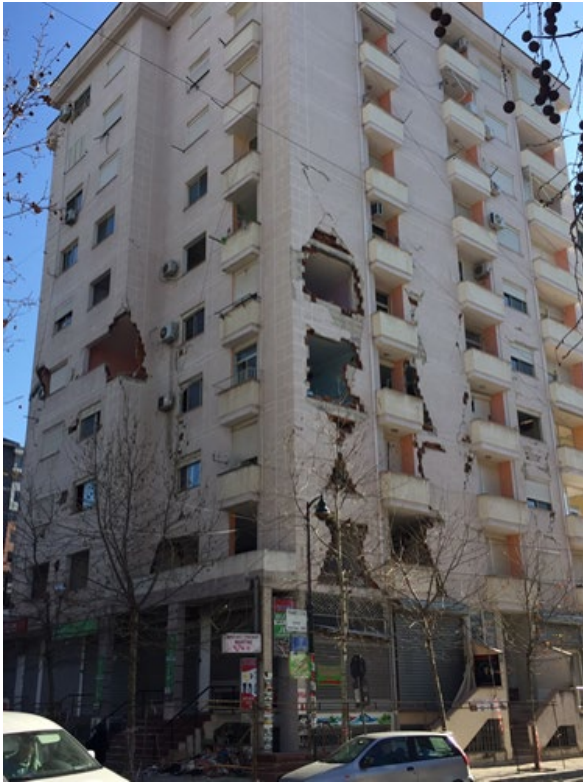
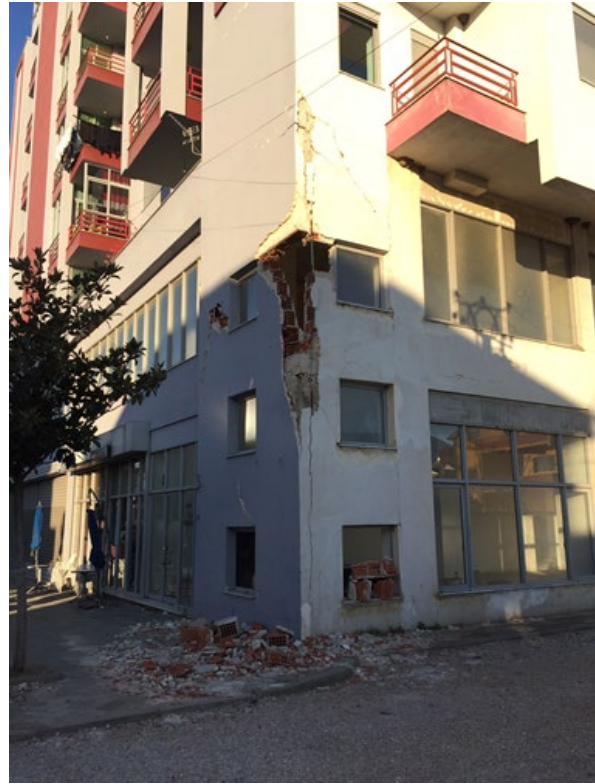
Figure 14. Damage to cladding in lower levels in Durrës (left) (41.3234, 19.4546); damage in Fushë-Krujë (right) (41.4785, 19.7266) (source: Jitendra Bothara).

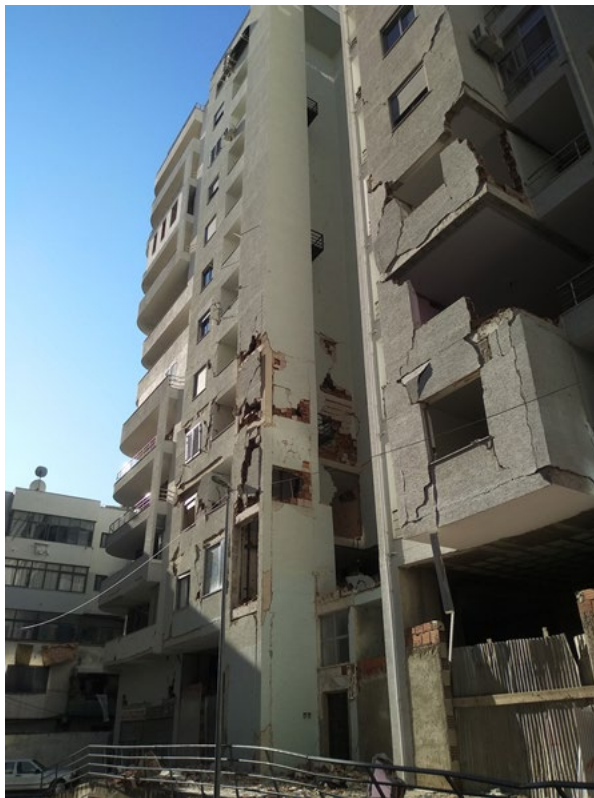
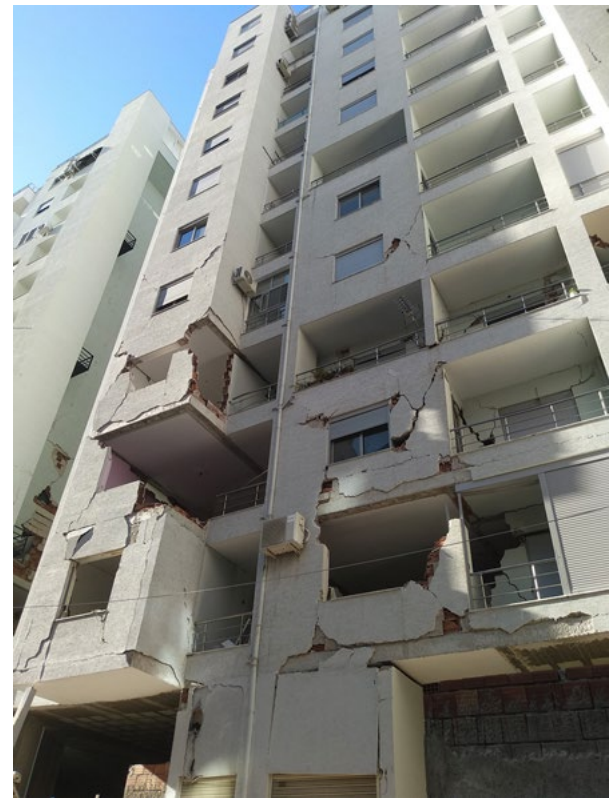
Figure 15. Damage to the masonry infill in lower floors in Durrës (source: Nikolić-Brzev et al., 2020).

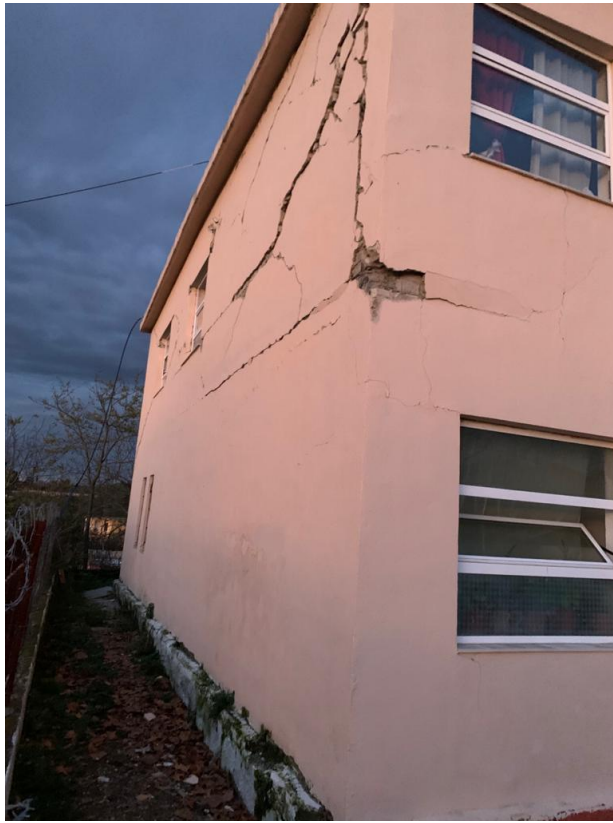
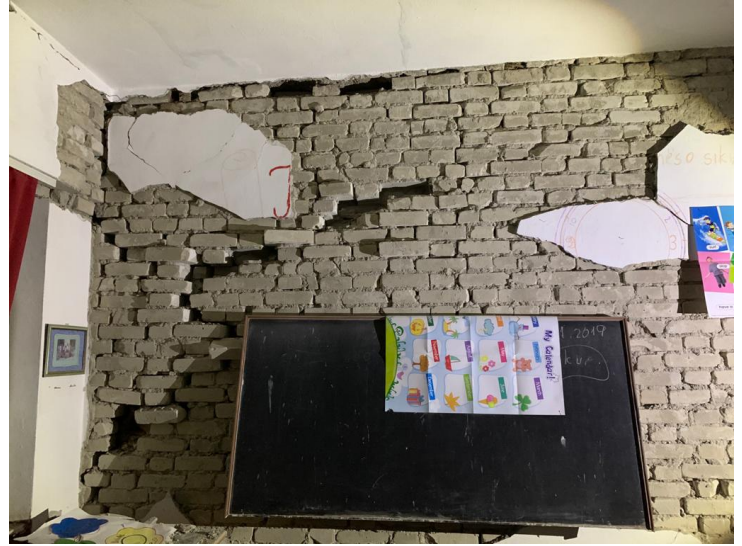
Figure 17. Damaged “Ramazan Subashi” school in Vorë, Tirana (source: Markel Baballeku).
