EERI Earthquake Reconnaissance Report:

M6.4 Albania Earthquake on November 26, 2019

Volume 1: Executive Summary

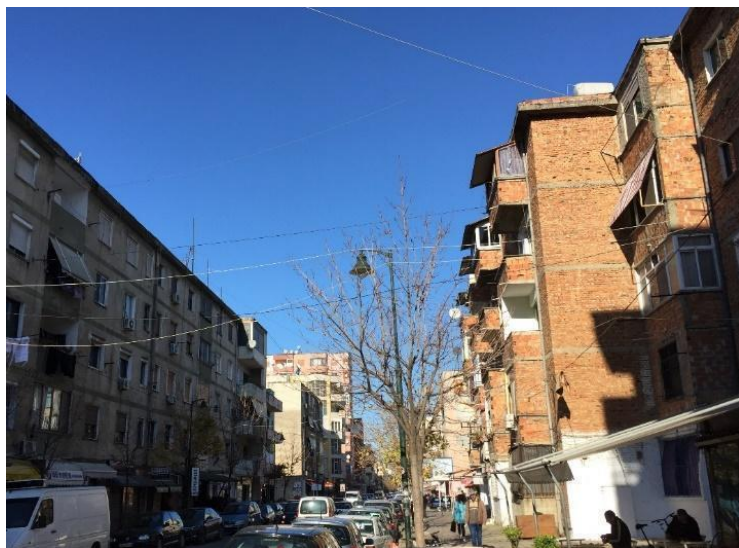
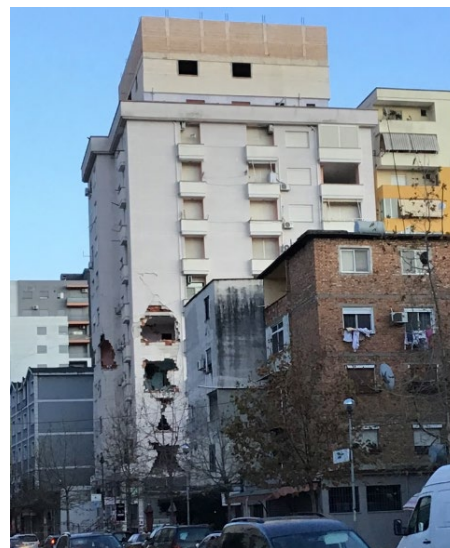
In general, masonry buildings performed well during the earthquake in November 2019. For example, many reinforced concrete buildings experienced damage or collapse, but the majority of mid-rise URM buildings from the 1960 to 1990 period remained undamaged. Many existing mid-rise URM buildings in Albanian centers were exposed to the November 2019 earthquake (Figure 20(a)). Figure 20(b) shows a high-rise reinforced concrete building with damaged masonry infills in Durrës and adjacent undamaged URM buildings. The good performance of mid-rise URM buildings can be explained by standardized building designs (templates) and regular plans and elevations. Because the construction was controlled by the government, there was a high-quality control of construction materials (e.g., use of solid clay bricks and cement mortar) and technical solutions (e.g., rigid reinforced concrete floors, good connections between structural elements, good interlocking between the walls).

Figure 20. URM apartment buildings: (a) a typical street in the center of Durrës showing URM apartment buildings from the 1960-1990 vintage and (b) an undamaged URM apartment building (front) and modern reinforced concrete frame building with damaged masonry infill (back) in Durrës (photos: SUZI-SAE).

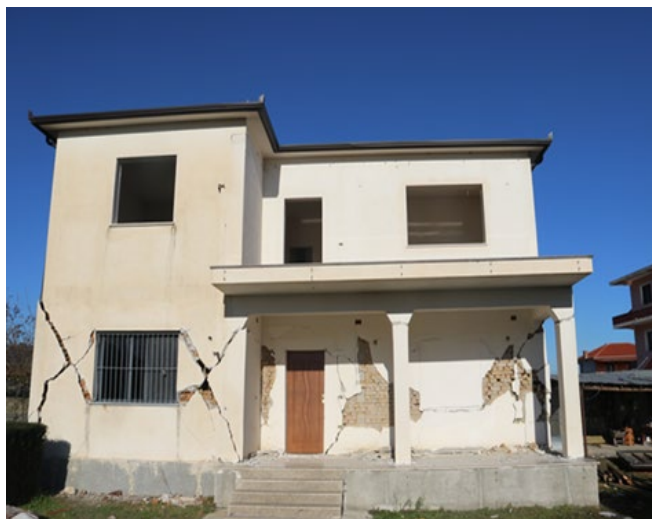
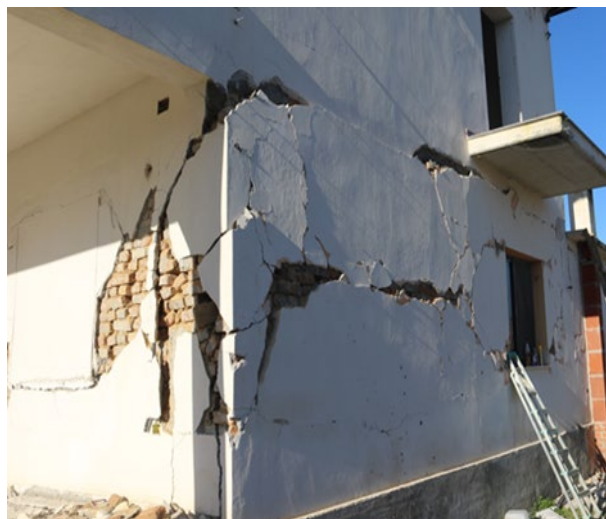
Both SUZI-SAE and EEFIT teams surveyed several low-rise URM buildings in the Bubq village (Krujë municipality), in which many single-family houses experienced damage, but there were no casualties. According to the information gained from local engineers, some houses were initially damaged because of the September 2019 foreshock, but they experienced more severe damage or even collapse in the November 2019 earthquake. Figure 21 shows failure of a typical single-family brick masonry house in the Bubq village, with a portico at the ground floor level and an irregular L-shaped plan with a re-entrant corner. It should be noted that many single-family masonry buildings in the affected area had irregular plan shapes. It can be seen from the photo that the damage was concentrated at the ground floor level. The observed damage was triggered by torsion of the portico. Horizontal cracks were observed in the columns of the first floor (portico) (Figure 21(a)) at the top. Also, a transverse wall adjacent to the portico experienced severe out-of-plane damage and a separation from the floor slab (Figure 21(b)).

Figure 21. Single-family URM building in the Bubq village: (a) severe in-plane damage of the piers located on the ground floor and (b) out-of-plane failure of the rear wall (photos: EEFIT).

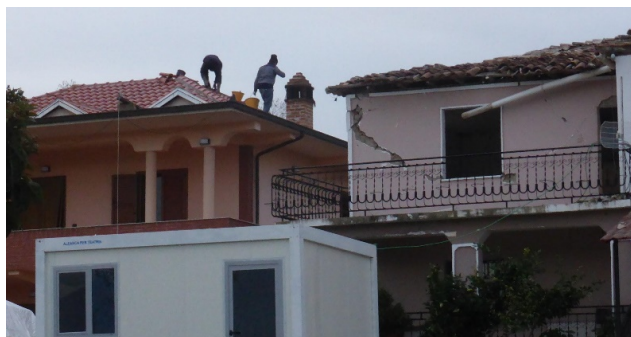
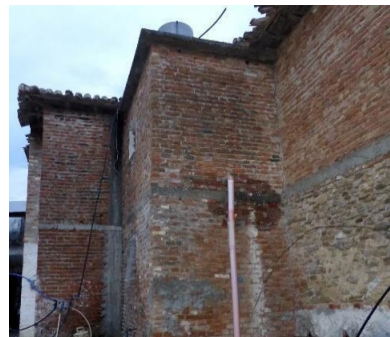
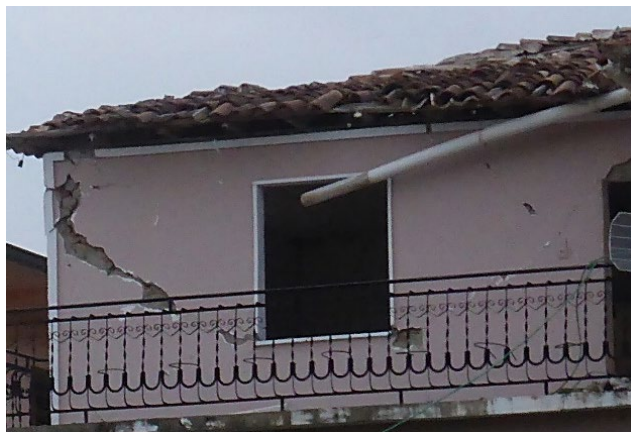
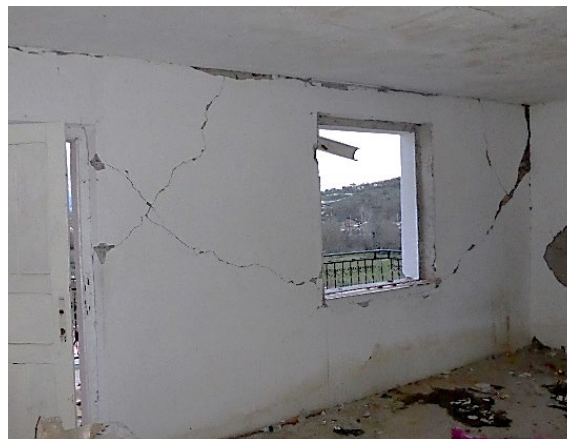
Figure 22 shows a front façade of another two-story building surveyed in Bubq village. This is an example of a building with both horizontal and vertical extensions. The original single-story building was constructed in stone masonry, whereas the extended portion (the second floor and a part of the ground floor) was constructed using solid clay bricks. The floor structure was a cast-in-situ reinforced concrete slab, and the roof was a timber truss with clay tile roofing. This building was located atop a small hill, and there was an adjacent, newer building of similar size, which was likely a reinforced concrete frame structure with masonry infills that remained undamaged (see Figure 22(a)). The damage in the masonry building was observed primarily at the top story level, in the form of diagonal cracks in the walls due to in-plane seismic effects (Figure 22(c)). The damage can be attributed to an irregular building elevation and a flexible roof structure. The absence of horizontal confining elements at the roof level was observed at the interior; a horizontal crack at the top of the wall indicates an inadequate roof-wall connection (Figure 22(d)). The roof covering (clay tiles) was noticeably displaced (Figure 22(c)).

Figure 22. Damaged single-family URM house in the Bubq village: (a) the front façade of a damaged URM building (right) and an adjacent reinforced concrete frame building that remained undamaged (left), (b) a rear view of the house revealing building extensions, (c) a damaged exterior wall at the second floor (exterior view), and (d) an interior view of the same wall (photos: SUZI-SAE).

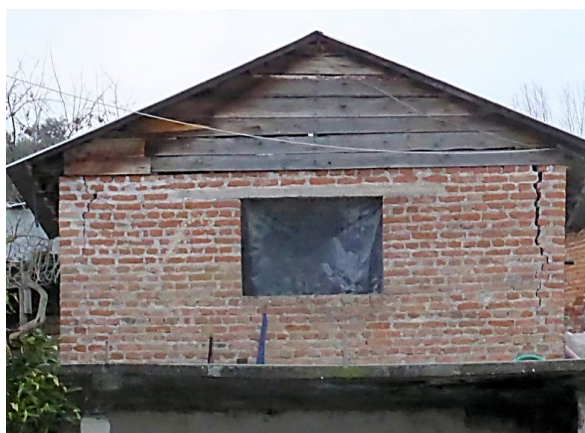
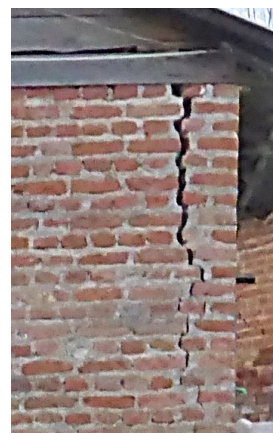
A two-story URM building with a timber roof in the Bubq village experienced severe damage in the form of vertical cracks at both ends of the gable wall (shown in Figure 23(a)), indicating the onset of an out-of-plane failure of the walls in the transverse direction. Note that the crack on the right end of the wall, which is extremely wide, extends over the entire floor height and indicates a risk of the transverse wall toppling outwards (Figure 23(b)). The observed damage can be attributed to the absence of horizontal confinement (ring beams) at the roof level, which could lead to the collapse of individual walls and roof and, ultimately, lead to a partial or complete collapse of the entire building.

Figure 23. URM building damaged due to out-of-plane failure mechanism in the Bubq village: (a) a view of the gable wall showing vertical cracks at both ends and (b) a detail of the vertical crack at the right end of the wall (photos: SUZI-SAE).

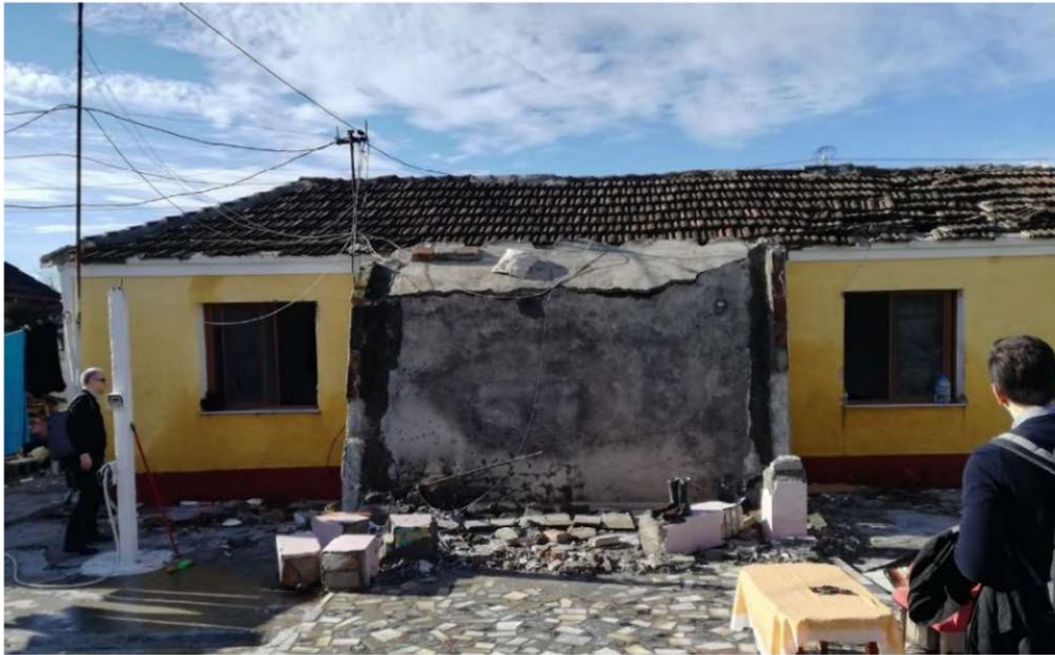
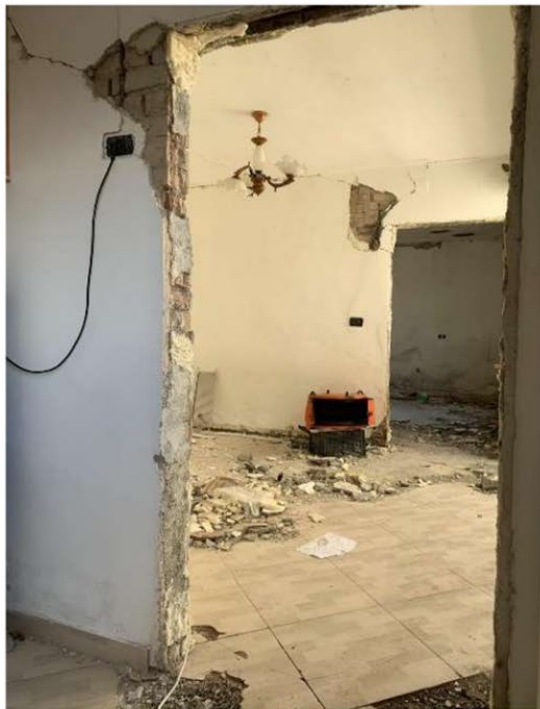
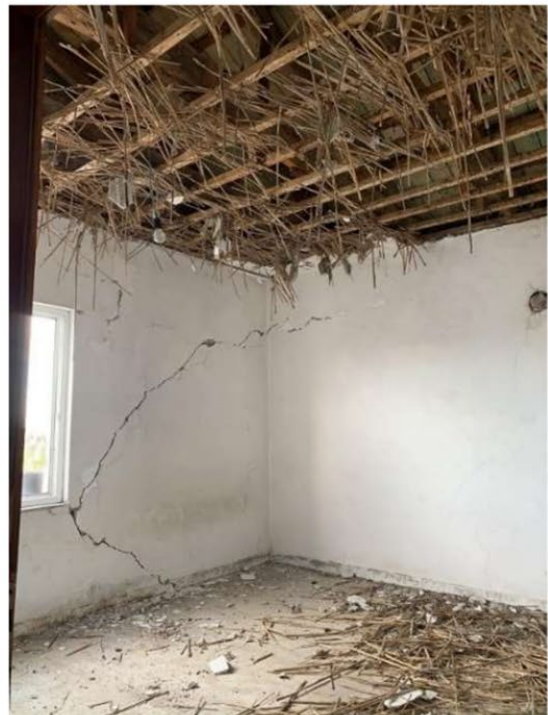
Four multi-family URM apartment buildings collapsed in Thumanë, and several single-family URM buildings were also damaged and surveyed during the visit. For example, a single-story URM building inspected by the HAEE team was severely damaged (Figure 24(a)). The building had 115 mm (one-wythe) thick brick masonry walls (Figure 24(b)) that experienced damage in the form of wide diagonal cracks (Figure 24(c)). The timber roof experienced a partial collapse, and clay tile roofing was dislocated (Figure 24(b) and 24(c)). Major damage of reinforced concrete slabs was observed in the form of cracking, permanent displacements, and corrosion of reinforcement.

Figure 24. Severely damaged single-story URM building in Thumanë: (a) Exterior view, (b) view of masonry brick wall, and (c) wide diagonal cracks in masonry brick wall (photos: HAEE).

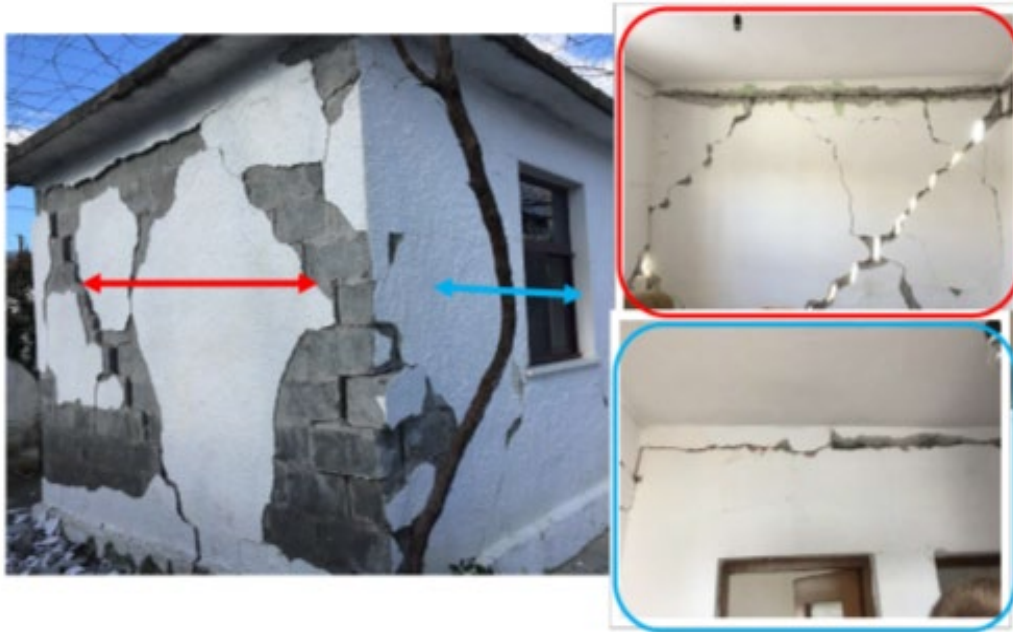
Figure 25 shows another single-story URM building in Thumanë with hollow concrete block masonry walls and a reinforced concrete roof. The walls were severely damaged because of in-plane (red color in the picture) and out-of-plane seismic effects (blue color). The in-plane damage was in the form of stepped cracks along the mortar joints, which is typical for concrete block masonry walls. A horizontal crack at the wall-to-roof slab can be attributed to the sliding behavior. A vertical crack was also observed at the wall intersection, indicating a poor bond between the walls. Significant damage observed in this building can be attributed to high seismic demand, use of low-strength concrete blocks, and inadequate wall connections to the roof.

Figure 25. A single-story URM building with hollow concrete block masonry in Thumanë: in-plane damage (red outline) and out-of-plane damage (blue outline) (photos: SUZI-SAE).

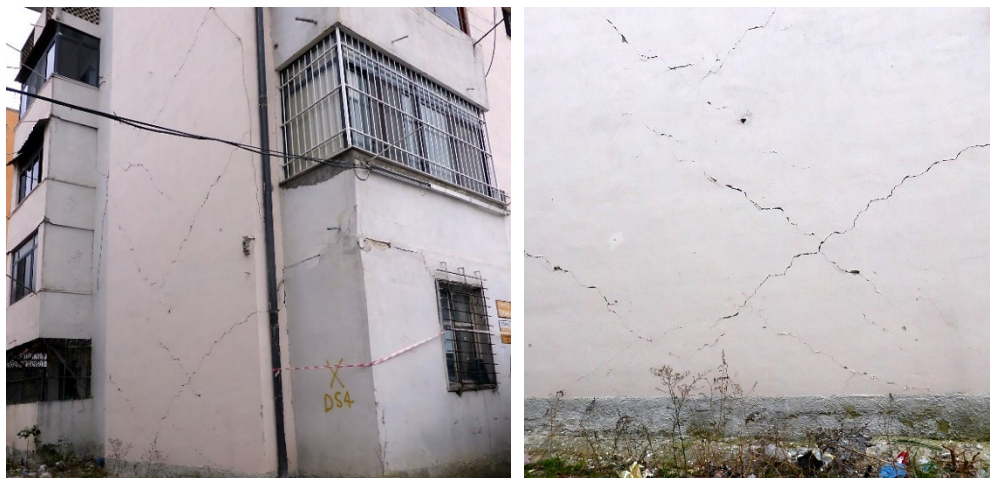
Figure 30 shows a five-story URM building in Fushë-Krujë that was damaged in the November 2019 earthquake. The damage pattern was in the form of diagonal cracks that developed because of in-plane seismic effects. These cracks were observed at the lower three floors, which were subjected to the highest seismic demand. This is an example of moderate damage that did not have a major impact on overall seismic safety. Additional damage patterns in mid-rise URM buildings are shown in Figure 31.

Figure 30. Moderate damage of a five-story URM building in Fushë-Krujë (photos: SUZI-SAE).

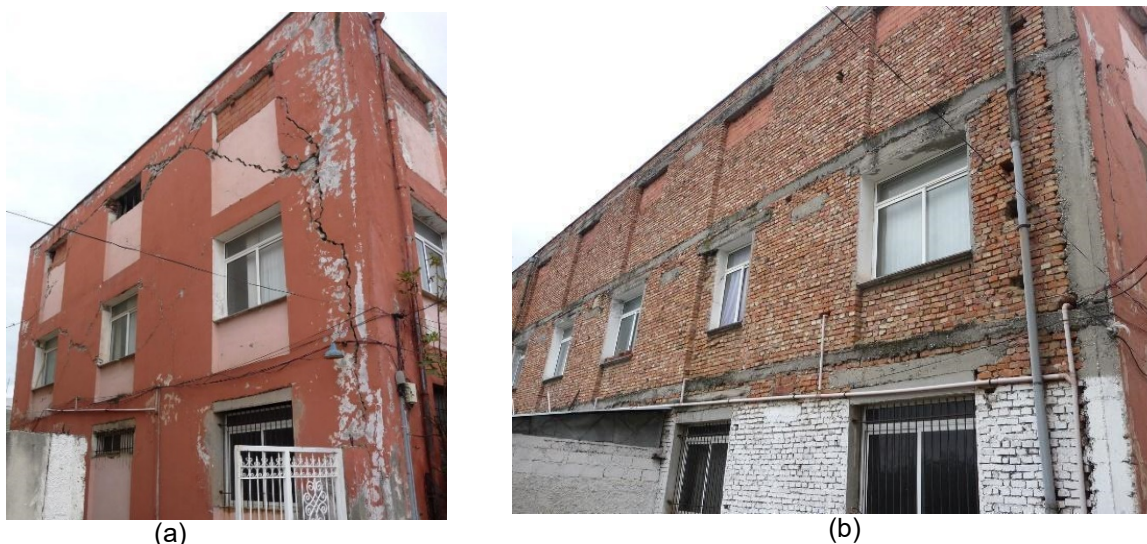
Figure 34. Damage of a confined masonry building in Durrës due to out-of-plane seismic effects: (a) cracks at the front facade (plastered) and (b) the rear side of the building revealing locations of reinforced concrete confining elements and floor slabs (photos: A. Charleson).

- Confined masonry buildings had regular plans and elevations, and very few such buildings experienced damage. Out-of-plane damage was observed in a confined masonry building with a relatively long exterior wall, in which reinforced concrete tie-columns were not provided at the intersections between longitudinal and cross-walls.

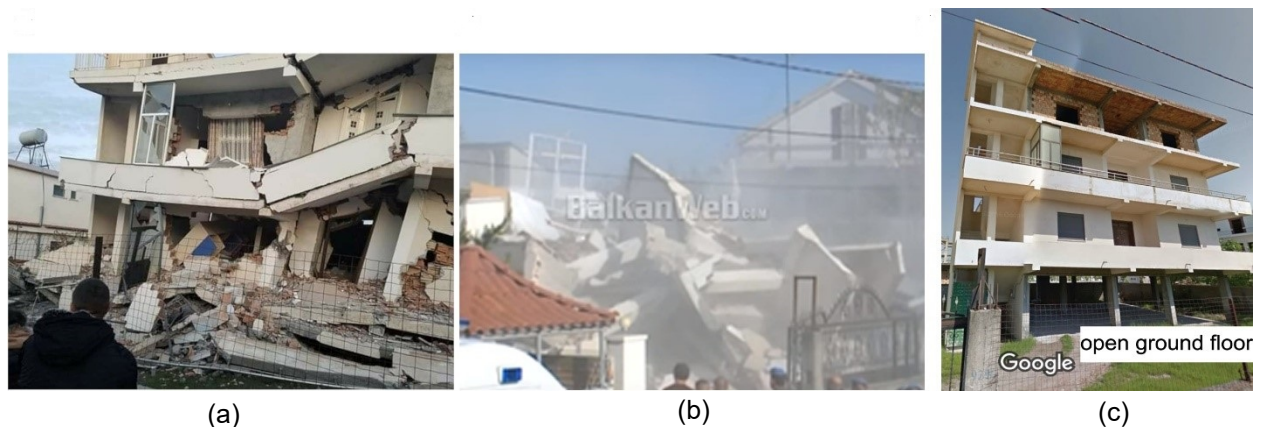
A collapsed single-family building that caused many casualties in Durrës is shown in Figure 36. The authors could not investigate this building closely because of its total collapse, but some observations are made based on media reports and Google Maps images from 2016 (see Figure 36(c)). The photo shows an open ground floor. The staircase was located on the side of the building, and an infill wall ran through the columns next to the staircase, likely giving rise to a torsional irregularity. Figure 36(a) indicates that the middle section of the roof slab rotated almost as a rigid body (Figure 36(a), (c)).

Figure 36. Collapsed single-family building in Durrës due to a soft-story mechanism: (a) a partially collapsed building after the main shock (source: <https://dosja.al/tragjedia-e-familjes-lala-ne-kenete-te-durresit-dalin-emrat-cilet-jane-viktimat-dhe-sa-gjenden-nen-rrenoja/>), (b) a building totally collapsed after several aftershocks (source: Balkanweb media <https://youtu.be/TjSA2nulJgs>), and (c) a pre-earthquake photo (source: Google Maps, available at <https://goo.gl/maps/6RMWmbfZz2huZ8Xr5>).

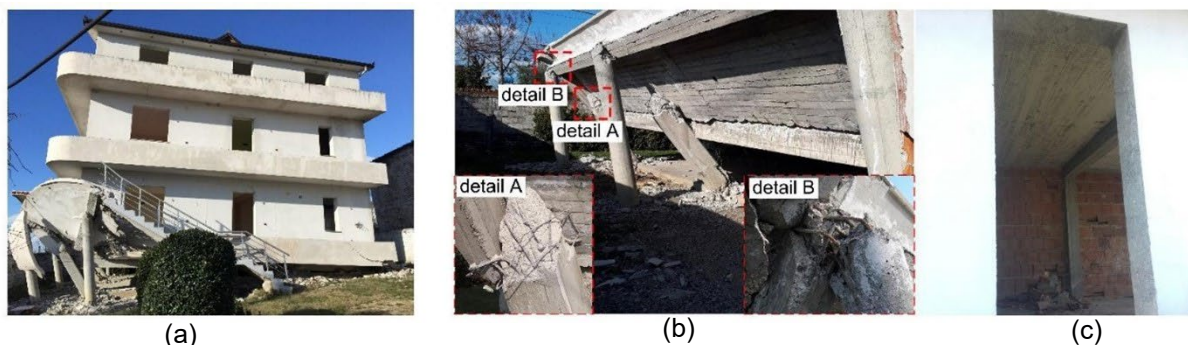
Photos of a four-story single-family house that partially collapsed in Thumanë are shown in Figure 37. The house had an open ground floor that was used as a parking garage, whereas upper floors had infill walls. The building had three bays in the longitudinal direction and two bays in the transverse direction. The columns were arranged in a regular pattern. The

columns were continuous from the ground to the top of the building. Circular columns were used at the ground floor only, supporting the balcony and two outside stairs to the first story. Framing along one direction only was present in some areas of the building (Figure 37(c)), but due to the limited access options, it could not be determined whether the entire building had frames in one direction only. Based on limited inspection, it was found that framing was present in the transversal direction of the building (shorter direction). Rectangular columns were 250 to 300 mm wide and 400 mm deep. Although the upper stories of the building remained almost intact, the ground floor columns were unable to sustain the imposed deformations in the longitudinal direction of the building (perpendicular to framing). According to locals that witnessed the construction of the building, the slabs were cast after the construction of the brick walls at each level to ensure a robust construction. Indeed, the upper stories were very rigid and suffered limited damage. A close-up examination of the failed columns at the ground floor revealed that the end regions were not detailed to sustain large deformations. Rectangular columns were reinforced with three or four vertical bars ($\varnothing 16$) at each column face (see Figure 37(b)). It was observed that the columns had $\varnothing 8$ ties with 90° hooks, which enclosed longitudinal reinforcement, at approximately 200-mm spacing in the end regions. Furthermore, reinforcement was absent in beam-column joints, and the longitudinal reinforcement in beams had insufficient anchorage length without hooks (see Figure 37(b)).

Figure 37. A partially collapsed four-story building in Thumanë due to a soft-story failure mechanism: (a) a general view of the collapsed building, (b) column failure at ground floor, and (c) frames spanning in one direction only (photos: SUZI-SAE).

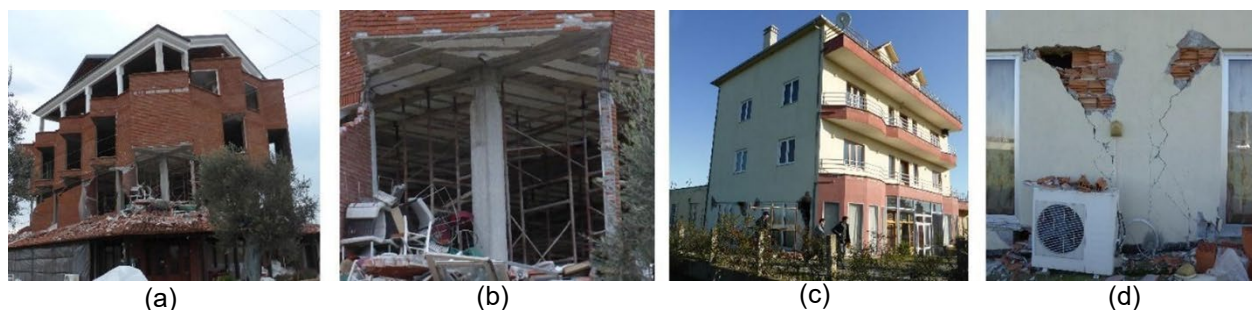
Examples of low-rise reinforced concrete buildings that suffered damage but did not collapse are presented in Figure 38. Both buildings shown in Figure 38 suffered damage of masonry infills and partition walls at lower floor levels. Masonry infills in Building 1 (shown in Figure 38(a), (b)) experienced out-of-plane failure. Note that the exterior walls that failed out-of-plane were not aligned with the main frame; this pattern was also observed in mid-rise buildings (refer to section 5.2). The building shown in Figure 38(a) and (b) suffered structural damage as well. Columns at the first floor above the ground floor sustained damage near the wide beam-column connections, as shown in Figure 38(b).

Figure 38. Damaged low-rise buildings: (a) Building 1 in Bubq with out-of-plane masonry infill failure, (b) close-up of a damaged column in the same building, (c) Building 2 at the outskirts of Tirana, and (d) damaged masonry infills in the same building (photos: SUZI-SAE).

Damage of a three-story building with wide beam-column frames located at the outskirts of Tirana is shown in Figure 38(c) and (d). As the ground floor level was used as a restaurant, the interior space was completely open, and the exterior infill walls had large openings. The upper floors were used for residential purposes and had infill walls. Columns were 400×400 mm squares, whereas beams were 600 mm wide and 300 mm deep. A one-story annex building was attached to two

sides of the main building with a separation gap and doubled columns. The annex building had only one story at the time of the earthquake, but it was intended to be expanded. According to the structural drawings, the columns and beams were detailed for ductile performance because critical regions had relatively dense transverse reinforcement. Although exterior infill walls suffered damage at the ground floor level (see Figure 38(d)), no damage was observed in the reinforced concrete columns, except for limited cracking at separation gaps with the annex building.

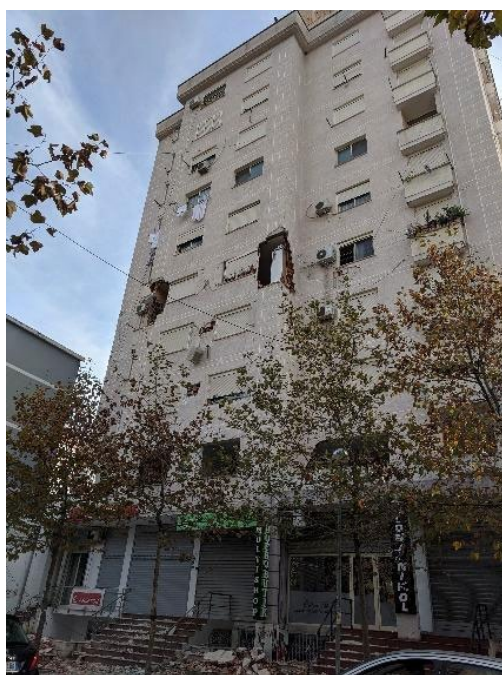
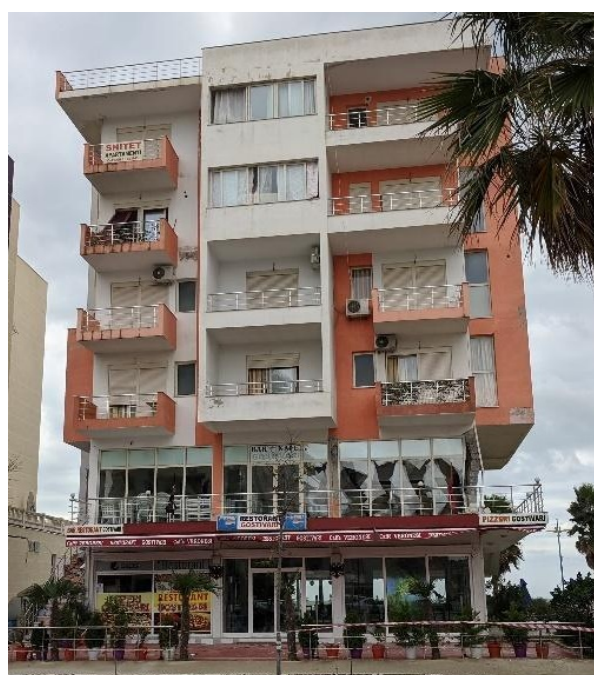
Masonry infill walls in these buildings have been typically constructed using clay blocks. In many cases, these walls are constructed with an offset relative to the reinforced concrete frames (see example shown in Figure 39(b)), which is one of the main causes of damage to infills and partitions in these buildings. To ensure the stability of infills against the out-of-plane failure, horizontal concrete "belt beams" have been often provided in recently designed buildings. The behavior of infills in reinforced concrete buildings is discussed in detail in section 4.4.

These are mixed-function buildings (commercial and residential). Typically, the ground floor and, in some cases, the lower 2-3 floors were used for commercial activities, which often results in irregular distributions of infills in elevations and plans. For example, a heavily damaged building in Durrës (Figure 39(b)) suffered significant structural damage and nonstructural damage (shattered glazing) in the columns at the lower two stories, whereas the upper stories did not suffer noticeable damage.

Figure 39. *Masonry infill panels in multi-story reinforced concrete buildings: (a) exterior walls constructed with an offset relative to the frame structure (Photo: Chiara McKenney) and (b) a damaged building in Durrës with irregular distribution of infills in elevation (photo: Chiara McKenney).*

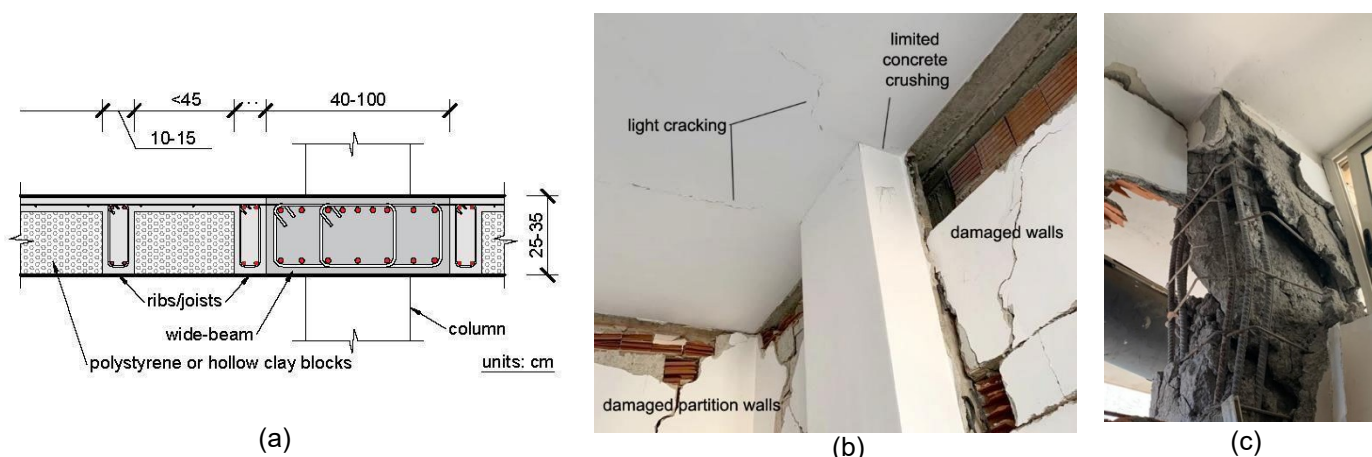
Figure 40. Wide beams in Albania: (a) typical detail (source: Brisid Isufi), (b) minor damage, and (c) a damaged column with poor detailing with the wide beams undamaged (photos: Markel Baballëku).

Minor cracking and spalling in the vicinity of wide beams was observed in a few buildings. An example of such damage in a 13-story reinforced concrete building in Durrës is shown in Figure 40(b). The lateral load-resisting system of the building consisted of reinforced concrete frames with an eccentric concrete core, which likely caused torsional effects in the building. Although the damage to wide beams was generally very limited, damage to partitions and infill walls was widespread in this building (refer to section 4.4 for further details on the behavior of infill walls). In general, the high flexibility of wide/shallow beams is a likely contributor to the widespread infill and partition damage in buildings, especially in buildings where shear walls were not provided.

In some cases, column failure was observed while the beams remained almost intact. An example is shown in Figure 39(c), which refers to a five-story building in the Durrës Beach area. The lateral load-resisting system consisted of columns (cross-sectional dimensions 400×400 mm to 400×600 mm) and shallow beams (700 mm wide and 250 mm deep). This building did not have shear walls; hence, the wide beam-column frames were the only lateral load-resisting system. In addition to the high deformation demands, the damage shown in Figure 40(c) is likely due to several factors, including poor detailing, insufficient confinement, and the presence of captive columns caused by partial-height infills.

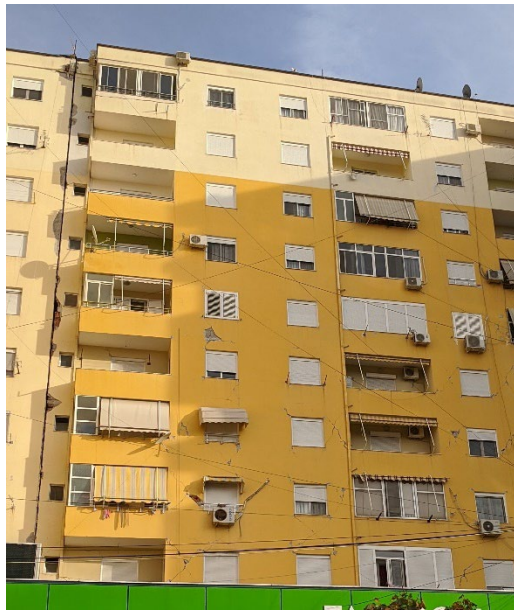
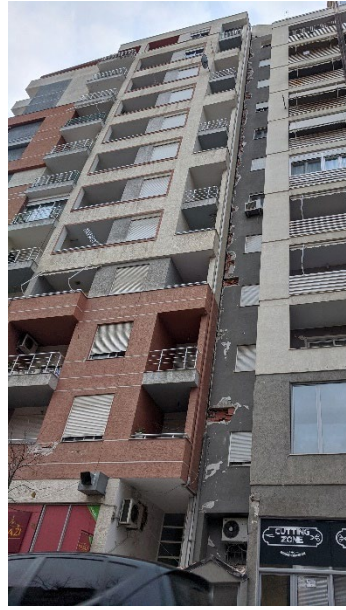
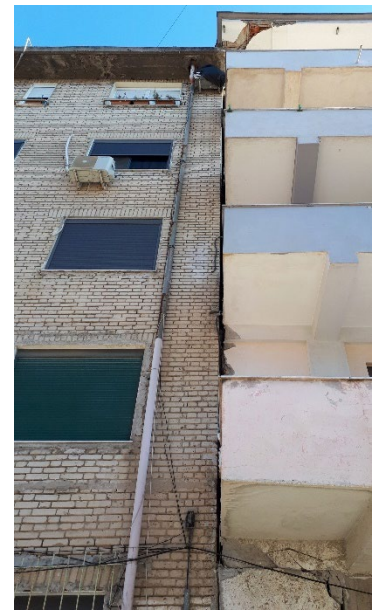
As previously discussed in section 2.1, a major drawback of the Albanian seismic design code KTP-N.2-89 (Academy of Sciences and Ministry for Construction, 1989) is the lack of specific guidance and explicit recommendations regarding the inter-story drift limits, which are critical for the limitation of damage to infills. On the other hand, the code contains guidance for sizing seismic gaps between adjacent buildings or building blocks. According to KTP-N.2-89, the seismic gap should be determined based on the combined displacements of the adjacent blocks plus 20 mm, but not smaller than 30 mm, and $h/250$, where h is the overall building height. The code requirements for seismic gaps are not always followed, especially in the case of building extensions. Localized pounding-related damage was observed in several instances (see Figure 41). Although generally repairable, this type of damage caused panic to the inhabitants.

Figure 41. Pounding-related damage in multi-family reinforced concrete frame buildings in Durrës: (a) and (b) damage at seismic gaps between the building blocks of the same building (photos: Chiara McKenney) and (c) a reinforced concrete building block and an adjacent masonry building (photo: Brisid Isufi).

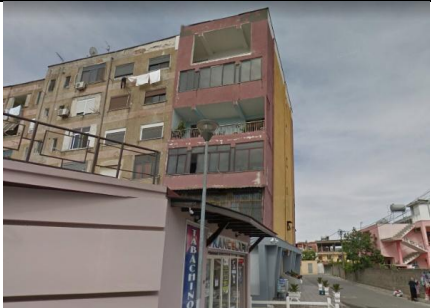
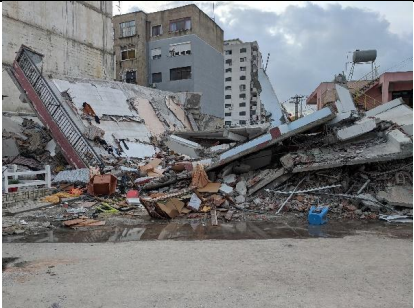
Collapsed six-story residential reinforced concrete building adjacent to another building that did not collapse
2

Buildings 1 and 2 in Table 5 suffered a total collapse, whereas the other two buildings (3 and 4) suffered damage to the lower stories that rendered them unrepairable. Building 1 was adjacent to a larger building of the same height (see Lekkas et al., 2019 for more photos and details). The other buildings shown in Table 5 were isolated. Buildings 2, 3, and 4 were located near each other in the Durrës Beach area. The collapse of these buildings can be attributed to a combination of structural and geotechnical failures (refer also to Volume 2 of this report).

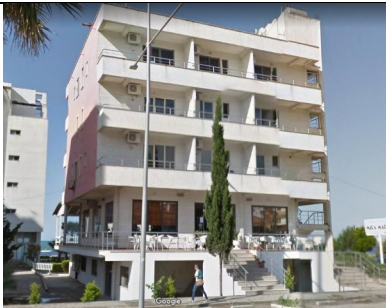
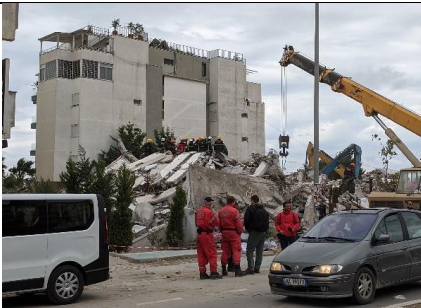
Collapsed five-story reinforced concrete hotel in Durrës
3

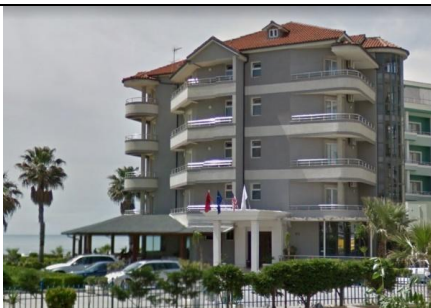
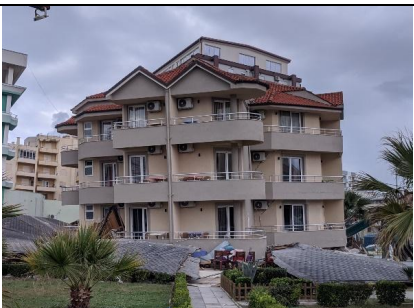
Six-story reinforced concrete hotel in Durrës; lower two stories collapsed
4

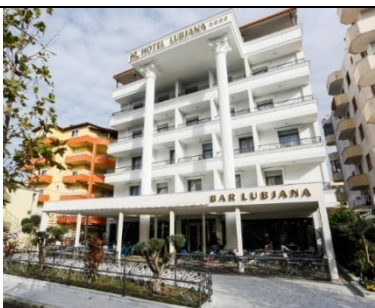
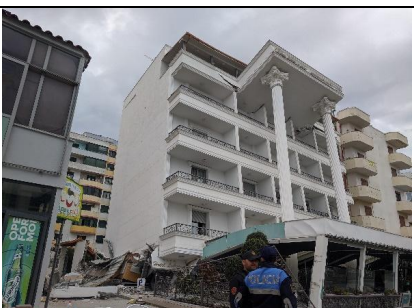
Reinforced concrete hotel in Durrës; ground floor collapsed

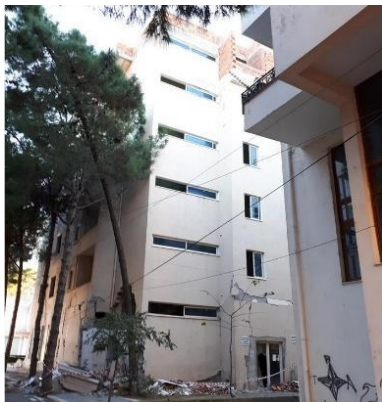
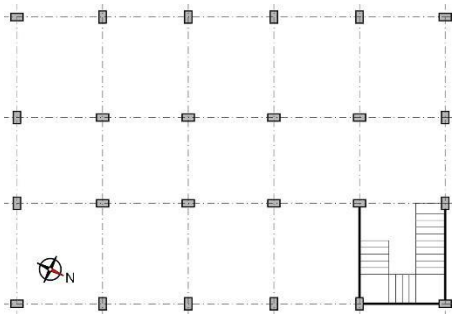
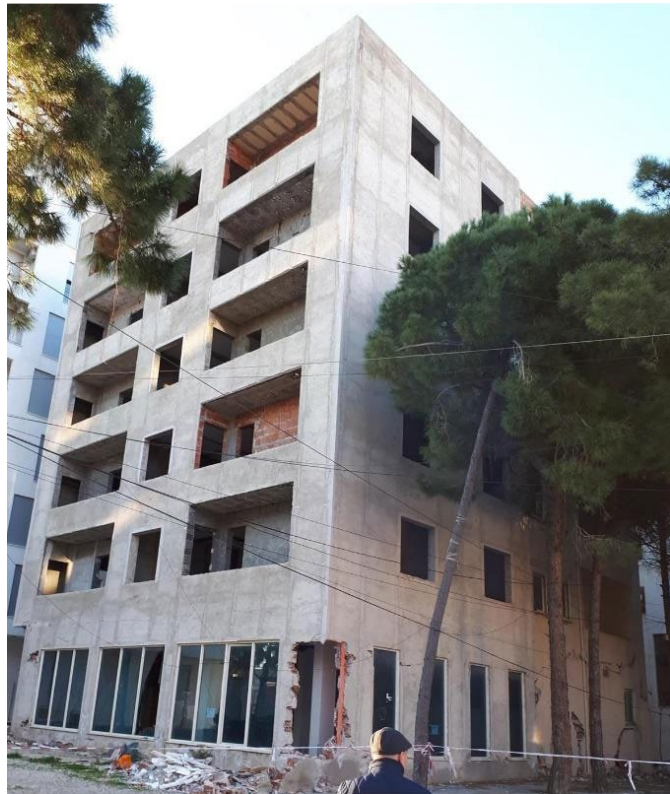
A severely damaged seven-story reinforced concrete frame building located at seaside Durrës is presented in Figure 42, Figure 43, and Figure 44. Based on the Google Earth images, the building was built between 2000 and 2005. The top floor was under construction and had a setback (see Figure 42(a)). The building had a grid of 4×6 rectangular columns arranged in a regular pattern with spans ranging from 3.5 to 4.2 m (see Figure 42(c)). Rectangular columns were around 300 mm wide and 500 mm deep. It can be noticed that most columns in longitudinal perimeter frames were oriented with their depths perpendicular to the frame direction, which reduced the torsional stiffness of the building. The floor system was in the form of a two-way ribbed reinforced concrete slab with 700 mm wide/shallow beams and polystyrene infill. The perimeter frame at the southeast façade had 300×500 mm beams at the first floor, but, because of limited access options, it could not be determined whether the perimeter beams were present at upper floors as well. The stairs, located at the north corner of the building, were supported by beams and adjacent perimeter columns (see Figure 43(b)). The building had an open ground floor with large openings in the exterior infill walls at the northeast and northwest façade, near the stairs (see Figure 42).

Figure 42. Six-story reinforced concrete building located at seaside Durrës: (a) the northwest façade (near stairs), (b) east corner, and (c) schematic floor plan (photos: SUZI-SAEF).

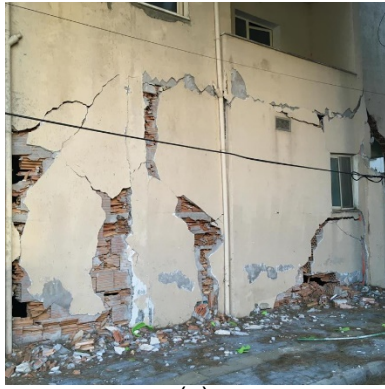
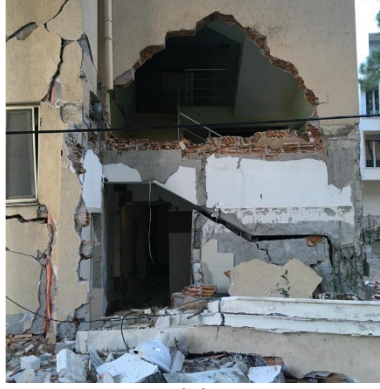
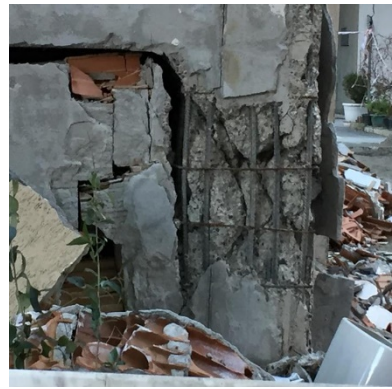
Figure 43. Damage of a six-story reinforced concrete building at seaside Durrës: (a) infill damage at the northeast façade, (b) infill and column damage at the stairs, and (c) shear and axial load damage of a staircase column (photos: SUZI-SAE).)

It is believed that both the stairs and infill, concentrated at the north corner of the building, had adverse local and global effects on the seismic performance of the flexible reinforced concrete building structure. Figure 43 shows damage of masonry infills on the north side and shear and axial load damage of a reinforced concrete column supporting the stairs resulting from lateral restraint along its height. Globally, stairs and adjacent infill walls caused higher displacement demands on perimeter frames due to torsional effects. This resulted in shear and flexural damage of perimeter columns at the southeast side, as shown in Figure 44. Apart from irregularities of the structure, inadequate detailing contributed to significant damage of the reinforced concrete columns. Figure 43 and Figure 44 show that reinforced concrete columns had $\varnothing 8$ ties with 90° hooks spaced at 200 to 250 mm. Reinforced concrete columns experienced a loss of concrete cover, buckling of longitudinal rebars, and fracture of ties and disintegration of concrete; see Figure 44(b) and (c).

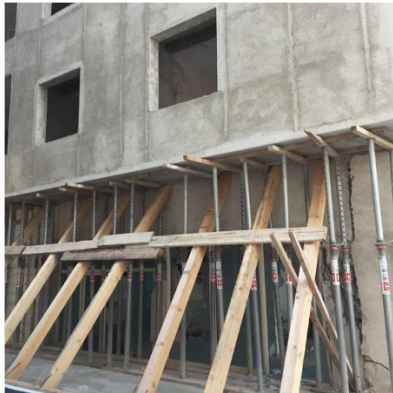
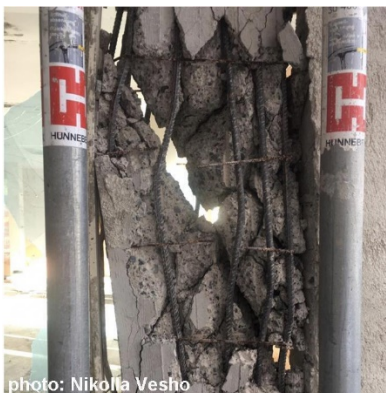
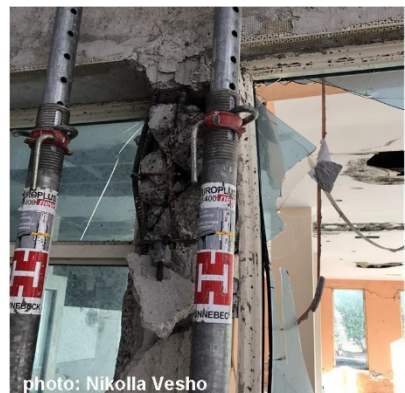
Figure 44. Damage at the ground floor of a six-story reinforced concrete building at seaside Durrës: (a) the southeast façade of the building, (b) damage to the corner column at the southeast façade, and (c) damage of the edge column at the southeast façade (photos: SUZI-SAE and Nikolla Vesho).

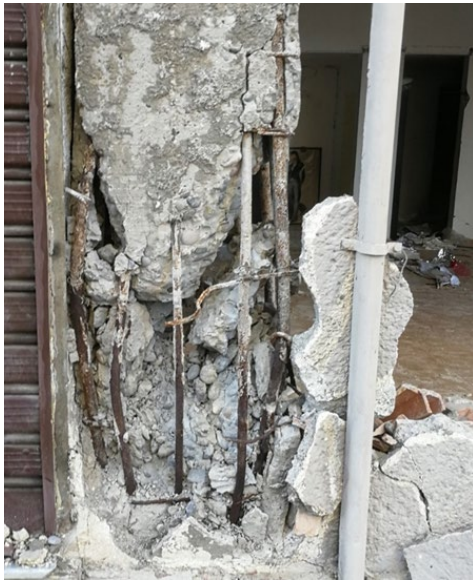
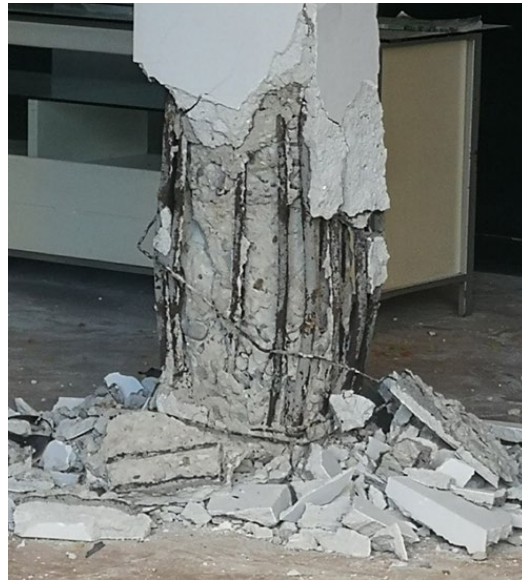
Figure 45 shows the failure of one external (Figure 45(a)) and one internal (Figure 45(b)) column of a reinforced concrete multi-story building in Durrës. The figure shows buckling of longitudinal reinforcement, opening of ties, and disaggregation of the concrete core. Although the year of construction is unknown, it is evident that the quality of both the materials and structural details was very poor. Figure 45 indicates low-strength concrete, smooth aggregate, mild steel longitudinal bars, and widely spaced, small diameter column ties without 135° hooks.

Figure 45. Examples of structural damage in mid-rise reinforced concrete buildings: (a) an exterior column and (b) an interior column (photos: EEFIT).

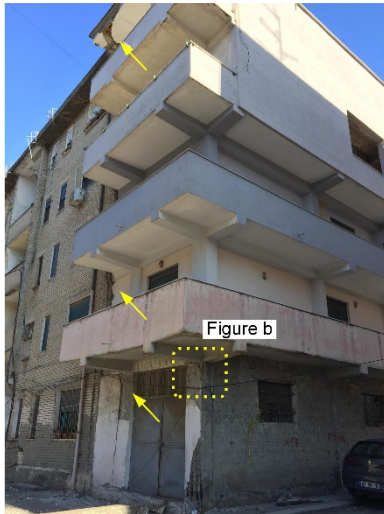
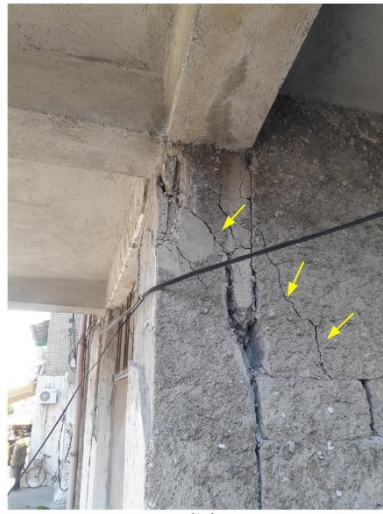
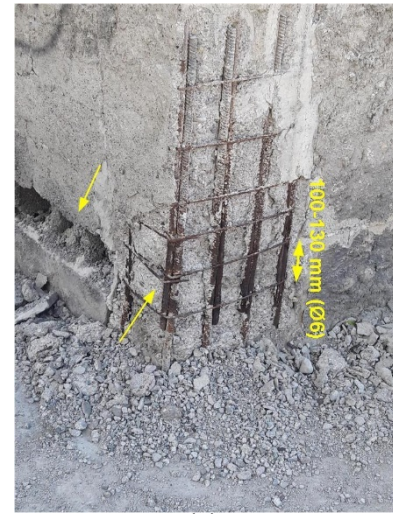
Damage to infill walls and reinforced concrete columns of a five-story reinforced concrete building is shown in Figure 46. The building was located near the fire station in downtown Durrës. The building had 3×2 rectangular columns arranged in a regular pattern. This building suffered minor damage due to the pounding effect with the adjacent masonry building (Figure 46(a)) caused by an insufficient seismic gap. Figure 46(b) shows damage at the top end of a reinforced concrete column, which was likely caused by interaction with the concrete block masonry infill (note the stepped cracks in infill that propagated into the column). Exterior column, damaged at the bottom end, had $\phi 6$ ties at 100- to 130-mm spacing and 90° hooks (Figure 46(c)).

Figure 46. Five-story reinforced concrete frame building at downtown Durrës: (a) damage due to pounding with an adjacent building, (b) damage at the top of a column at the southwest corner due to interaction with the concrete block infill, and (c) damage at the base of a column at south east corner (photos: SUZI-SAEE).

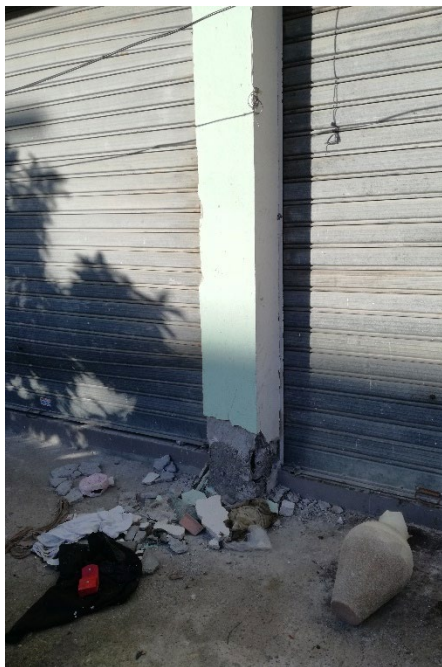
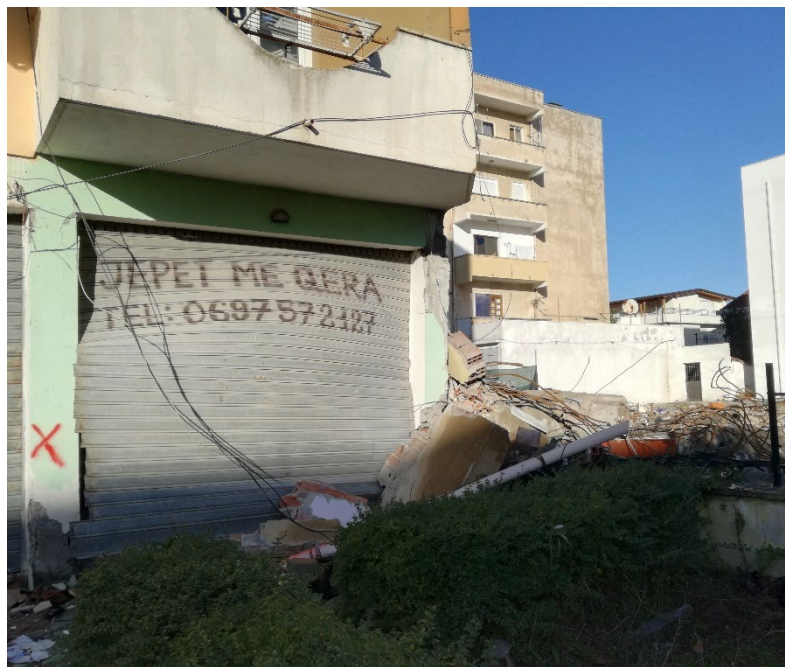
Another case of a severely damaged reinforced concrete building is presented in Figure 47, which shows flexural and shear failures in the exterior columns (Figure 47(a)). Construction flaws observed in the previously described case studies, such as low quality of the concrete that resulted in the initiation of core crushing and widely spaced hoops, were observed in this case as well. An additional contributing factor that appears to have further aggravated the damage of the corner column is the interaction with the collapsed adjacent building (Figure 47(b)).

Figure 47. Damaged building in Durrës: (a) a damaged column base and (b) interaction with the adjacent collapsed building (photos: HAEE).

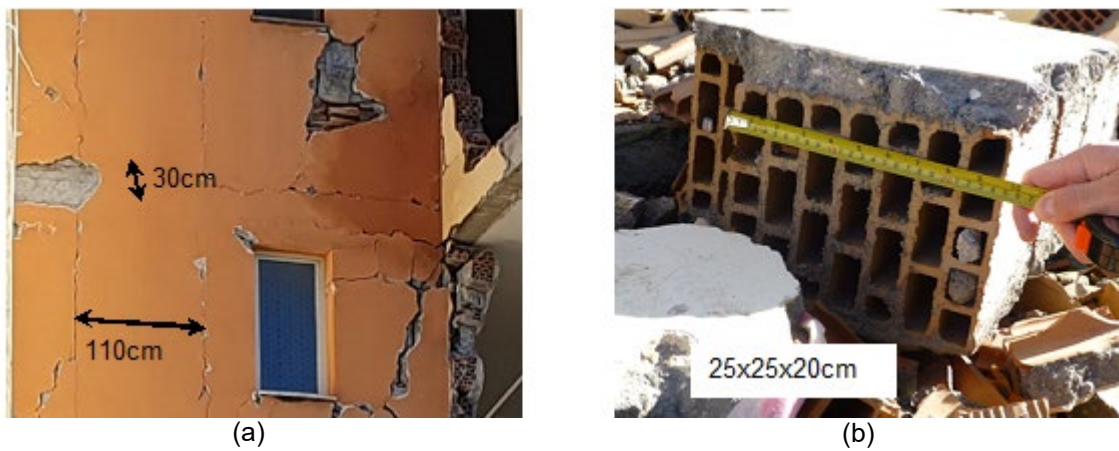
Interior and exterior columns have large cross-sectional dimensions, approximately 80×80 cm and 110×35 cm, respectively. The dimensions of the exterior column can be seen in Figure 51(a) because of the vertical cracks formed in the plaster. Figure 51(a) also shows the cracks corresponding to the position of the beams that have a depth equal to the thickness of the floor slab and beam (approximately 30 cm).

Figure 51. Typical 2000s multi-story reinforced concrete building: (a) plaster cracks and the dimensions of beams and columns and (b) dimension of clay block masonry units used for the infill construction (photos: EEFIT).

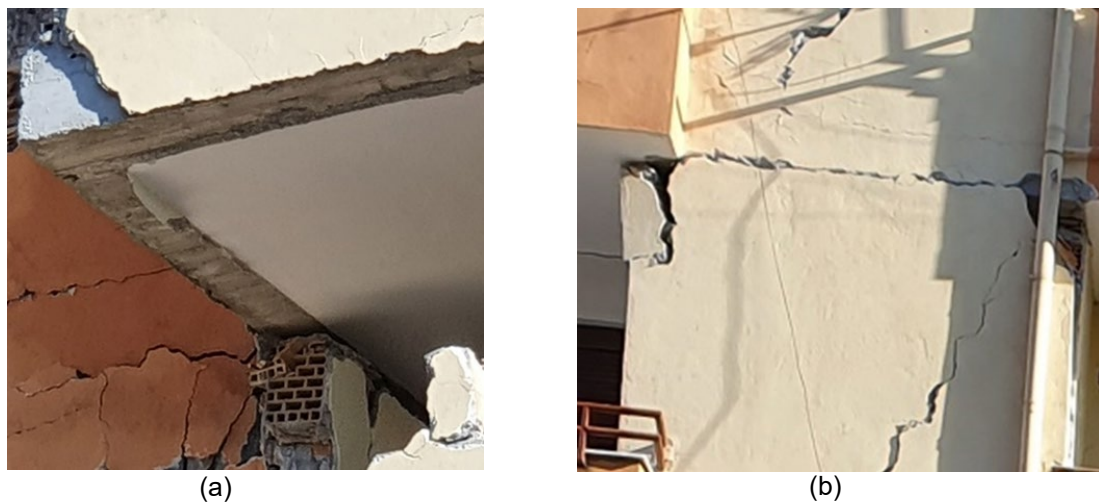
Infill panels are constructed using clay blocks (25×25×20 cm), as shown in Figure 51(b). The interaction of the flexible structure with the stiff infills caused a significant damage to infills. Moreover, some of the unconfined walls either collapsed or experienced heavy damage (Figure 50(a)). In addition, as shown in Figure 52, the damage pattern is also characterized by horizontal cracks at the floor level in the lower side of the floor slabs. This is related to the lack of construction detailing and a poor connection between the top side of the infill panels and floor slabs. This configuration promotes the detachment of the infills from the beams. This damage pattern is distributed over the bottom five stories in the building, and it can be observed in Figure 52(a). Figure 52(b) shows a close-up of the damage pattern at the eastern façade of the building, which highlights significant vulnerability of stiff masonry panels, especially when they are not enclosed by the reinforced concrete frames. For more information about infill panels, see section 4.4

Figure 52. Severe damage of masonry infills: (a) collapse of an infill panel and (b) detachment of the infill panel and formation of horizontal cracks (photos: EEFIT).
