EERI Earthquake Reconnaissance Report:

M6.4 Albania Earthquake on November 26, 2019

Volume 1: Executive Summary

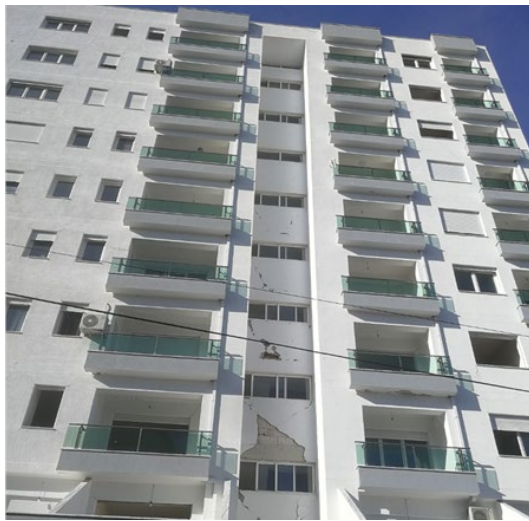
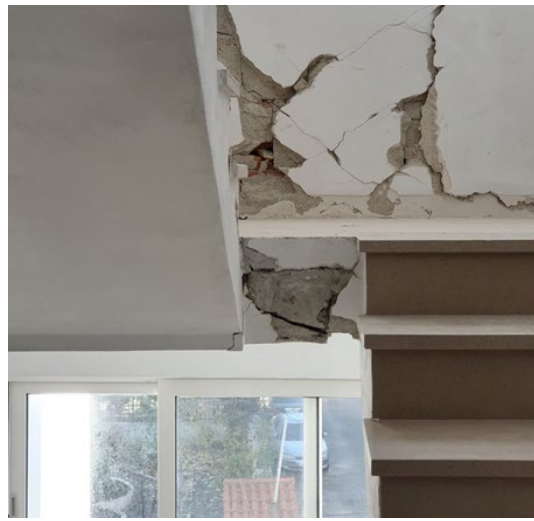
The damage was mostly concentrated in the staircase and interior infill panel areas of the building. The exterior and interior damage in the staircase area can be observed in Figure 54(a) and (b), respectively. This damage is likely due to large displacements caused by the presence of the core wall, which induced torsional effects. The staircase was unable to accommodate these displacements, and it experienced large shear cracks in the stair-landing area, specifically in the exterior beams and the adjacent nonstructural walls. Extensive damage was observed in the lower five stories of the building.

Figure 54. A typical post-2010 multi-family reinforced concrete residential building partially designed according to Eurocode 8: (a) exterior damage related to the interaction with the stairs and (b) damage in the stair-landing area (photos: EEFIT).

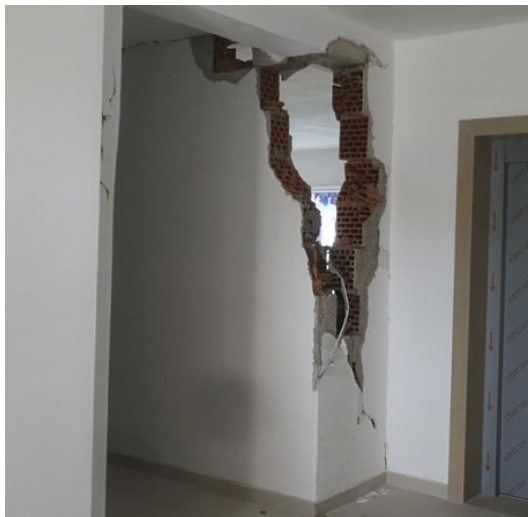
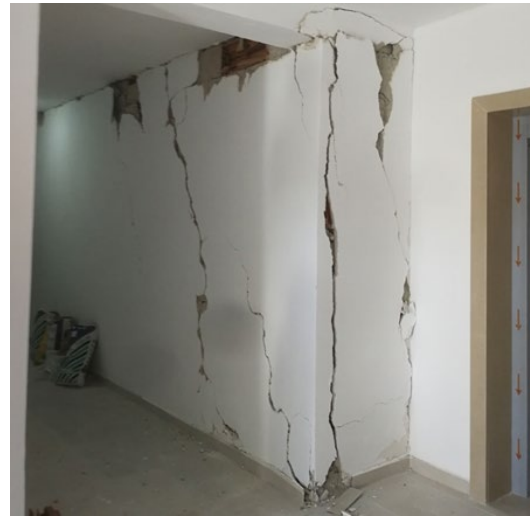
As in the case study described in Figure 51, the infill panels are generally composed of clay blocks (25×25×20 cm). The interaction of the flexible frame structure with the stiff infills resulted in significant damage to the infills. This extent of damage was more significant in internal partitions because of a lack of confinement of these walls by the reinforced concrete frame elements and inadequate connections at wall intersections. Figure 55(a) and (b) show the same intersection of internal masonry panels at the second and the fifth story, respectively.

Figure 55. Damage at the intersection of interior masonry partitions in a typical post-2010 multi-story reinforced concrete residential building: (a) the second story and (b) the fifth story (photos: EEFIT).

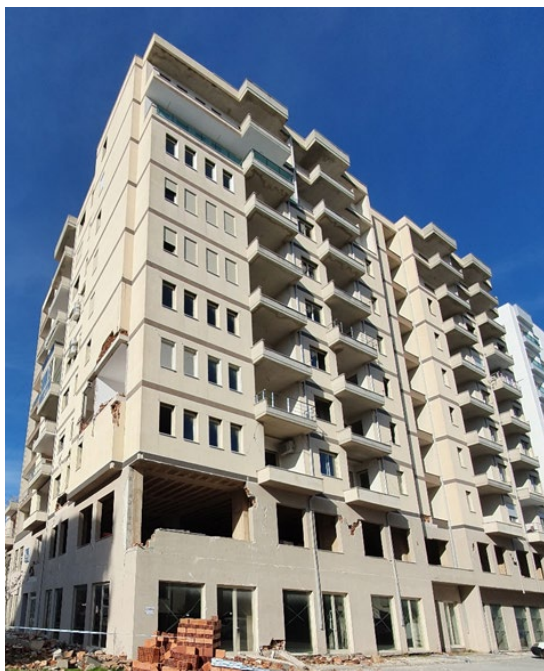
In addition, most likely due to the torsional effects, exterior infills furthest from the core wall experienced damage in the form of shear cracks. This was more apparent in an adjacent building (also under construction) with identical geometry and other characteristics (Figure 56). The damage of exterior partitions that were offset with regards to the reinforced concrete frames is shown in Figure 56. Clearly, the lack of partition connections to the reinforced concrete frames significantly affects seismic response of nonstructural components, results in cracking and in some cases out-of-plane failure of these walls. This is also highlighted in Figure 57, which shows that the belt beams are ineffective when a masonry wall is not aligned with the reinforced concrete frame. It is worth mentioning that many buildings with similar characteristics showed the same damage pattern. For more information about infill panels, see section 4.4.

Figure 56. A typical post-2010 multi-family reinforced concrete residential building designed partially according to Eurocode 8: (a) exterior damage due to torsional effects and (b) failure of exterior masonry walls offset with regard to the frame (photos: EEFIT).

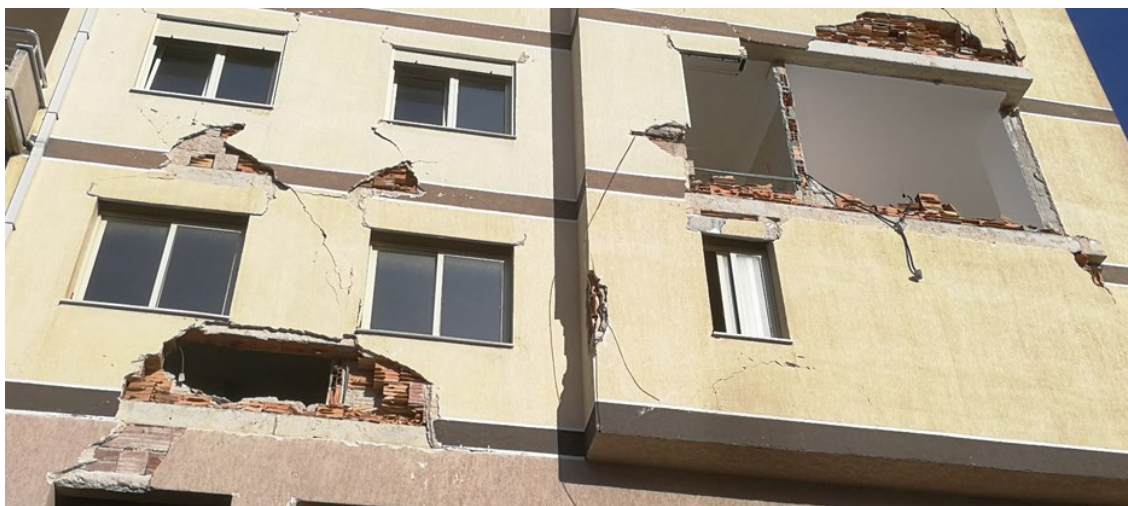
Figure 57. A typical post-2010 multi-family reinforced concrete residential building partially designed according to Eurocode 8 (note the lack of effectiveness of belt beams in masonry infills) (photos: EEFIT).

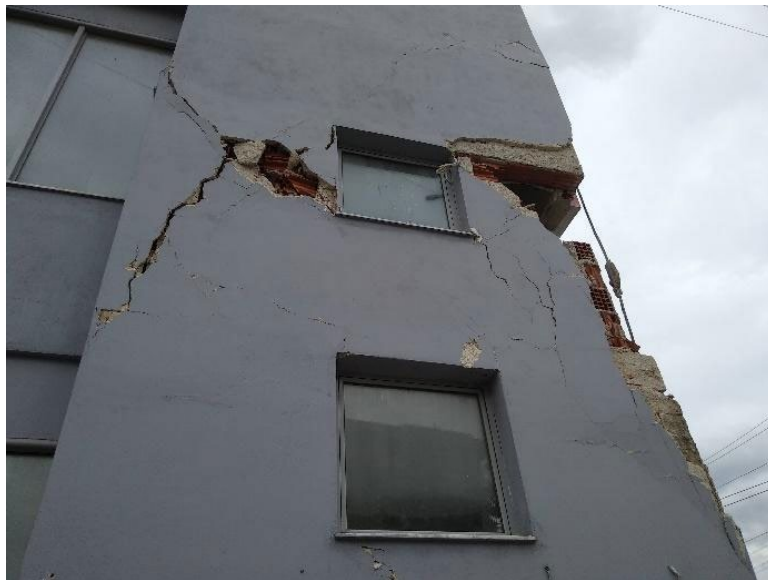
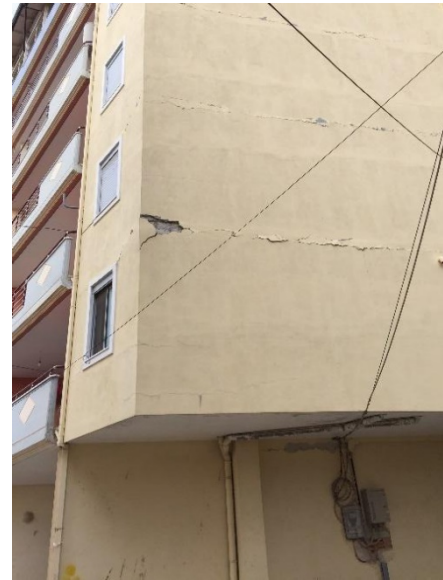
Infill damage in reinforced concrete structures was dominant in Durrës (Figure 58(b)) but was also observed in Fushë-Krujë (Figure 59(a)), Krujë (Figure 59(b)), and Tirana and Bubq (Figure 60). It is important to point out the influence of the infills on the global behavior of the whole structure and damage caused to the structure, as discussed in section 4.2. This section focuses on the damage of masonry infill walls, which was the predominant damage pattern in reinforced concrete buildings exposed to this earthquake.

Figure 59. Examples of masonry infill damage in reinforced concrete buildings: (a) Fushë-Krujë and (b) Krujë (source: Nikolić-Brzev et al., 2020).³⁹

Significant damage in masonry infills can be attributed to the relative flexibility of reinforced concrete frame structures, which by their deformations caused in-plane damage to the infills (see section 4.2). This type of damage can be manifested in the form of diagonal (“X”-shaped) cracks (Figure 59(a) and Figure 60) or damage in the corners of infill walls (Figure 55 and Figure 60(b)). Two other characteristic types of in-plane damage, which were also observed in this earthquake, are horizontal sliding along the mortar bed joints or damage in the central part of the wall (Figure 61).

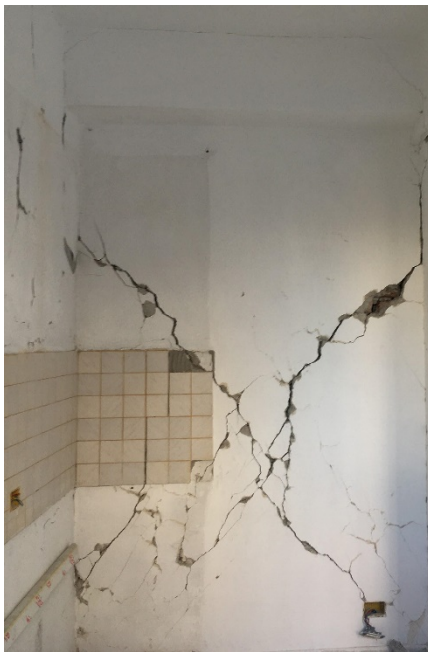
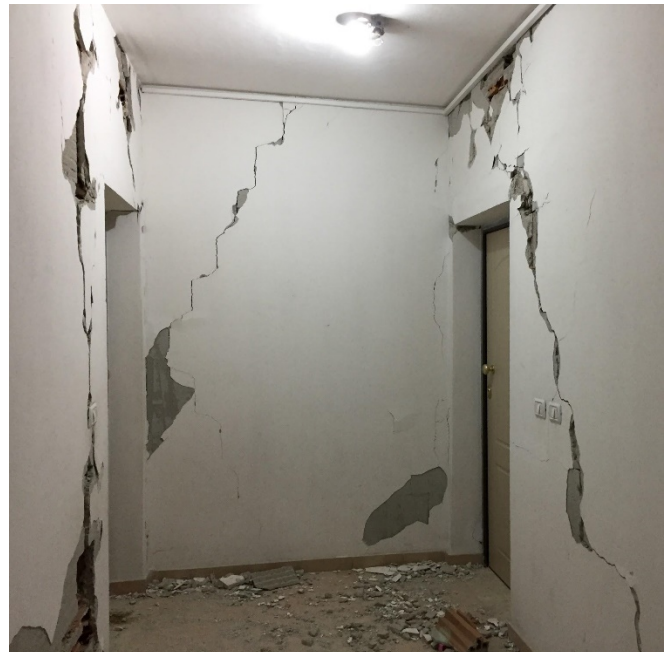
Figure 60. Diagonal cracks in masonry infills (photos: SUZI-SAEE).

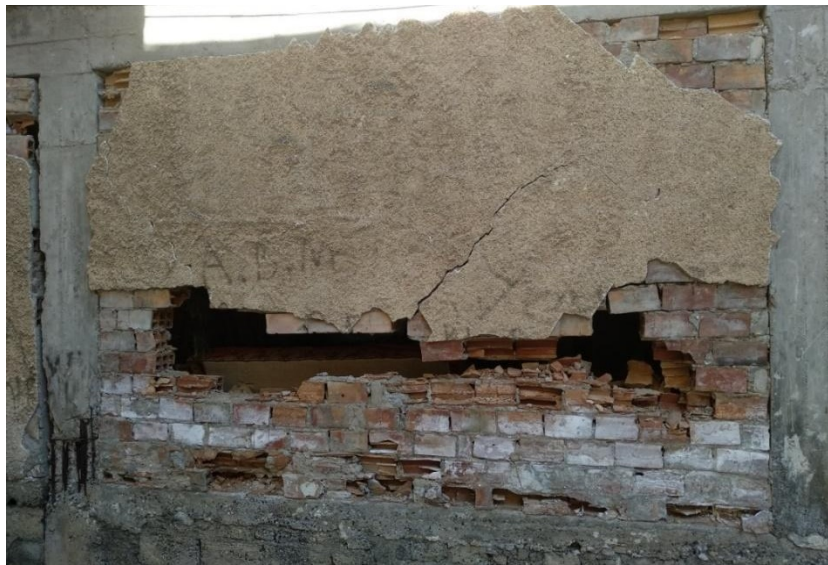
Figure 61. Damage of infill wall by bed joint sliding and failure at central portion of the wall (photo: Marko Marinkovic).

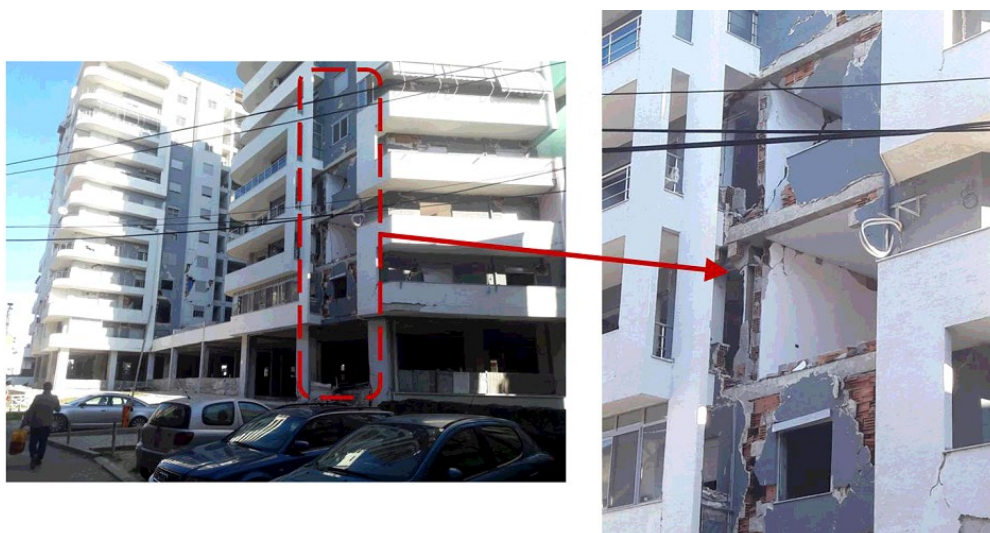
Figure 65. Out-of-plane collapse of infill walls in Durrës. The red outline indicates the area of the detailed view shown in the right part of the figure (source: Nikolić-Brzev et al., 2020).

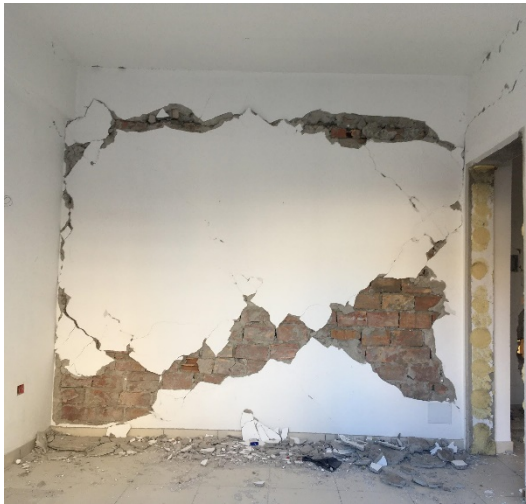
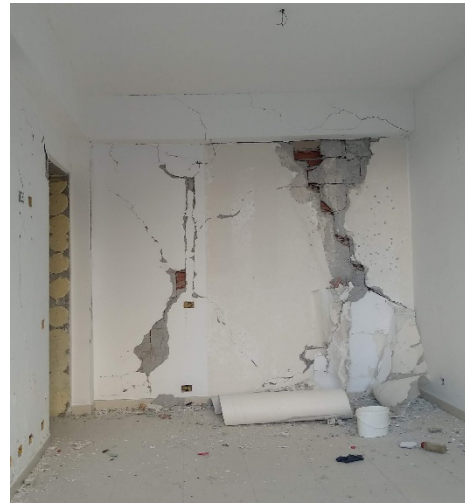
Figure 66. Damage of masonry infills inside the buildings in Durrës (photo: SUZI-SAE).

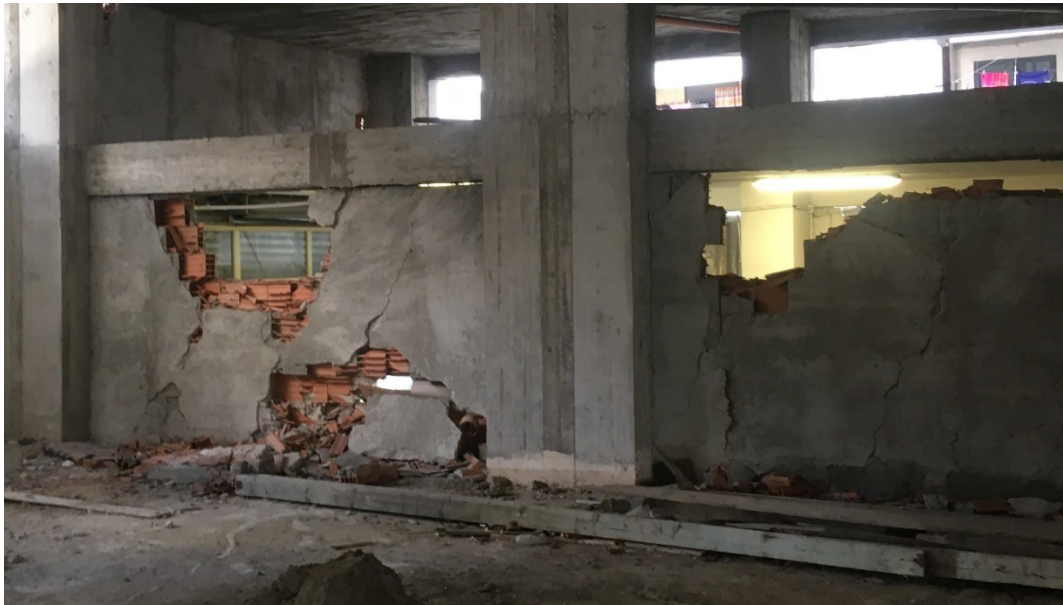
Figure 67. Severe damage/collapse of interior masonry infills at ground floor level of a reinforced concrete building in Durrës (photo: SUZI-SAE).

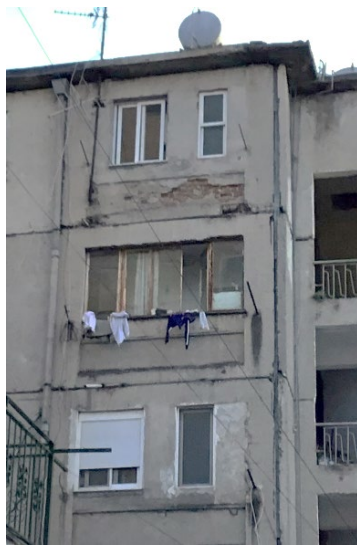
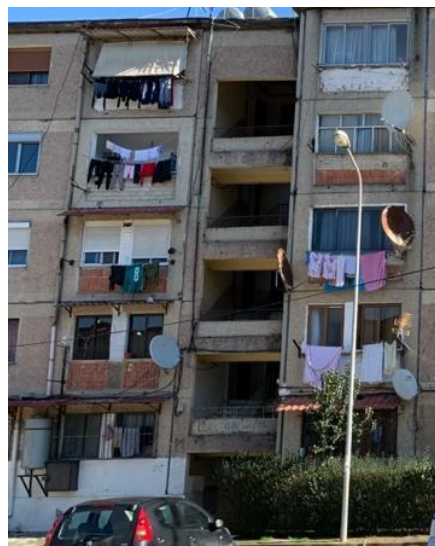
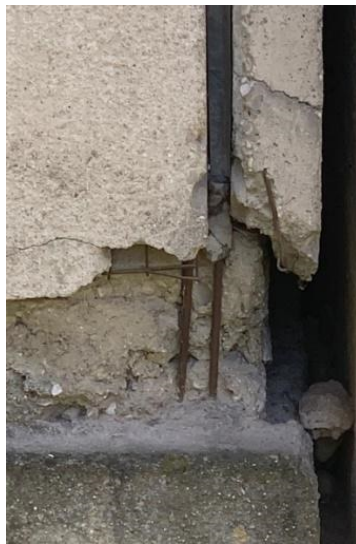
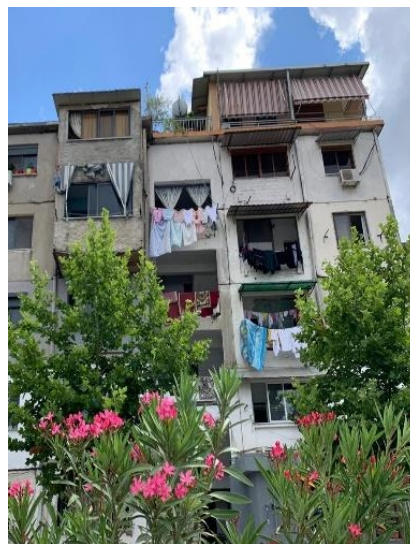
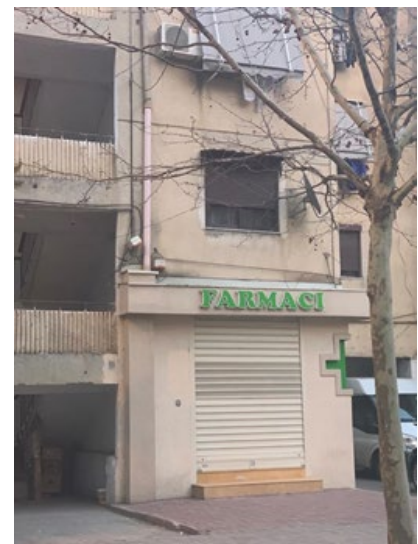
Most of these buildings are more than 40 years old and poorly maintained. In many instances, the pre-earthquake condition of the buildings was poor because of the deterioration of concrete and steel in exterior panels as a result of the aging and exposure to atmospheric agents as well as the strain effects (e.g., temperature-induced cracks). Another factor that contributed to the deterioration was interventions (modifications) of the original structure performed by the building inhabitants, which usually occurred illegally and without input by qualified engineers. It should be noted that it was not easy to make modifications in these buildings, so the cases of intervention are not very common. Figure 77 illustrates the condition of Albanian LPBs, including deterioration and building modifications/interventions.

Figure 77. *Pre-earthquake condition of Albanian LPBs: (a) deterioration of facade elements, (b) the use of masonry to build exterior walls, (c) deterioration of concrete and corrosion of the reinforcement in an exterior wall at the ground floor level, (d) an example of illegal horizontal and vertical building extensions, and (e) an inappropriate ground-floor intervention (photos: Merita Guri, Svetlana Brzev, and Markel Baballëku).*

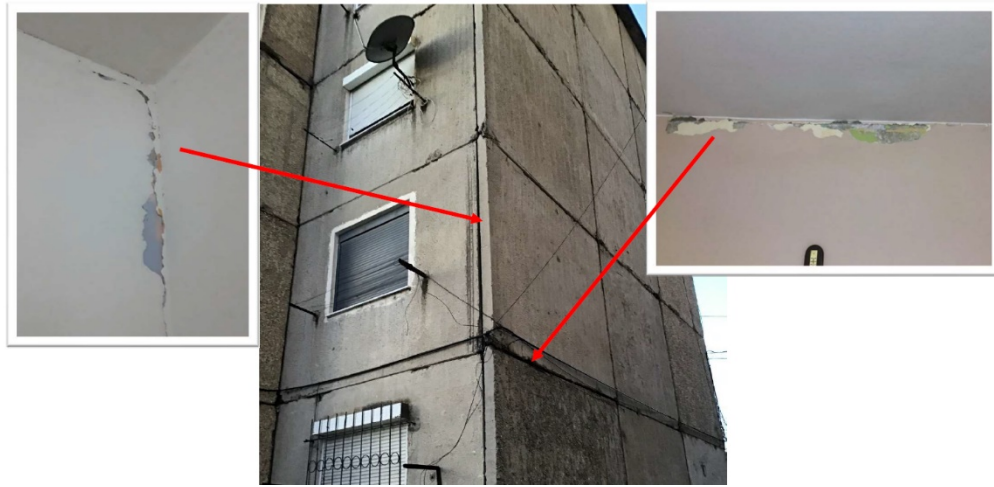
LPBs either remained undamaged or experienced minor structural damage during the November 2019 earthquake, as discussed by Guri, Brzev, and Lluka (2021).⁵² The damage patterns were mostly in the form of horizontal or vertical cracks within the panel connections. The extent of cracking ranged from minor plaster cracks to moderate cracks in the joints. These crack patterns signify the onset of structural damage in LPBs, where the damage is mainly in the form of cracking in the grout between the panels and does not affect the structural safety. The extent of damage also depended on the soil conditions at the building location. Durrës and some areas of Tirana (e.g., the Kombinat area) are well known for soft soil conditions that amplify earthquake effects. LPBs are rigid structures and are more vulnerable to earthquake effects in soft soil areas due to soil-structure interaction. Figure 78 and Figure 79 show the cracking pattern for LPBs in the Kombinat area of Tirana. Figure 78 shows horizontal cracks at the wall-floor connection and vertical cracks where the wall panels connect at the wall intersections. Figure 79 shows vertical cracking along the interface between adjacent interior subpanels PM3a and PM3b (note that interior panels had to be subdivided to limit the weight below 3.6 tons—the crane capacity).

Figure 78. Cracking pattern at the interface between horizontal and vertical panels and at the wall intersections (Kombinat area in Tirana) (source: Guri et al., 2020).⁵³

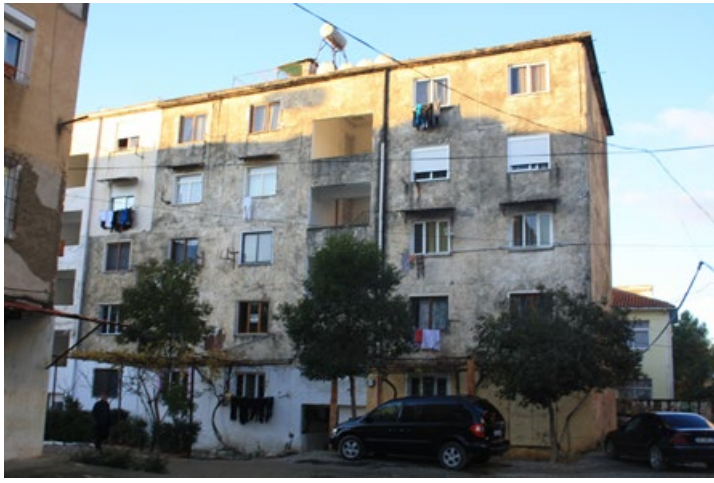
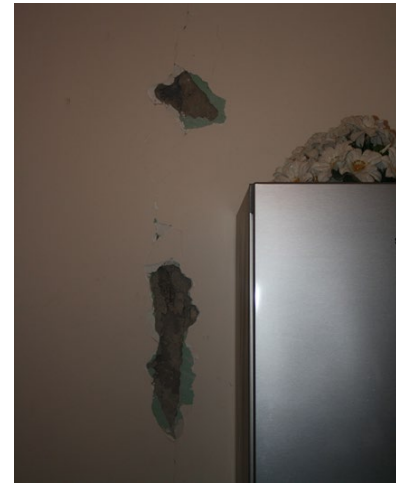
LPBs in Laç seemed to have poor maintenance, and the deterioration of exterior wall panels was visible (see Figure 80(a)). There were no external signs of earthquake-induced damage in any of the buildings. Minor cracking along the panel connections at the bottom two stories was visible from the inside. For example, vertical cracks developed along the wall panel connections, and horizontal cracks developed along the slab-to-wall connections (Figure 80-b).

Figure 80. LPBs in Laç: (a) a typical building, Module 1, and (b) cracking at the wall panel connections (photos: EEFIT).

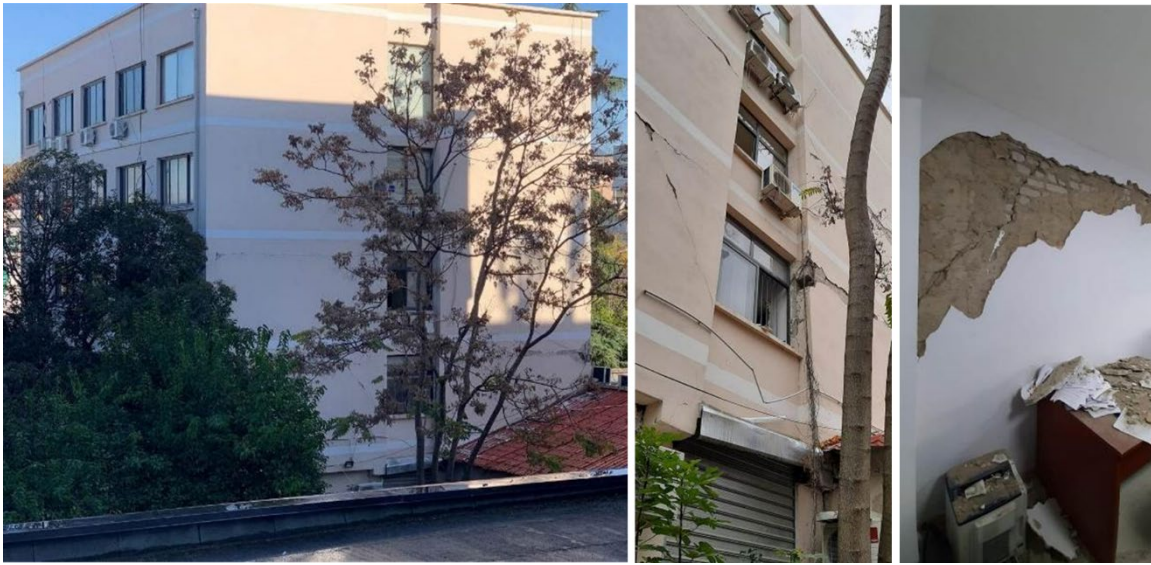
Figure 86. Masonry infills damaged in the National Territory Planning Agency building in Tirana. Shear cracks and partial separation from the frame shown (photos: Markel Baballëku).

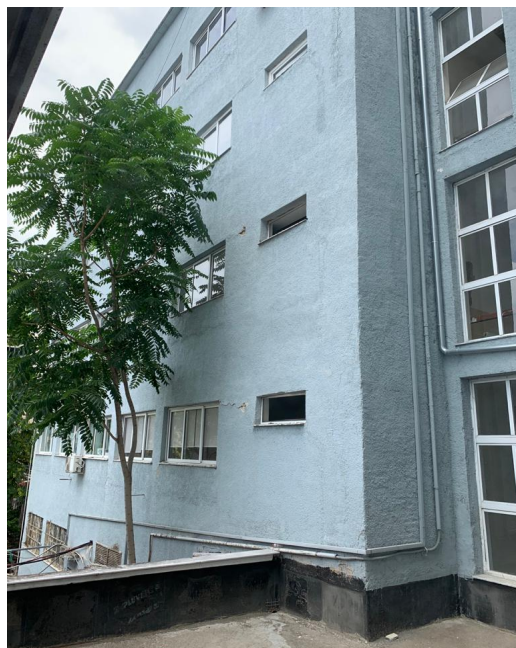
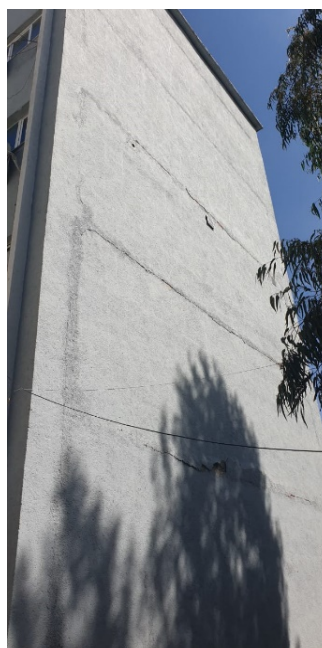
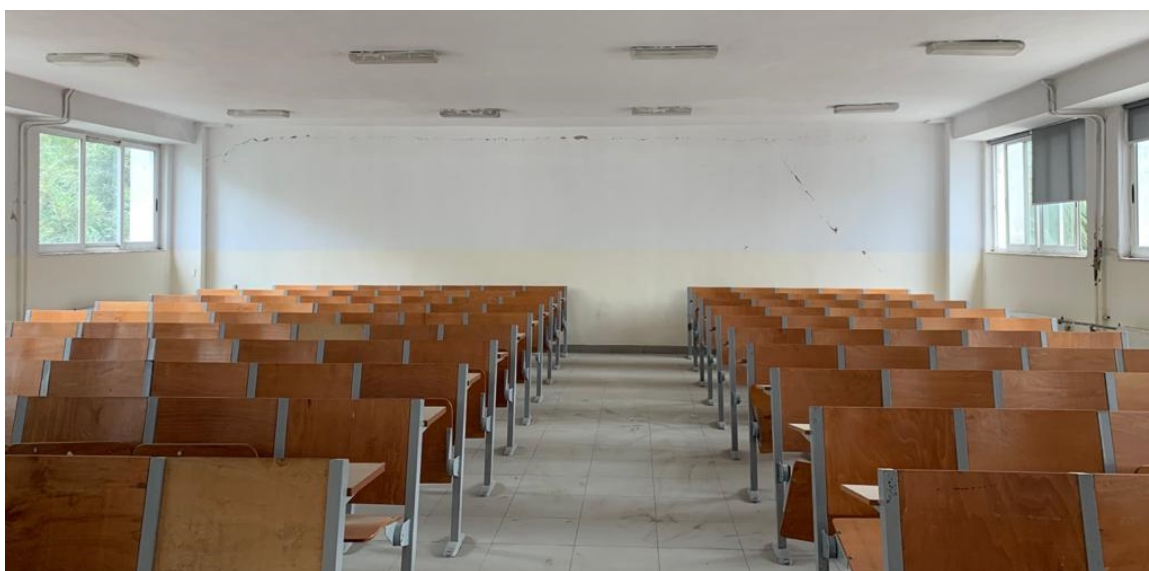
According to the available data, this building experienced moderate damage due to the January 1988 Tirana earthquake, especially in the connections and nonstructural masonry walls. The September 2019 earthquake caused damages similar to the January 1988 earthquake; however, the masonry core experienced further damage due to the November 2019 earthquake. Diagonal cracks were observed around the main entrance. Damage induced by pounding effects was also observed in the masonry core. In the PRCFBs, damage was observed only in the infill walls and one-way prefabricated reinforced concrete slabs (Figure 89, Figure 90, and Figure 91).

Figure 89. Minor damage of infill walls in the FIN Building at the Polytechnic University of Tirana: (a) the façade of the west block with cracks in the infill walls between windows, (b) façade of the south block with the infill wall separated from concrete frame (damage after the September 2019 foreshock), and (c) interior view of east block with damage and separation to the infill wall (photos: Markel Baballëku).

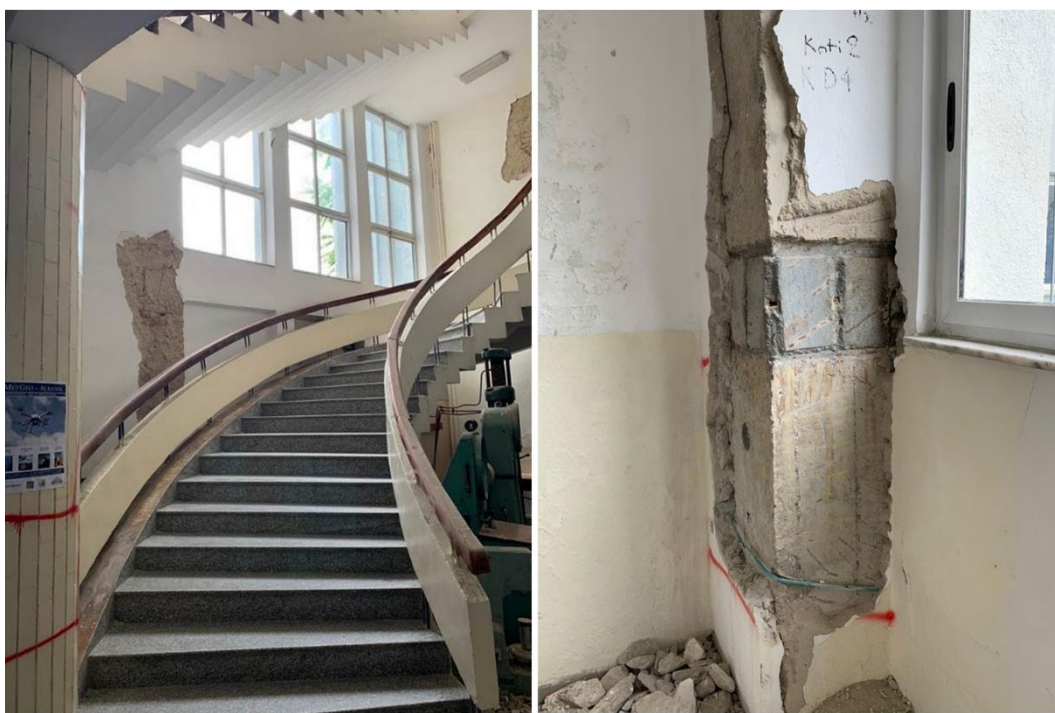
Figure 91. Staircase area of the FIN Building at the Polytechnic University of Tirana: (a) damage at the beam support area and (b) an exposed reinforced concrete column after the inspection (no damage observed) (photos: Markel Baballëku).

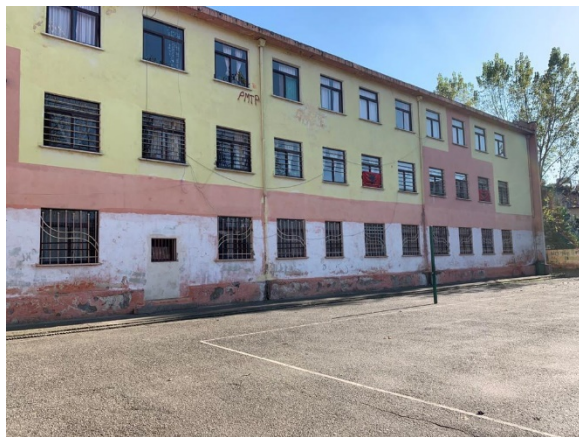
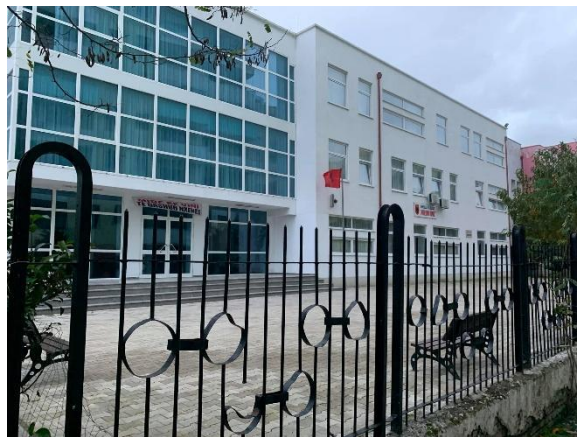
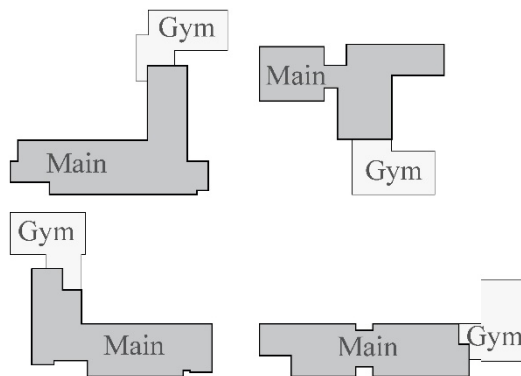
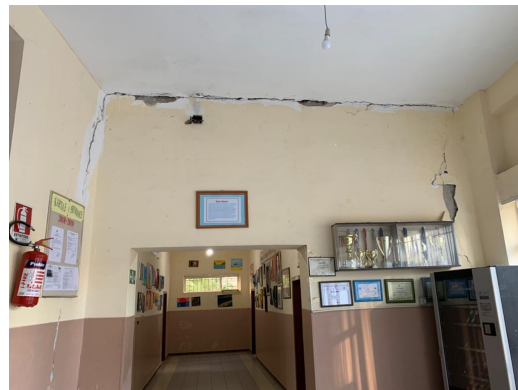
Figure 92. Typical school buildings in Albania: (a) a masonry pre-1990 school, (b) a reinforced concrete modern school (photos: Markel Baballëku), (c) examples of template designs for schools before 1990 (source: Baballëku, 2014), and (d) two structurally independent units of the "Shaqe Mazreku" school building in Durrës (photo: Markel Baballëku).

annex buildings or floor extensions are typically structurally independent (separated by a joint from the main school building), as shown in Figure 92(d). The annex buildings, especially when used as a gym area, are flexible, often made of reinforced concrete frames, and quite different from the rigid main structure. The use of prefabricated slab panels is very common.

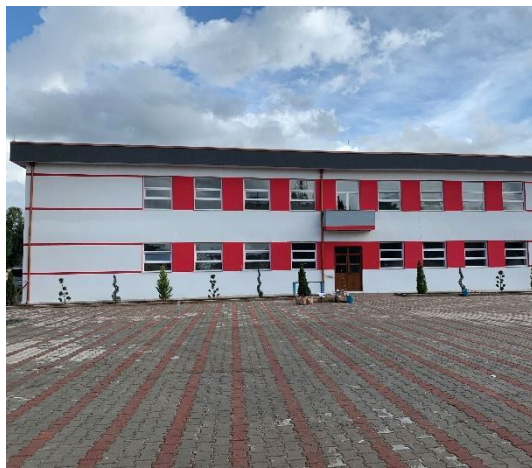
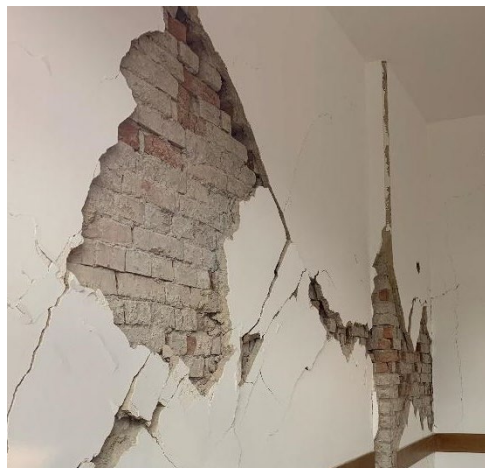
A two-story masonry school in Thumanë was among the most damaged. It was declared unsafe and demolished subsequently. The school was built in the 1970s and recently refurbished. Its structure was regular, symmetric about one axis, and relatively small compared to schools in Tirana and Durrës (approximately 34×11 m). A general view of the school is shown in Figure 93(a). Although limited damage was visible from the exterior of the school, the structure was severely damaged in the interior. A failed masonry wall can be seen in Figure 93(b). From limited investigation due to safety concerns, only in-plane failures were detected. After uncovering the plaster and thermal coating of the façade, it was observed that the masonry piers between the windows were also damaged and deteriorated because of aging. It has been reported that the same school had suffered structural damage from a M5.1 earthquake on July 4, 2018.

Figure 93. Severely damaged school in Thumanë: (a) the exterior of the school, (b) shear failure of a wall, and (c) damaged masonry piers (photos: Markel Baballëku).

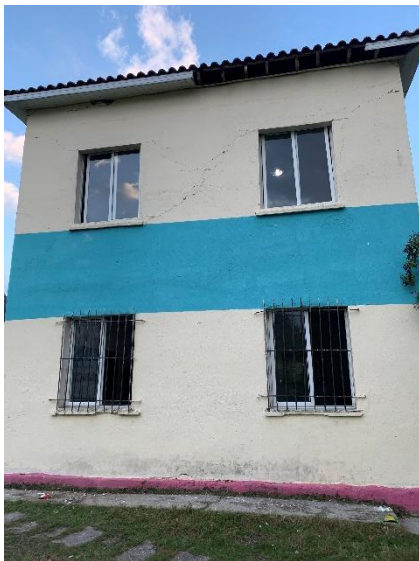
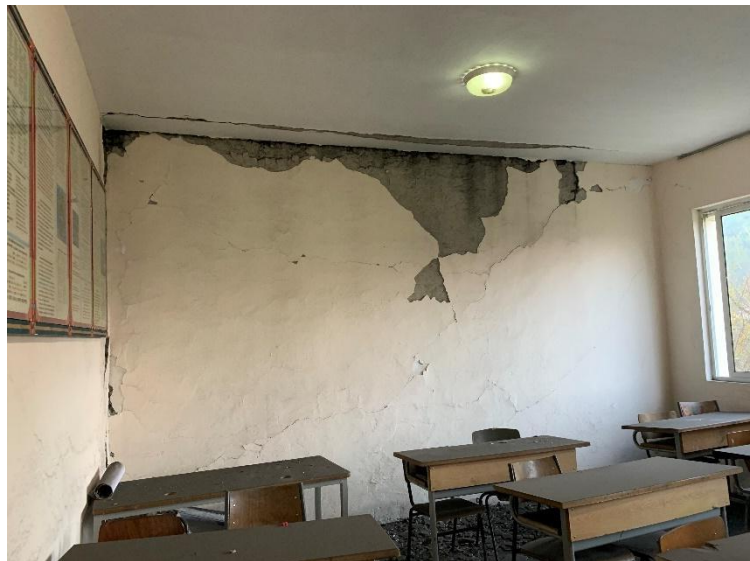
A school in Pezë was also considered unsafe and demolished (Figure 94). The two-story structure was made of masonry with silicate solid bricks. The first story was covered by narrow prefabricated panels, whereas the second story was covered by a timber roof. Diagonal cracking of the walls was visible from the exterior in this case (Figure 94(a)). Damage at the slab panels and the slab-wall connection was present. In several locations, the walls were disconnected from the slab, constituting a hazard for out-of-plane collapse (Figure 94(b)).

Figure 94. Severely damaged school in Pezë: (a) diagonal cracking of second story walls and (b) damage from the inside (photos: Markel Baballëku).

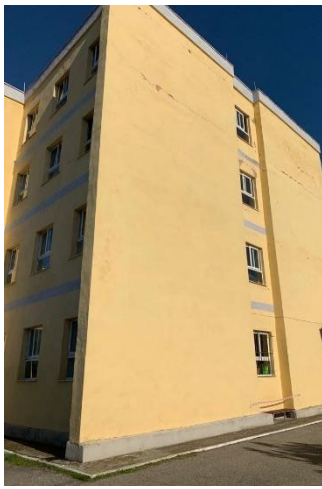
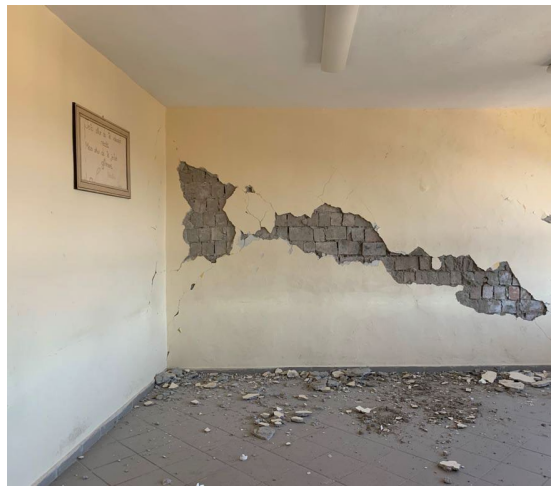
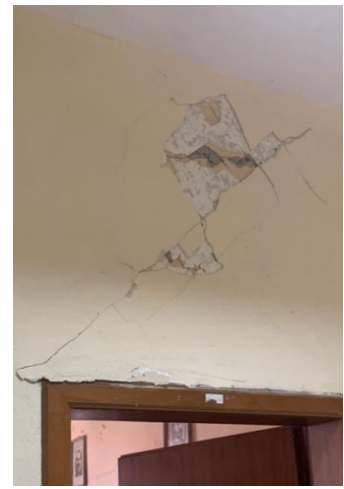
A school in Shijak (near Durrës) that was built in 1983 suffered damage during the earthquake (Figure 95). The case of this school is special because it originally had three stories and a masonry structure, but a fourth story was added in 1988. Damage at the junction of the old building with the new story is visible from the exterior of the building (Figure 95(a)). From the inside, the building suffered severe damage of the plaster, both in the old structure (with solid bricks) and the new story (containing hollow bricks; Figure 95(b)). Diagonal cracking of the spandrels above doors was also present (Figure 95(c)). Examples of minor structural or nonstructural damage to masonry schools in Durrës and Maminas is shown in Figure 96.

Figure 95. School in Shijak with damage concentrated near the added story: (a) Exterior of the school, (b) a damaged wall at fourth floor, and (c) damage above door openings (photos: Markel Baballëku).

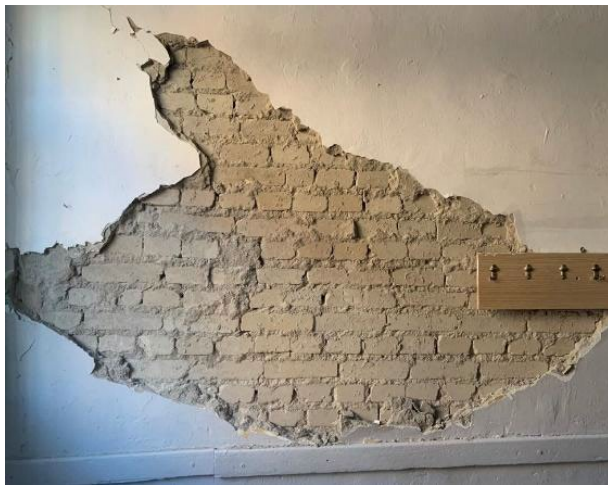
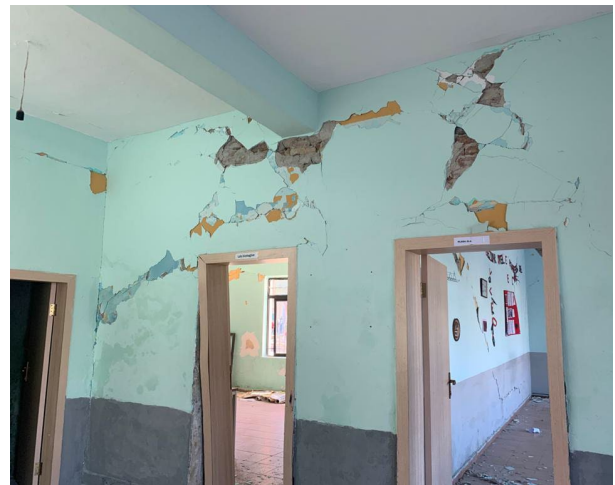
Figure 96. Minor structural or nonstructural damage to masonry schools: (a) damaged plaster at a three-story school in Durrës and (b) deteriorated materials and damage likely aggravated by the earthquake in a two-story school in Maminas (photos: Markel Baballëku).

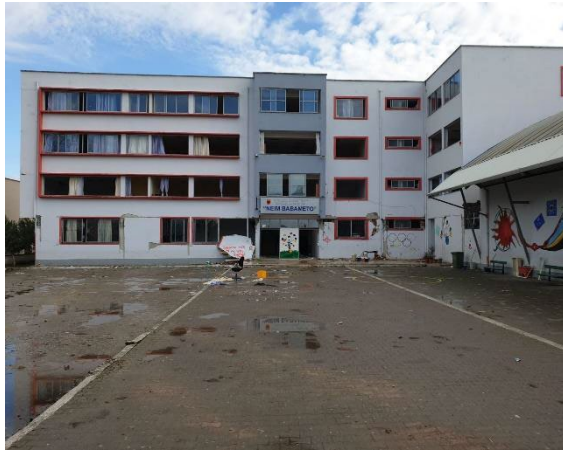
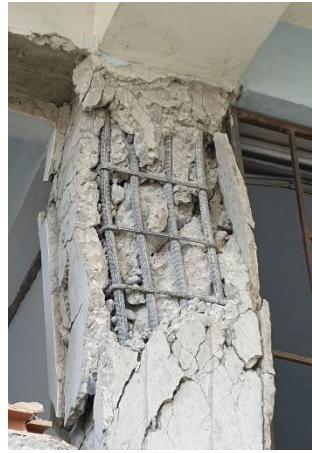
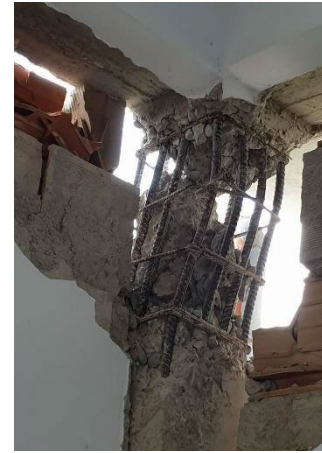
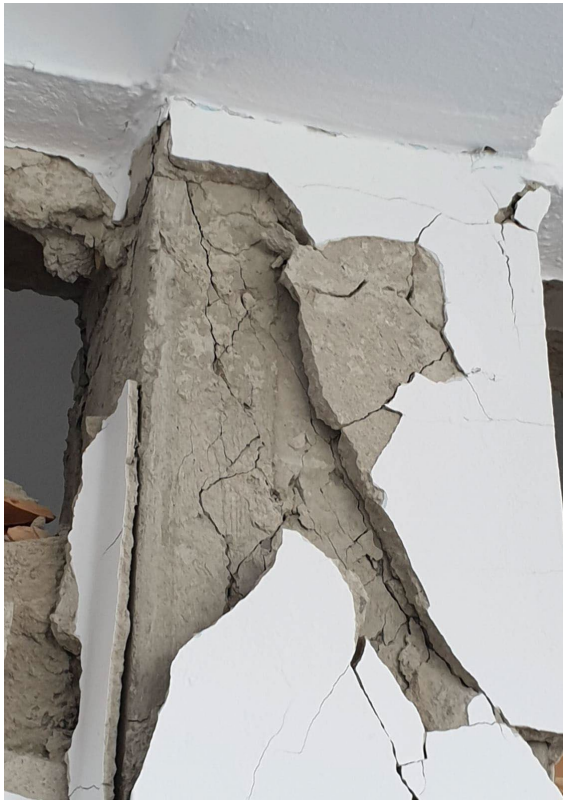
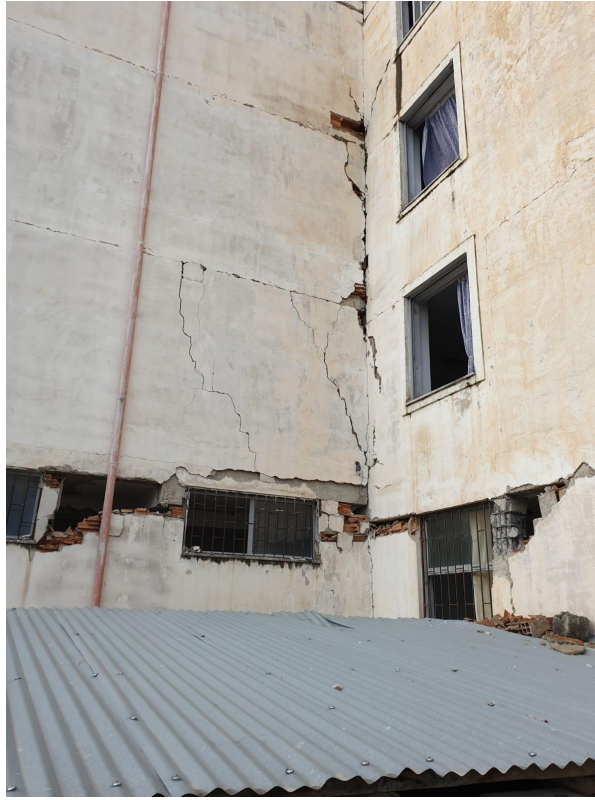
Ground-floor exterior columns were severely damaged in this school. The interior columns suffered damage, too (Figure 97(d)). Damage was concentrated at the column's section near the beam-column connection of the ground floor. Excessive plastic lateral deformation of the structure was present at the end of ground shaking, as can be induced by Figure 97(b) and (c). These figures show also that the severely damaged columns had only one Ø8-mm hoop encircling the 12 longitudinal Ø20-mm bars. The hoops were not anchored into the concrete core but bent at 90°. Figure 97(c) indicates that the anchorage of the hoops was insufficient because the hoops opened. Nonstructural damage (damage to infill walls) was extensive in this school, as shown in Figure 97(e).

Figure 97. Severely damaged reinforced concrete school in Durrës: (a) a general view, (b), (c), (d) damaged columns, and (e) nonstructural infill damage (photos: Markel Baballëku and M. Carmi).

Although fewer in number, damages in reinforced concrete school buildings were encountered as well. Typical damages in these types of schools were similar to those encountered in residential buildings (section 5), which was mostly nonstructural damage to the infill and partition walls. The school "Neim Babameto" in Durrës represents a case of severe structural damage. This is a relatively new four-story school (Figure 97(a)). The structure consists of reinforced concrete spatial moment-resisting frames (no shear walls). The stories are of the same height, and the structure is regular in elevation. The beams in this structure are deeper than the slab, unlike the wide/shallow beams that are often used in residential buildings (section 5). The school had a rectangular grid of columns with a spacing of approximately 5 m in the longer direction and 6m – 3m – 6m in the shorter direction. Columns were square, with 300×300 mm sections in the exterior, and the beams were 300 mm wide and 500 mm deep. The beams were more heavily reinforced than the columns, especially for hogging bending moments. While also considering the dimensions of the columns and beams mentioned above, it appears that this building had a strong beam–weak columns configuration.

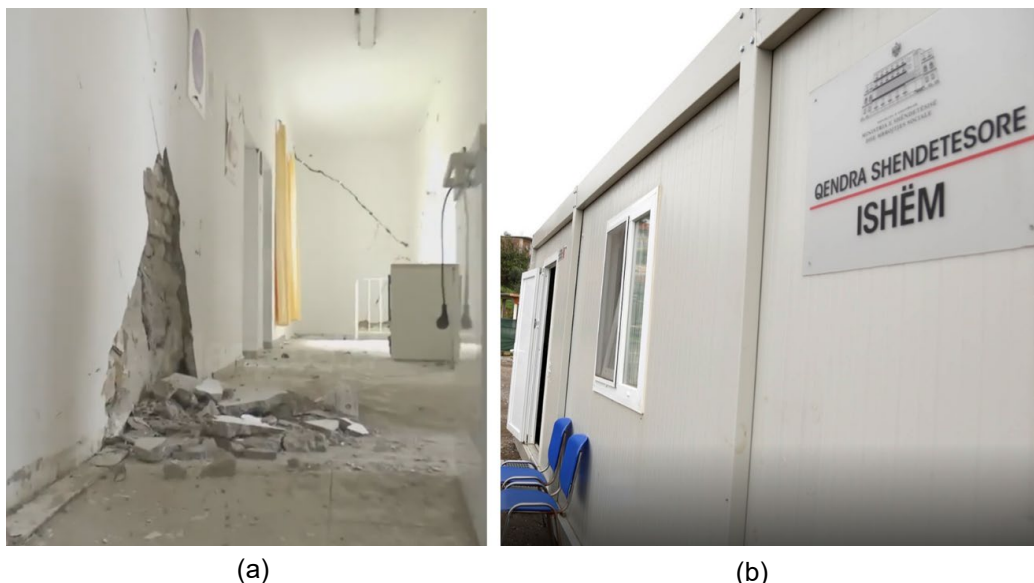
Figure 98. *Ishëm healthcare center suffering damages from November 2019 earthquake: (a) the damaged hospital building and (b) temporary shelter for healthcare services (source: https://www.youtube.com/watch?v=iQnEyL_PIE&list=ULbzHFOD3Cgw0&index=35624; https://www.youtube.com/watch?v=Wxk06YFdiro&feature=emb_err_woyt).*

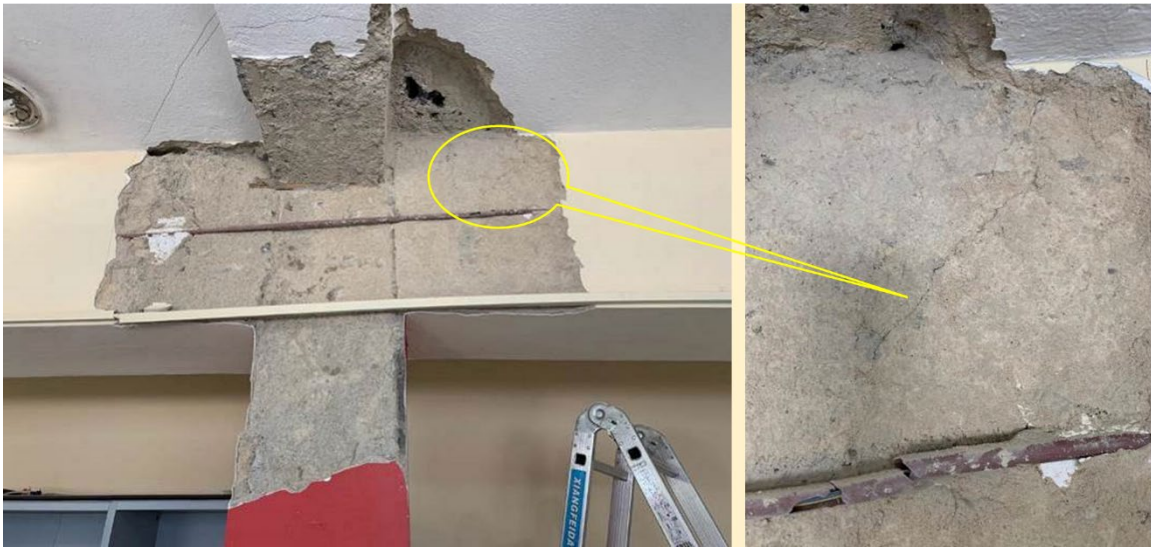
Damages to QSUT were very limited. The distance from the epicenter and the consideration of these buildings as important during design might have contributed to this lack of damage. Limited nonstructural damage was reported (cracked plaster and other minor damages). An example of a minor structural crack in a reinforced concrete prefabricated beam in a prefabricated frame building is shown in Figure 99.

Figure 99. Minor cracks on a prefabricated concrete beam at ground floor of a prefabricated frame building in QSUT (photos: Markel Baballëku).

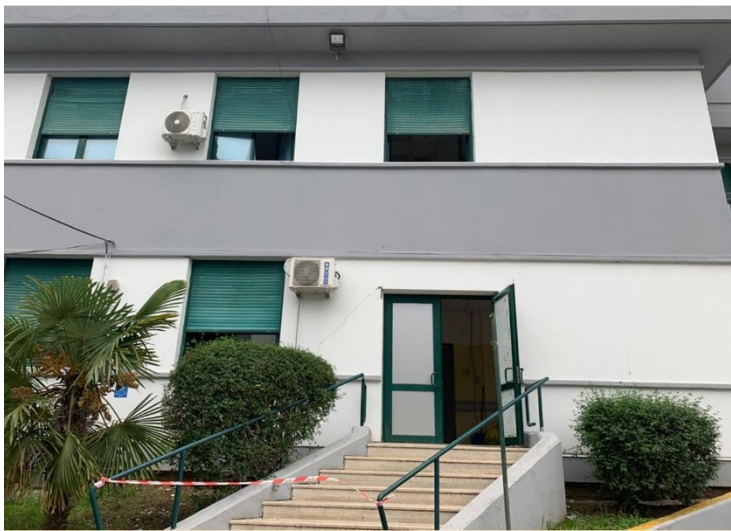
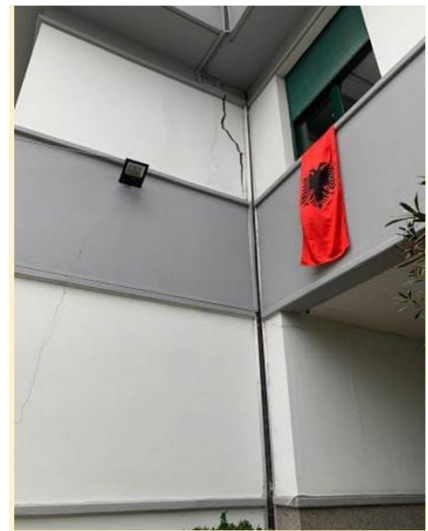
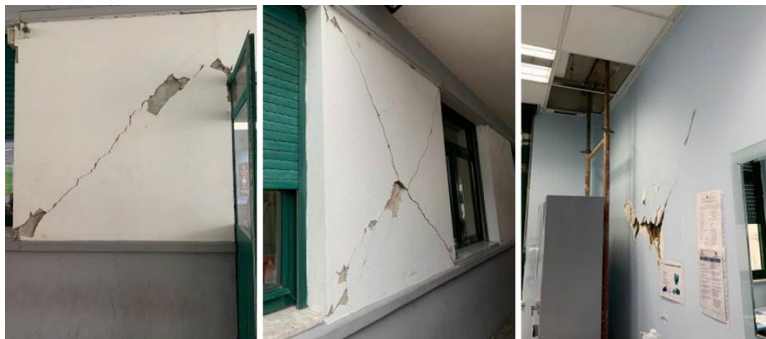
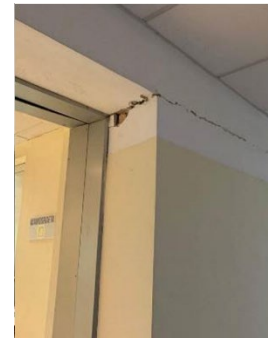
The Durrës Healthcare Center suffered minor damage during the main shock on November 26, 2019. The hospital staff reported more damage to the building after the M5.3 aftershock on November 28, 2019. The aftershock caused panic to hospital staff and patients for about an hour. The subsequent inspection showed that most of the damages were limited to infill walls. Some photos are presented in Figure 100.

Figure 100. Damage patterns in the healthcare center of Durrës: (a) slight damage to exterior infill walls, (b) interaction with an external elevator, (c) shear cracks in infill and partition walls, and (d) damage at seismic joints (photos: Chiara McKenney).

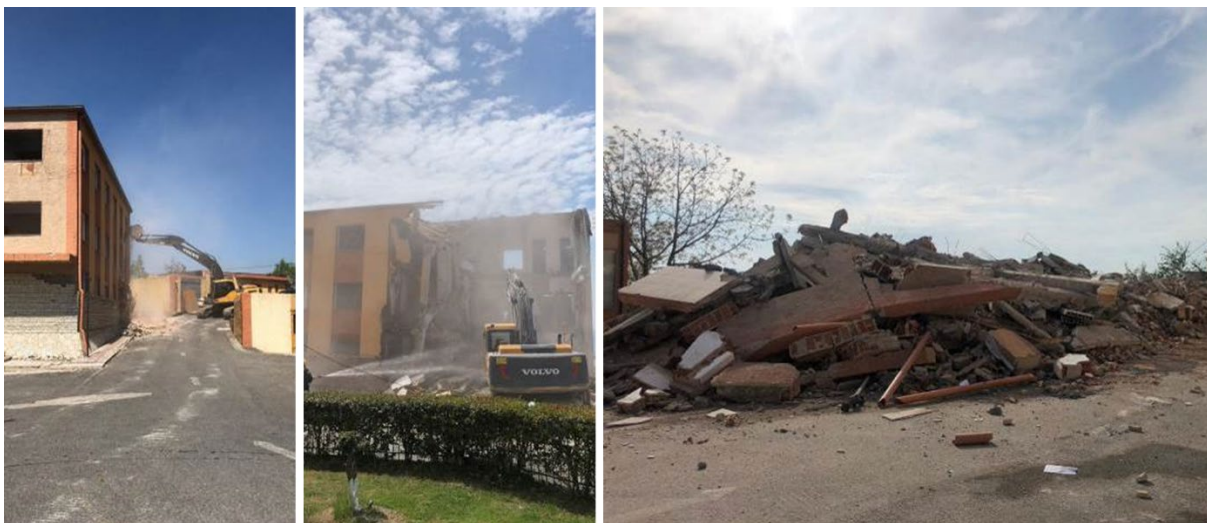
The three-story administrative building constructed as a reinforced concrete frame with masonry infill walls suffered moderate damage in its entrance area where one of the columns was damaged (shear cracks near to the joint). The administrative building was evacuated after the earthquake and was subsequently demolished (Figure 101).

Figure 101. Demolition of administrative building of the Kruja hospital building (photo: Aida Dedja).
