EERI Earthquake Reconnaissance Report:

M6.4 Albania Earthquake on November 26, 2019

Volume 1: Executive Summary

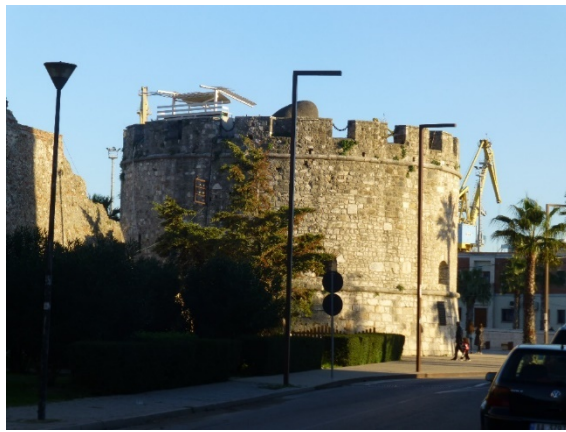
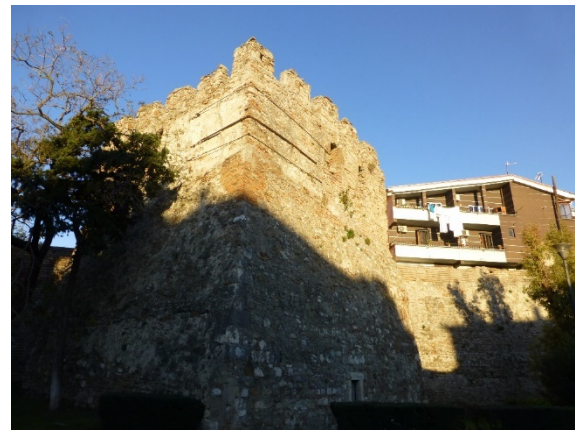
The castle was built in the first century BCE and acquired its final form in the fifth century during the rule of Byzantine emperor Anastasius I Dicorus. The fortification walls were devastated in the 1273 earthquake and had to be extensively repaired (Wikipedia, n.d.).⁶³ The castle was reinforced with several guard towers under the Republic of Venice (Figure 103(a)), whereas the walls were reinforced during the Ottoman Empire. The walls present different typologies of stone and brick masonry. Signs of the alterations and repairs of the walls and towers are visible, including local reconstruction of masonry walls and provision of metal ties for stitching the wall corners at the exterior (see Figure 103(b)).

Figure 103. Alterations and repairs of the Durrës Castle: (a) the Venetian tower and (b) gate tower (photos: EEFIT).

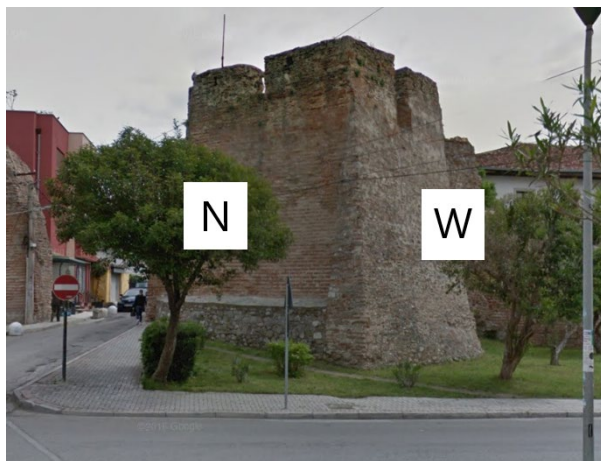
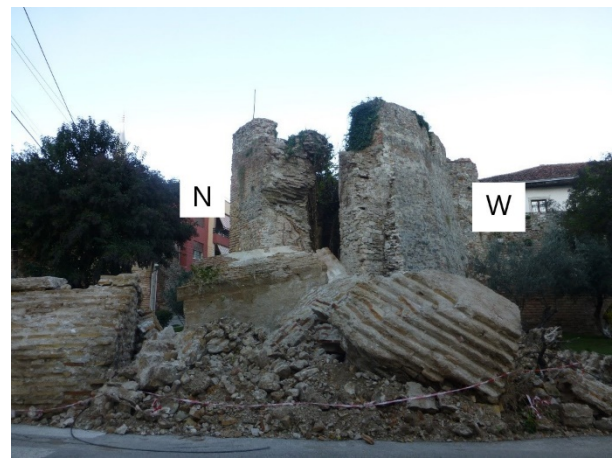
The damage caused by the November 2019 earthquake was concentrated in the tower gate located at the intersection between Anastas Durrsaku Street and Xhamia Street. A view of the tower before and after the earthquake is presented in Figure 104. The tower has a squared shape and is offset toward the road with respect to the fortification walls. By observing Figure 104(a), it is possible to identify different masonry technologies possibly associated with numerous alterations over time. The north façade shows a stone masonry base course supporting brick masonry walls. Toward the top, the wall changes from brick to stone masonry. On the contrary, the west façade was constructed with uniform stone masonry except for the merlons, which show a different type of stone masonry. The local repair of stones with brick is also visible on the wall. The stone masonry at the merlons appears to be in poor condition, with a visible decay and loss of mortar. Different types of masonry are connected at the corner, where the two walls rely on a poor interlocking, if any. Although it was not possible to access the interior of the tower, it was possible to observe extensive vegetation on the interior wall surface, which is a sign of a lack of roofing but also a lack of maintenance before the earthquake, possibly leading to the earthquake damage.

Figure 104. North (N) and west façade (W) of Durrës Castle before (a) (source: Google Maps) and after (b) the November earthquake (photot: EEFIT).

The collapsed material is quite varied (Figure 104(b)), and the masonry appears to have failed in blocks, which can be explained by the presence of very thick mortar joints, which are generally thicker than the masonry units (Figure 106). It is unknown whether the existing brick masonry is a part of the original wall or a result of a more recent alteration; this construction practice was quite common in the Byzantine time, particularly in seismic areas and/or in soft soil conditions (Binda, Tedeschi, and Baronio, 1999).⁶⁵ Studies on similar masonry structures showed that this type of material behaves more like concrete than mortar because its aggregate size reaches values closer to a modern concrete (Baronio, Binda, and Tedeschi, 1997).⁶⁶

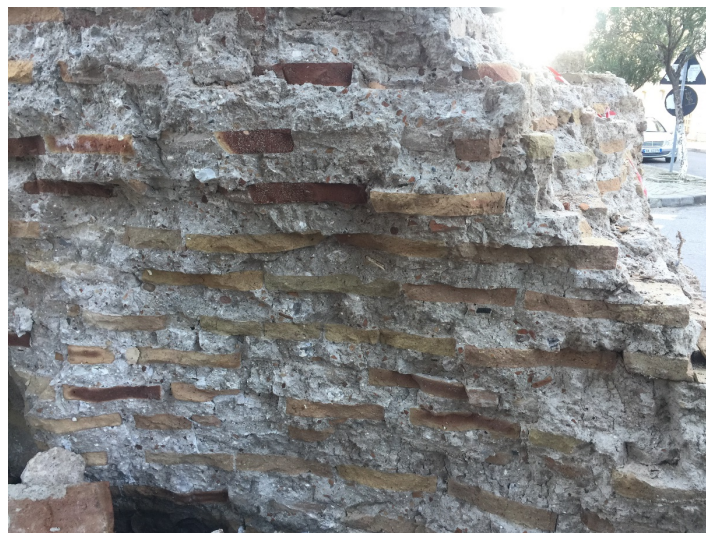
Figure 106. Close-up view of the collapsed masonry wall with thick mortar joints (photo: Federica Greco).

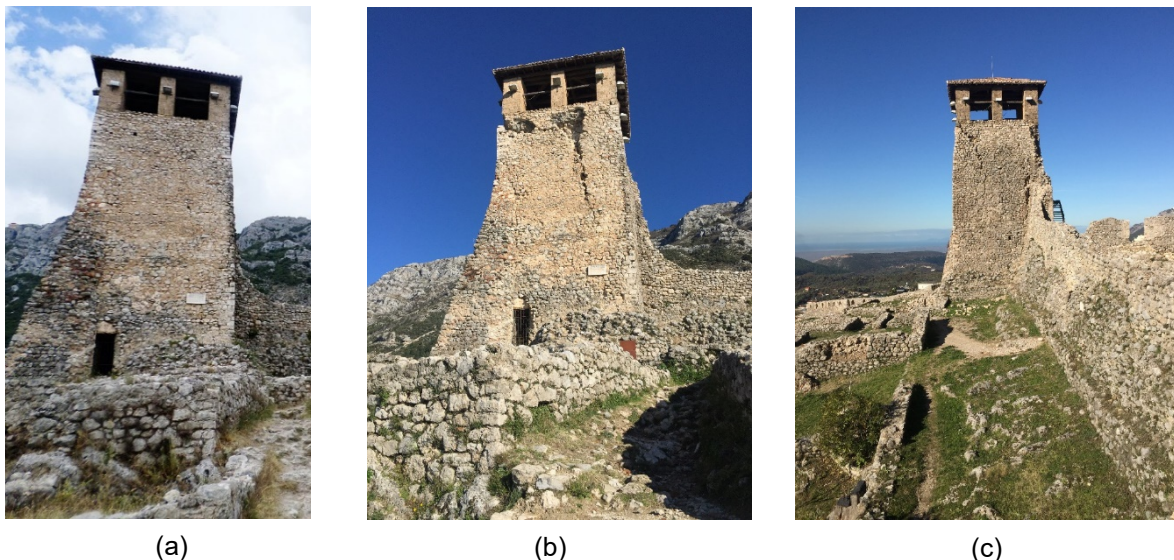
A view of the tower before and after the earthquake is shown in Figure 107. The type of failure observed is a global mechanism consisting of long vertical cracks in the walls and a significant out-of-plane displacement of the masonry walls toward the corners. No damage is observed on the belfry at the top of the tower, which proves the negative effect of the rigid floor system that was a part of the 1970s intervention. Such a high rigidity is usually not compatible with historic masonry and is often the source of earthquake damage.

Figure 107. A view of the tower at Krujë Castle: (a) front view before the earthquake in 2005 (source: copyright image available at https://commons.wikimedia.org/wiki/File:Krujë_Watchtower_and_Castle_Walls.JPG), (b) front view after the earthquake, and (c) side view after the earthquake (photos: EEFIT).

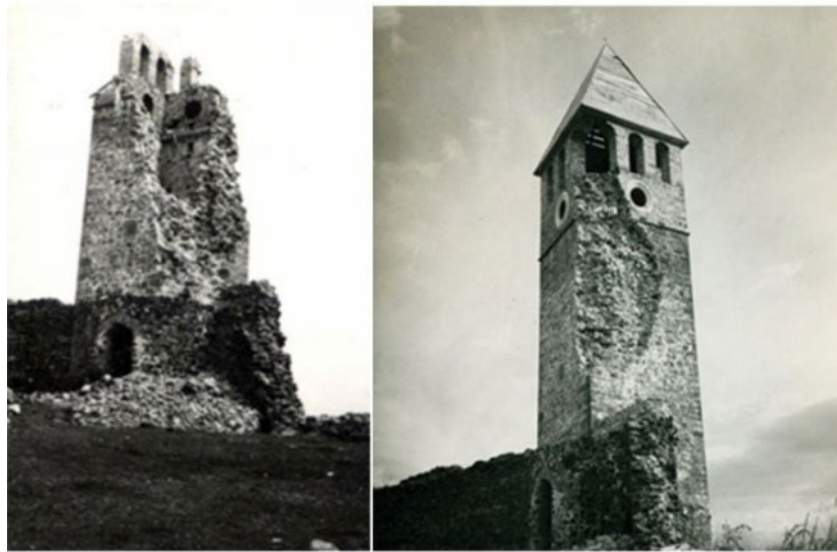
Figure 109. Damage of the tower in the Prezë Castle at different time periods (source: Mustafaraj and Yardim, 2014).

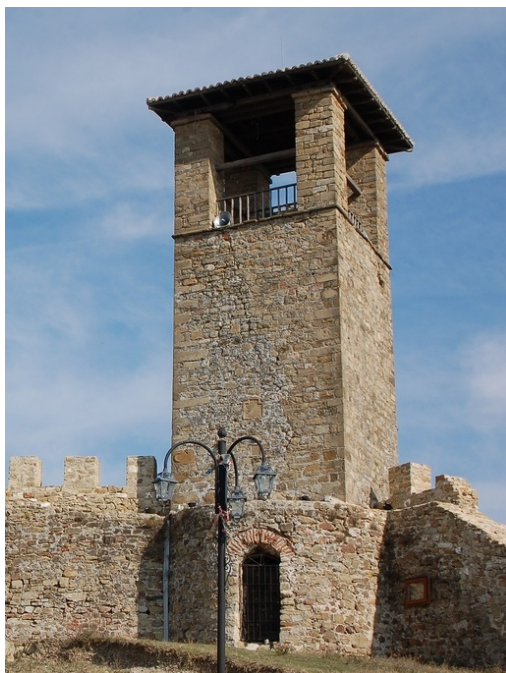
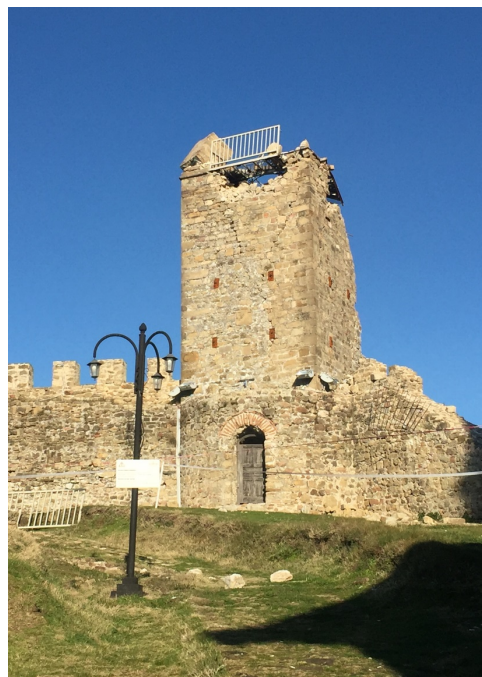
A view of the tower before and after the earthquake is presented in Figure 111. From Figure 111(b), it is possible to observe that the clock tower completely lost the roof and the columns framing the top floor. Figure 112 shows the opposite side of the tower, where the damage is more extensive and includes the loss of masonry in the upper third of the tower height (below the top floor).

Figure 111. View of the tower: (a) before (source: <https://qarkutirane.gov.al/2015/10/23/castle-preza/> accessed 2020) and (b) after the earthquake (source: EEFIT).

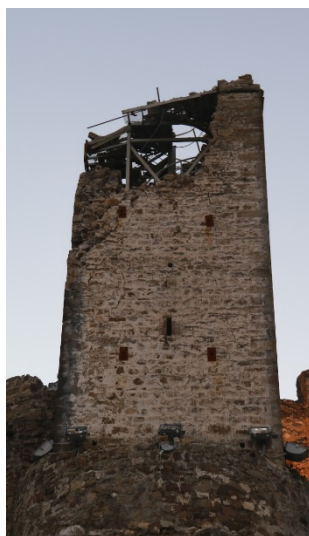
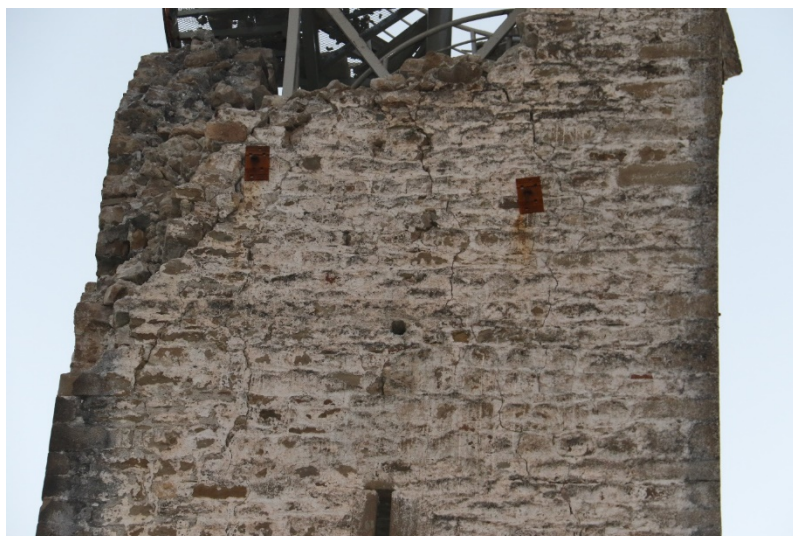
Figure 112. Damage of the clock tower at the south side (a) and close-up of the damaged portion (b) (photos: EEFIT).

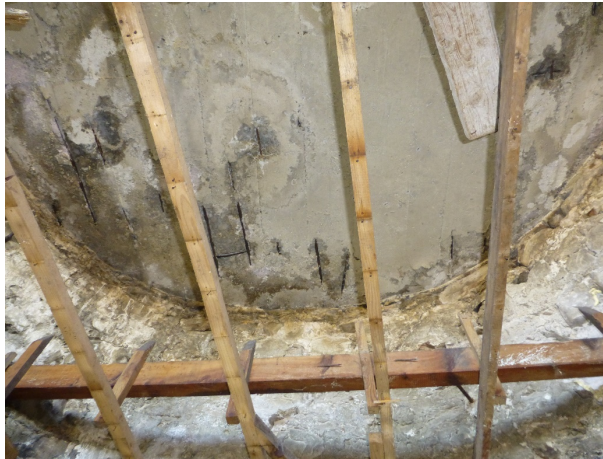
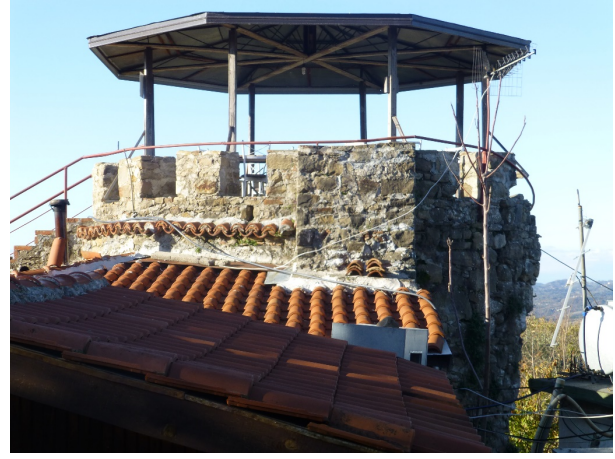
The damage was also observed in the north tower (Figure 108), which has a circular shape and stone masonry walls. Visible alterations of the original tower observed during the visit included the introduction of a reinforced concrete slab to create a terrace at the roof level (Figure 113(a)) and a new building on the side of the fortification walls adjacent to the tower (Figure 113(b)). The damage occurred in the exterior wall of the tower facing the cliff, which is the most vulnerable location because of the lack of confinement provided by adjacent structures. The masonry collapsed out-of-plane,

Figure 113. View of the tower and an alteration of the original configuration: (a) the new reinforced concrete slab and (b) new constructions adjacent to one side of the tower (photos: EEFIT).

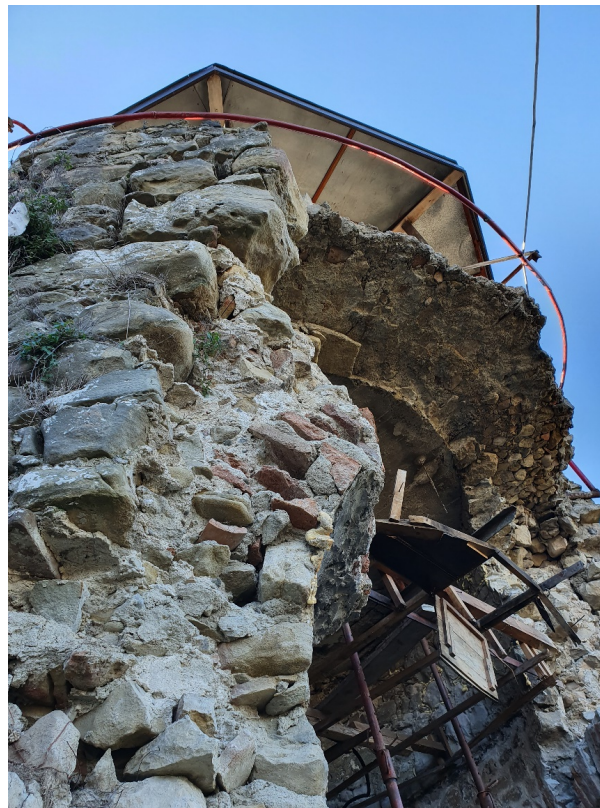
whereas the new reinforced concrete slab remained undamaged (Figure 114). The presence of the new, heavy floor activated a larger seismic mass and resulted in an increased seismic demand for overturning capacity on the wall.

Figure 114. Close-up of the tower showing damages (photo: EEFIT).

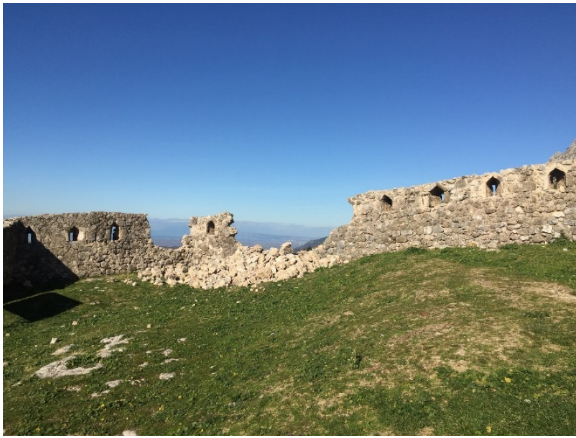
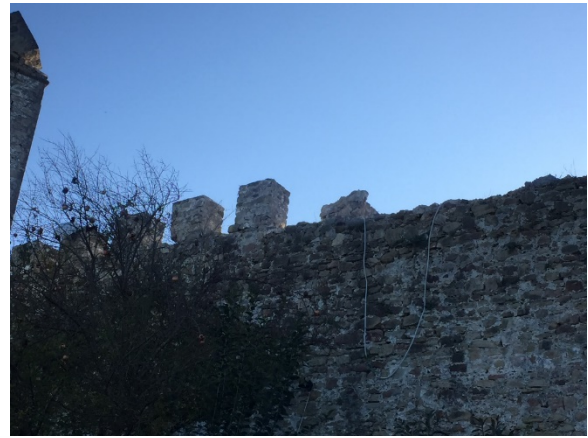
Fortified walls at a few sites suffered damage due to the November 2019 earthquake, particularly the fortified walls within the Krujë and Prezë castles. The damage was localized and consisted of the out-of-plane failure of the masonry merlons, as shown in Figure 115. Seismic vulnerability of the merlons, especially due to out-of-plane earthquake effects, is common and characteristic for ancient, fortified structures. This mechanism was observed occurring even at low-peak ground accelerations starting at about 0.05 g (Ferretti, Coisson, and Lenticchia, 2018).⁷²

Figure 115. Collapsed areas of the fortified walls: (a) Krujë Castle and (b) Prezë Castle (source: EEFIT).

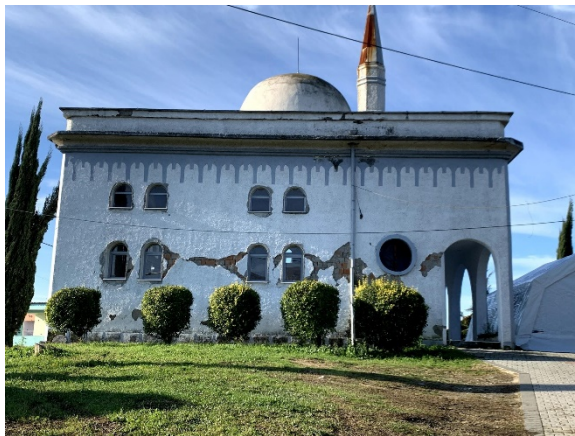
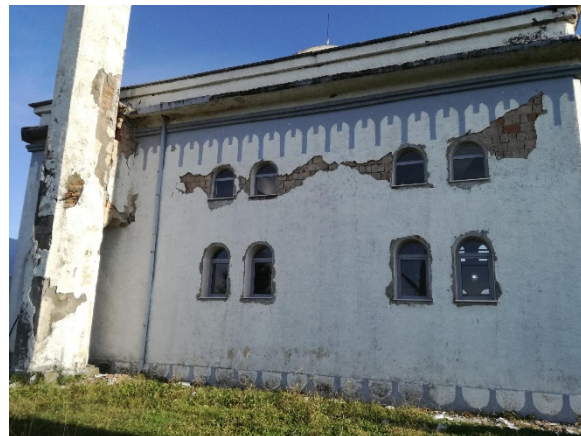
An exception was the mosque located in the Thumanë village (Figure 116), which experienced major damage. The structural system consists of exterior load-bearing masonry walls and reinforced concrete frames inside the interior of the mosque. The horizontal and vertical mortar joints are irregular in terms of the shape and thickness, and the thickness is variable.

Figure 116. Exterior view of the mosque in Thumanë showing damage in masonry walls and minaret (photos: HAEE).

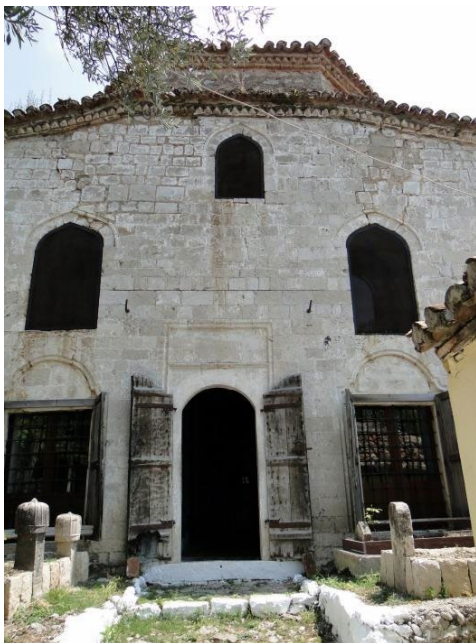
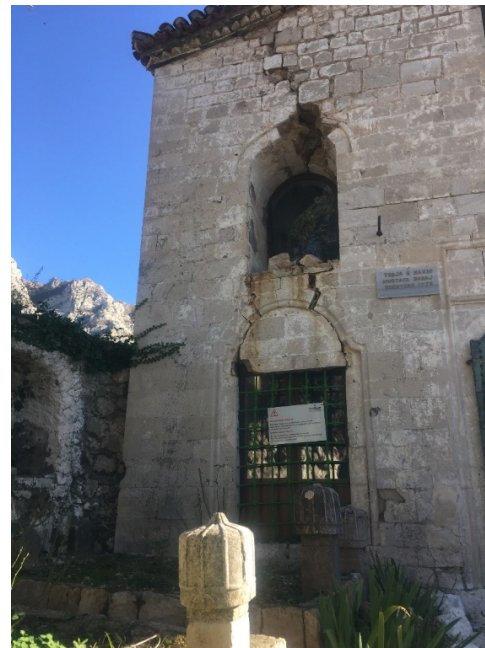
Figure 120. Tekke of Dollma: (a) before the earthquake (in 2010) (source: <http://www.visionsoftravel.org/Krujë-dollma-teqe-albania/>) and (b) after the earthquake (photo: EEFIT).

A comparison of the “before” and “after” exterior photos of the Tekke of Dollma (Figure 120) revealed that the cracking was present in the masonry walls at the same locations before the earthquake. The original causes for this cracking could be due to the ground instability observed in the area, as well as previous earthquakes. Therefore, the November 2019 earthquake appears to have caused a progression of the existing damage and significantly increased the size of the pre-existing crack pattern.

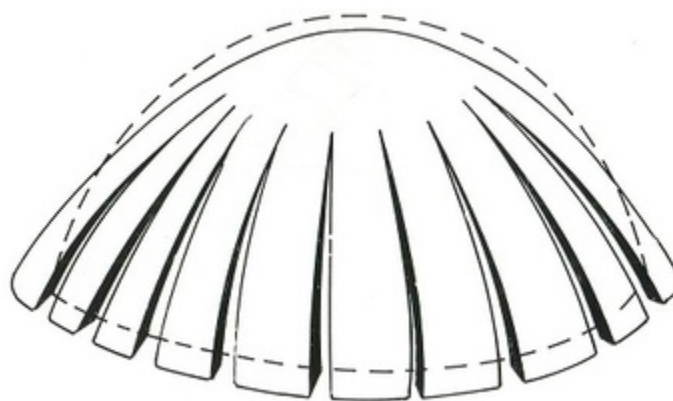
The Tekke of Dollma inside the Krujë Castle also suffered damage in the earthquake. The building has a square shape that becomes hexagonal in the upper part to envelope the central dome (Figure 119). The dome is sitting on squinches, which are in turn resting on the stone masonry walls. In-plane cracking was observed in the masonry walls. The cracks propagated diagonally from the bottom portion of the walls at corners and extended through the openings (Figure 120(b)). The corner failure is likely to be the cause of the cracking in the dome, which can be seen in Figure 121. From a glimpse of the inside, the dome presents a meridian crack pattern without cracking at the crown portion but with regular cracking (like “slices”) in the lower part, as shown in the schematic illustration by Heyman (1995)⁷³ presented in Figure 122. This type of failure is generally caused by movement in the dome’s support, causing an increase of the dome’s span.

Figure 122. An exaggerated schematic illustration of the cracking pattern in the dome due to the span increase (source: Heyman, 1995).
